ROAD SAFETY AUDIT

Bridgewater Central Square &
Bedford Street (Route 28/Route 18) at Grove Street
Town of Bridgewater

November 2019

Prepared By:
McMahon Associates, Inc.
350 Myles Standish Boulevard, Suite 103
Taunton, MA 02780

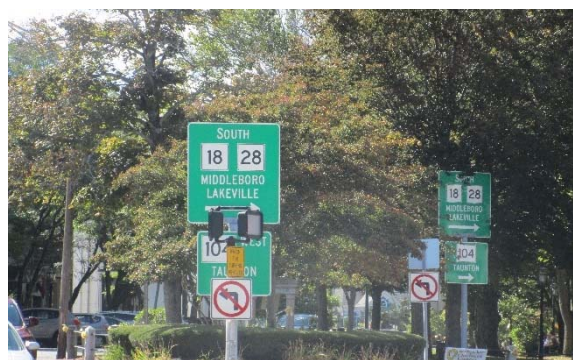
During the field visit, audit team members noted signage clutter and visibility issues within the entirety of Central Square. The guide signs within the northern section of Central Square for Routes 18, 28 and 104 were angled in a way which made visibility difficult. Additionally, the guide signage for Broad Street southbound was angled incorrectly and was noted to possibly be extraneous due to other available signage. The signalized intersection of Main Street (Route 28)/Central Square/Summer Street (Route 104)/Broad Street (Route 18) was also noted as leading to confusion and visibility issues for drivers. It was noted that the intersection does not provide the most up-to-date signalization equipment including backplates with retroreflective borders and visors. Sun glare and the angle of the signal heads was also noted to obstruct and impede the visibility for drivers.

Image 1: Guide Signage for Routes 18, 28, and 104

- Review the existing signage provided at the signalized intersection for removal or replacement, and consider implementing advanced warning signage, lane guidance signage and street signage at the intersection.

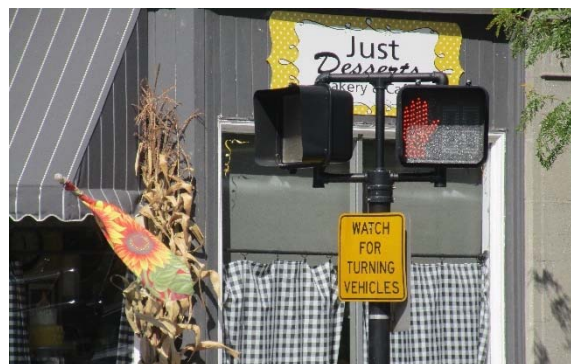
The pedestrian signalization equipment accessibility, push buttons and curb ramps were also noted to be non-compliant with Americans with Disabilities Act (ADA) standards. The signalized intersection provides concurrent pedestrian phasing which increases potential conflict between turning vehicles and pedestrians (for example, vehicles turning left onto Summer Street (Route 104) would conflict with concurrent pedestrian phasing on the approach). The pedestrian crossing locations currently provide signage at the intersection warning pedestrians to “Watch for Turning Vehicles” which is not an MUTCD standard sign. The pedestrian crossing on the Main Street (Route 28) approach was observed to be relatively wide and due to the existing pre-timed signalization pedestrians were observed to wait for a significant amount of time to cross. The Main Street (Route 28) and Broad Street (Route 18) pedestrian crossings were also noted to inconsistently allow pedestrians to cross concurrently or call only one of the crossings.

Image 2: “Watch for Turning Vehicles” Signage

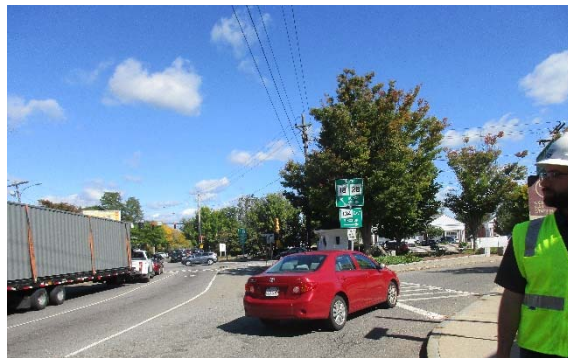
The geometry at this signalized intersection creates poor sight lines and visibility issues. Specifically, the northbound Central Square approach aligns with curbing on the northeast corner of the intersection instead of the Broad Street (Route 18) northbound receiving lane. The current signalization allows the eastbound Main Street (Route 28) right-turn to operate concurrently with the westbound Summer Street (Route 104) permitted left-turning movement. Due to the wide cross-section of the Central Square southbound receiving lanes, the two movements were observed to create potential conflict where right-turning vehicles are turning right on red from Main Street (Route 28) eastbound and cutting-off left-turning vehicles during the protected portion of the phase.

**Image 3: Central Square Approach
Right-Turn Lanes**

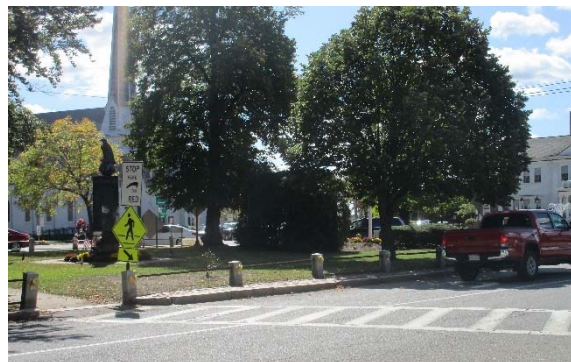
As noted by audit team members during the site visit, many of the signs within Central Square are non-compliant, outdated, and are not visible to drivers. It was noted that many of the signs are close to the ground, do not provide MUTCD-compliant height (at least 7') required, and are hazardous for pedestrians. Guide signage within Central Square was noted to be blocked by trees and there is a lack of guide signage visible to drivers from School Street. It was also noted that Central Square contains a large amount of sign clutter or confusing guide signage. Vehicles were observed to weave between lanes within Central Square to access angled parking within Central Square or the correct lane assignment. Audit team members stated that drivers familiar with the area know there is parking behind the businesses, a Town-owned parking lot to the east, library parking and angled parking within Central Square. Visitors and those unfamiliar with the area are likely unaware of off-street parking locations as the area lacks wayfinding signage.

Image 4: Central Square Pedestrian Crossing Providing Non-Compliant Signage

- Evaluate the existing Central Square and approach signage for relocation, removal, and replacement.
- Evaluate the existing guide signage for relocation or removal and consider implementing guide signage for available municipal parking lots proximate to Central Square.

- Consider removing the rotary signage and replace with one-way and chevron signage and implementing geometric improvements at the approach corners to Central Square to reduce time vehicles are in conflict with other movements.

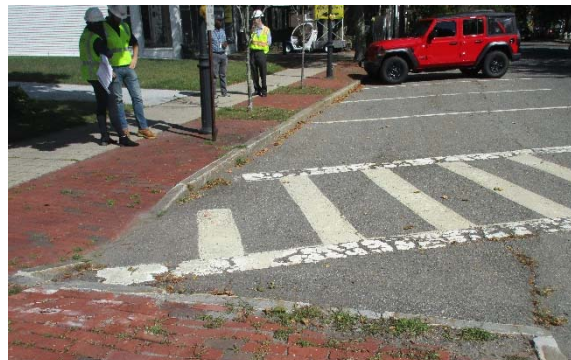
Central Square currently provides curb extensions which do not align with the mid-block crosswalks and it was noted that some crosswalks lack pedestrian ramps at their terminus and instead align with driveways. A number of the mid-block pedestrian crossings are also angled which limits visibility for drivers and provides longer than necessary pedestrian crossing distances. The angled parking within Central Square was also noted to be located too close to pedestrian crossings which obscures driver sight lines of crossing pedestrians.

Image 5: Pedestrian Crossing Adjacent to Angled Parking

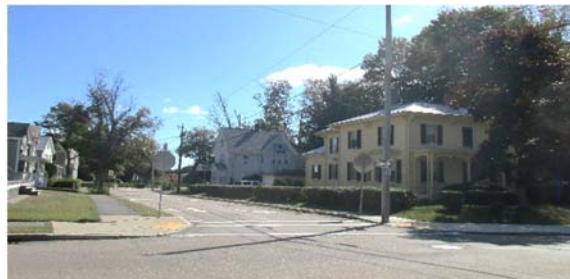
During the RSA, the audit team observed that the two-lane westbound approach on Grove Street and the vegetation on the southeast corner of the intersection may cause driver visibility issues. The height of vegetation on the southeast corner was observed to be approximately driver's eye height, and a row of hedges ends just after the stop line on Grove Street. It was noted by the team during the audit that left-turning vehicles on the Grove Street approach may block a drivers' visibility to travel through the intersection. Crash number 34 specifically noted that the crash was indirectly caused by the driver on Grove Street having limited vision of Bedford Street (Route 28/Route 18) due to a left-turning vehicle on the Grove Street approach. Audit team members knowledgeable of the area mentioned that drivers from the Bridgewater State University campus use Grove Street to access Route 18 to the south or Route 104. It was also noted that there are a number of construction projects taking place around Bridgewater diverting commercial traffic to residential areas to avoid vehicle queuing around Central Square.

Image 6: Grove Street Westbound Approach Lanes

indirectly caused by the driver on Grove Street having limited vision of Bedford Street (Route 28/Route 18) due to a left-turning vehicle on the Grove Street approach. Audit team members knowledgeable of the area mentioned that drivers from the Bridgewater State University campus use Grove Street to access Route 18 to the south or Route 104. It was also noted that there are a number of construction projects taking place around Bridgewater diverting commercial traffic to residential areas to avoid vehicle queuing around Central Square.
