Centre Street (Route 123) at Plymouth Street

Municipality of Brockton

November, 2017

Old Colony Planning Council

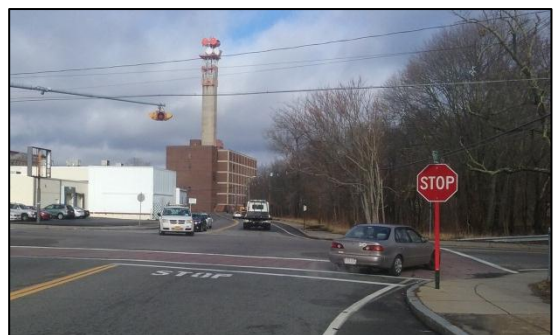
Safety Issue: Lack of Sight Distance Due to Vegetation and Parked Vehicles

Sight distance for vehicles approaching the intersection on Plymouth Street from the north as well as from the south is obscured by the presence of vegetation along the east side of the intersection parallel to Trout Brook and Plymouth Street. In addition, vehicles on the Plymouth Street northbound approaches have sight blocked due to parked cars along the west side of Plymouth Street and the south side of Centre Street (Route 123).

Vegetation to the right of the photo (northeast corner) obscures sight distances for vehicles waiting at stop line on the southbound approach

Enhancements: Trim back the vegetation on the northeast and southeast corners of the intersection to improve sight lines and consider prohibiting parking by posting “No

Parking” signs (R7-1) on Plymouth Street west side south of the intersection and on Centre Street (Route 123) south side west of the intersection far enough back to prevent sight blockage.

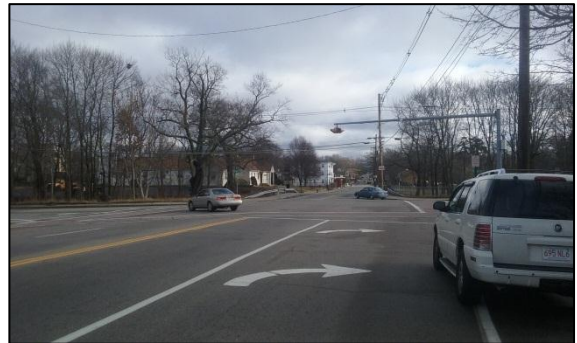
Safety Issue: Vehicle parking too close to the intersection

Vehicles park on Centre Street (Route 123) along the south side of the street on the eastbound approach (in front of the housing complex) right up to the intersection. In addition, vehicles are parked too close to the intersection on Plymouth Street along the west side of the street (in front of the housing complex). The right turn radii is hindered for buses, heavy vehicles, and right turning traffic (Centre Street eastbound to Plymouth Street southbound) due to these parked cars and parking maneuvers along the west side of Plymouth Street and the south side of Centre Street (Route 123) hinder moving traffic. The parking enforcement is not done on a regular basis, and the posted time limit for parking is only posted in one location (across the street from the BAT Parking Garage). In addition, these parked cars close to the intersection hinder the sight distance for Plymouth Street northbound vehicles looking west.

Vehicle parked too close to the intersection on the eastbound Centre Street (Route 123) approach.

Enhancements: Limit parking and post No Parking on Plymouth Street west side south of the intersection and on Centre Street (Route 123) south side west of the intersection far enough back to prevent sight blockage. Parking along the south side of Centre Street (Route 123) west of the intersection and parking along Plymouth Street on the west side south of the intersection, should be limited to permit parking for residents in the housing complex.

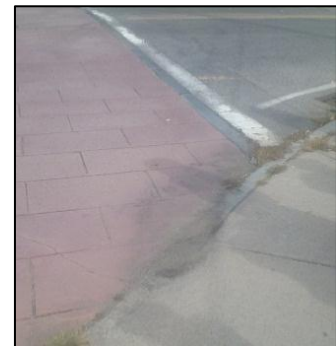
Safety Issue: Drainage Issues and Catch Basin Locations

A catch basin is located in the crosswalk at the southwest corner of the intersection. In addition, there are signs of ponding at the base of the curb ramp.

Signs of ponding on the crosswalk

Enhancement: Evaluate existing drainage conditions and relocate the catch basin that is within the crosswalks and other catch basins if necessary to improve drainage.
