ROAD SAFETY AUDIT

Crescent Street Intersection Improvement Project

City of Brockton

December 30, 2015

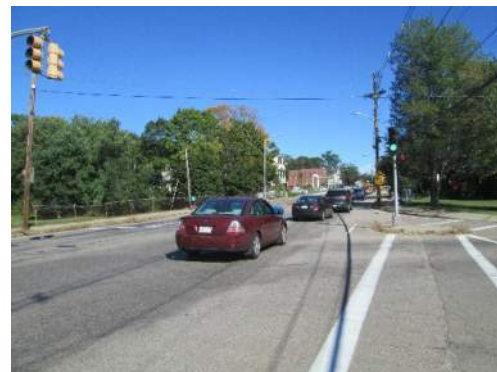
The Crescent Street EB left lane is a left turn only lane. No pavement markings are present in advance of the intersection that identify that a left turn lane is coming up even though there are pavement markings right at the intersection approach. An old and outdated “Left Lane Must Turn Left” sign is present at the intersection. Vehicles accustomed to the intersection are aware of the left turn lane. However, vehicles not accustomed with the intersection often wait and try to merge into the right lane to cross through the intersection. This creates a queue of cars behind them and may contribute to crashes at this intersection. This movement also creates congestion in front of the Fire Station emergency response bays and appears to have resulted in many crashes as shown on the crash diagram for the intersection. Five (5) crashes have occurred in connection with this problem. Refer to Appendix C for more detailed crash data.

Figure 3: Looking East on Crescent Street

1. Provide advanced lane designation signs for each approach to the intersection including the Crescent Street EB lanes indicating a left turn only lane and a thru/right lane
2. Replace existing street name signs with larger MUTCD compliant street name signs.

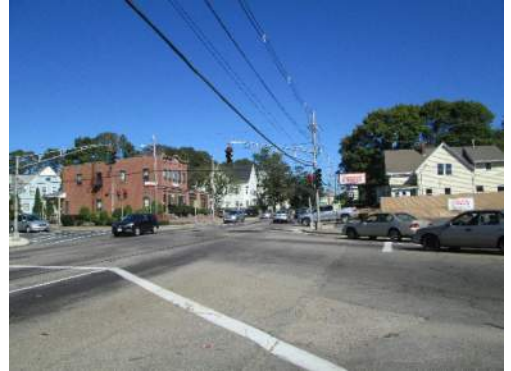
The all red clearance interval phase of the existing signalized intersection is only 1 second long. It appears that vehicles waiting to make a left turn from Crescent Street eastbound to Lyman Street northbound may find themselves in the middle of the intersection when the next green phase on Lyman Street has started. Approximately twelve (12) of the vehicle crashes may have been caused by Crescent Street eastbound vehicles running the red light. Refer to Appendix C for more detailed crash data.

Figure 4: Vehicle running a red light

1. Re-evaluate signal phasing.
2. Evaluate if the existing green ball signal head can be replaced with a doghouse style signal head to provide green arrow indications during the lead phase.
2. Replace old existing traffic signals with new fully activated traffic signals mounted on mast arms with signalized pedestrian crossings.

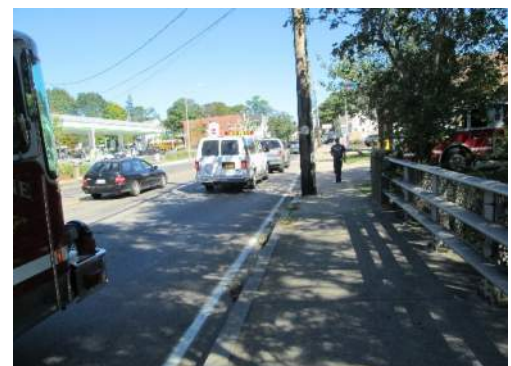
As stated in Safety Issue #6, vehicles that are unfamiliar with the intersection traveling east on Crescent Street block the Fire Station emergency response bays. There is a sign that states not to block the Fire Station driveway, but the sign is mostly ignored.

Figure 5: Vehicles obstructing the Fire Station emergency egress

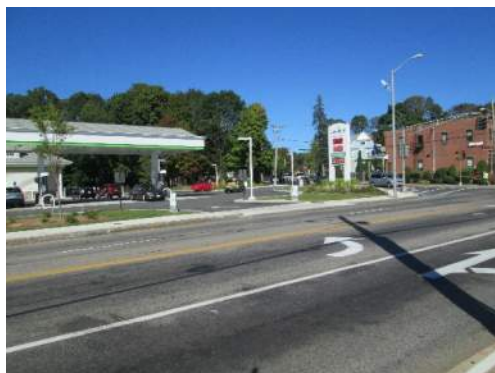
The newly constructed Cumberland Farms is located on the northwest corner of the intersection. The Cumberland Farms has a two-way driveway curb cut on the Crescent Street western approach and a second two-way driveway curb cut on the Lyman Street northern approach. It also has a one-way-in driveway curb cut located on Crescent Street right at the northwest corner of the intersection. This third driveway allows cars to enter the Cumberland Farms from the middle of the intersection. This third driveway curb cut creates a potential safety hazard, with conflicting vehicles and pedestrians

Figure 6: Access at Cumberland Farms

1. Close the one-way-in Cumberland Farms driveway curb cut that forms the third driveway.
2. Close the Dunkin Donuts third driveway curb cut located on Lyman Street immediately south of the intersection curb radius.

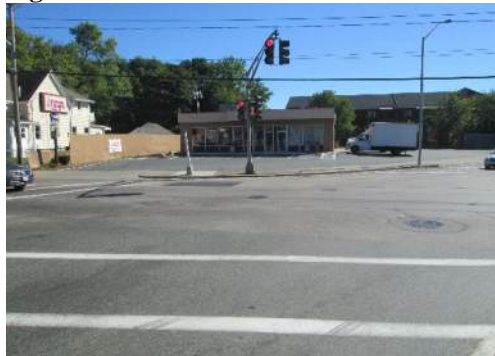
There have been two crashes that appear to have occurred at this third Dunkin Donuts' driveway curb cut. Although we are not aware of any crashes that have been attributed to the third Cumberland Farms driveway, vehicles were observed driving through the middle of the intersection to enter Cumberland Farms through their third driveway curb cut. Refer to Appendix C for more detailed crash data.

Figure 7: Access at Dunkin Donuts

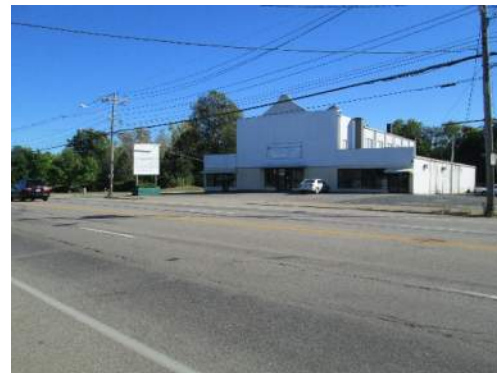
Figure 9: Looking South at the Church

Left turn movements on Crescent Street westbound to enter the Church and Day Care Center located on the south side of Crescent Street, just west of the intersection, create potentially unsafe conditions for vehicles. Vehicles often stop traffic in the left lane and wait to make the turn, creating a queue into the intersection.

1. Add left turn lane pavement markings to provide a center left turn lane to serve the Church and Day Care Center. Extend a painted or raised median to the Plymouth Street intersection from the Church and Day Care Center left turn lane and also use it to shield a left turn lane at Plymouth Street.

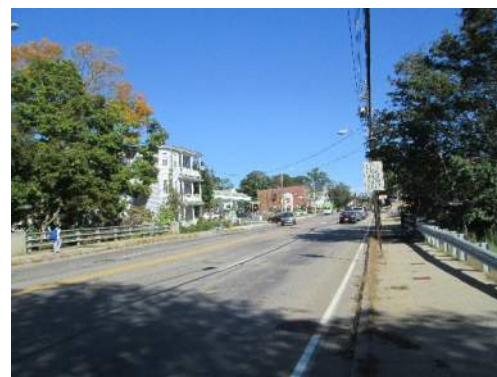
Figure 10: Vegetation to the East inhibiting Fire station egress sight distance

1. Clear trees and brush in area immediately behind the sidewalk and guardrail.

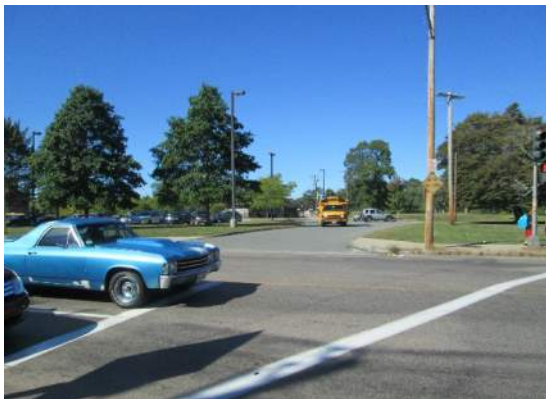
Figure 11: Looking North at Plouffe Academy Driveway

Review of the turning movement volumes indicate there are rarely any right turns from Summer Street to go eastbound on Crescent Street. The intersection is currently signed as no left turn allowed. However a fire truck was observed making the left turn movement. The Fire Department representative suggested that left turns be permitted from Crescent Street westbound to Summer Street.

1. Re-align the Plouffe Academy Middle School parking lot driveway with the intersection and include the school driveway into a new fully activated traffic signal.
2. Evaluate the impact of eliminating the no left turn restriction from Crescent Street westbound to Summer Street. If the left turn restriction is to remain, than a short term solution would be to change the signal indications for westbound Crescent Street to be green thru arrows from green balls for clarity of allowable movements.

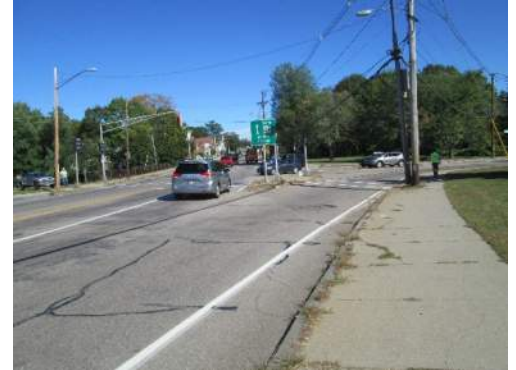
Figure 13: Looking East on Crescent Street Right Turn Lane

A member of the RSA team observed that drivers didn't seem to slow down much as they approach the right turn slip lane from Crescent Street eastbound to Summer Street. A member of the RSA team observed that some cars seemed to be speeding from the Plymouth Street intersection to beat the red light at Summer Street. There were two (2) crashes at this location due to out of control vehicles, where speed may have been a

3. Re-align the Crescent Street right turn slip lane to Summer Street to force vehicles to make a slower more deliberate turning movement.
4. If the left turn restriction is to remain, than a short term solution would be to change the signal indications for westbound Crescent Street to be green thru arrows from green balls for clarity of allowable movements.
5. Eliminate the right turn slip lane from Summer Street north to Crescent Street eastbound.

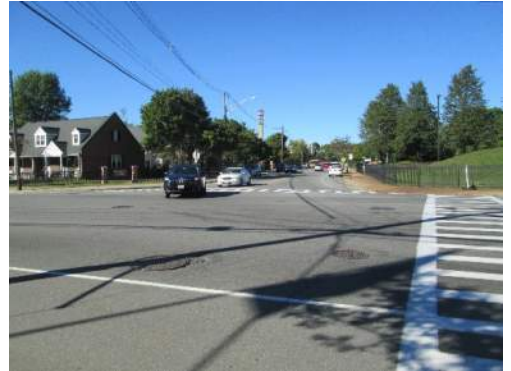
Figure 15: Looking North at Plymouth Street

Vehicles traveling along Crescent Street in both travel directions have sufficient sight distance and often speed as a result. Drivers are able to see the crosswalks, but not necessarily the pedestrians waiting to cross the wide street. Plouffe Academy Middle School employs crossing guards to help the young students cross the street before and after school hours. Vehicles making a right turn from Crescent Street westbound onto Plymouth Street were observed speeding around the corner, some vehicle's tires could be heard "squealing."

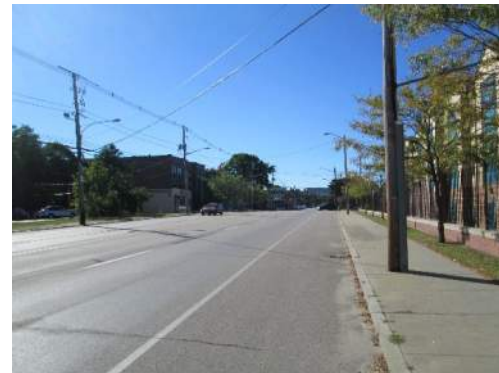
Figure 16: Looking West on Crescent Street (Plouffe School)

Each approach to the intersection has a painted crosswalk but no wheelchair ramps. The crossing distance is also unreasonably long on Crescent (65 feet) and causes problems for pedestrians. Any pedestrian trying to cross has to navigate across four lanes of traffic on a heavily traveled road. Some pedestrians were observed waiting on the double yellow center line for cars to pass. A crash involving a pedestrian (student) crossing Plymouth Street hit by a vehicle turning left from Crescent Street eastbound was reported at this intersection. It was also noted that very often there are students that are walking to or from school prior to when the crossing guards are in place causing safety concerns.

1. Repair or replace existing flashing beacon school zone mast arm signs.
2. Install School Zone speed limit signs on the Crescent Street and Plymouth Street approaches.
3. Move the Plymouth Street stop sign further south to align with the painted Stop line.
4. Install pedestrian crossing signs.

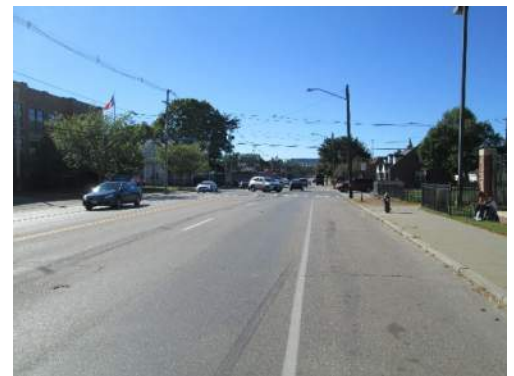
Figure 17: Looking West on Crescent Street

Pedestrians and vehicles on Plymouth Street have little to no sight distance on Crescent Street in both directions. On both sides of the intersection there are fill slopes, fences and parked cars that obstruct sight distance. Pedestrians have to walk into the shoulder at times to get a better view of the oncoming traffic. Vehicles trying to turn onto Crescent Street from Plymouth Street have to pull forward into the roadway to get a clear view.

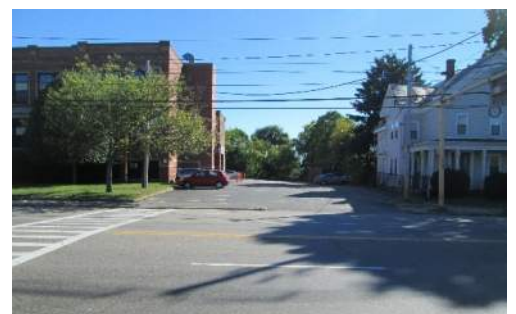
Figure 18: Looking South at Adult Learning Center Driveway

The Adult Learning Center driveway is located adjacent to the southwest side of the Plymouth Street intersection. The placement of the driveway makes it difficult for exiting vehicles wanting to go westbound on Crescent Street or northbound on Plymouth Street. These vehicles have to wait for gaps in both the eastbound and westbound traffic before making the exiting movement. Vehicles trying to enter the Adult Learning Center from Crescent westbound have to

wait for gaps in the eastbound traffic before turning into the parking lot. There have been two (2) reported crashes at the Adult Learning Center driveway.

1. Provide a fully dedicated 5 foot wide bike lane that will also discourage vehicles from parking on Crescent Street because there will not be adequate space for them to pull over.
2. Remove the currently allowed on-street parking on Crescent Street and place No Parking signs at appropriate locations. Work with Brockton Police department for initial enforcement of no parking for school drop off or pick up.
3. Work with the Plouffe Academy Middle School to add signing and distribute flyers directing parents to the Plymouth Street parent drop-off and pick-up lot.

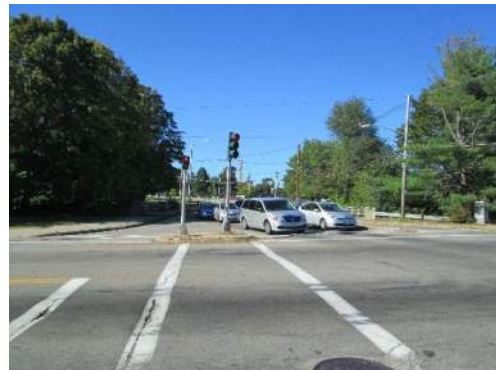
There are two through lanes on Summer Street on the west side of the intersection; however there is only one receiving lane on the east side of the intersection. Further east on the Summer Street at the next intersection the pavement markings show an exclusive left turn lane and a through lane.

Figure 20: Vehicles queuing on Summer Street

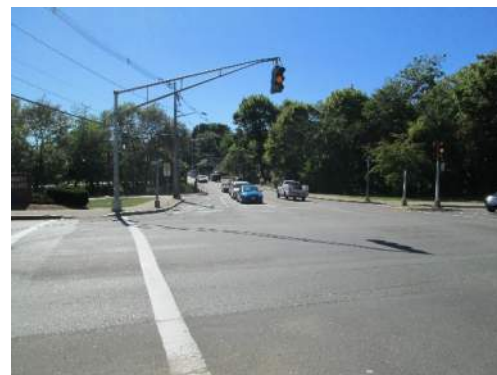
Figure 21: Looking West at Grove Street

The audit team observed that the Grove Street right turn lane has only enough room for two or three cars. Vehicles traveling over the bridge must abruptly turn right to make it into the right turn lane.

1. Consider widening the bridge to extend the length of the right turn lane on the Grove Street northbound approach.
