# ROAD SAFETY AUDIT

Route 123 (Belmont St.)/West St./West Side Plaza Dr.,  
Route 123/Forest Ave./West Side Plaza Dr.  
Route 123/West St.

City of Brockton

May 5, 2016

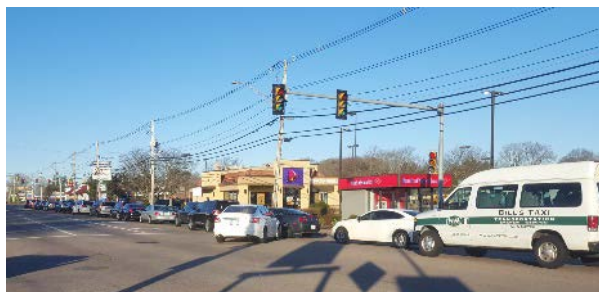
1. Between 6:40 a.m. and 7:20 a.m. and 2:00 p.m. and 2:20 p.m., when students are either arriving at or departing from Brockton High School, long queues form in the westbound left turn lane on Route 123 at Angus Beaton Drive which extend through the entire study corridor and beyond the easterly West Street intersection. This results from the high number of students which cross Belmont

Street at Angus Beaton Avenue during these time periods. Students are dropped off/picked up in the shopping center parking lot on the north side of the street. Crossing guards activate the exclusive pedestrian phase and then augment the red signal indications with hand held STOP signs. The pedestrian phase is called almost every cycle which results in the long delays and queues on Belmont Street. The long queues result in gridlock on Belmont Street with drivers becoming frustrated and exhibiting aggressive driving behavior as seen in Image 1.

**Image 1: Belmont Street WB during school arrival**

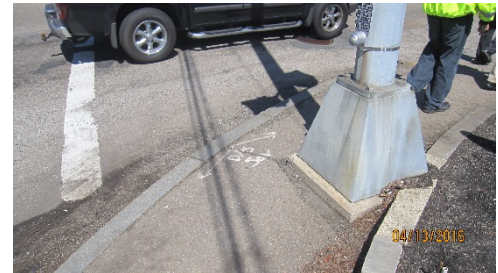
1. There are a number of locations along the corridor where poor placement of signal equipment reduces the sidewalk width to less than two feet.
2. The transition from sidewalks to crosswalks does not meet current design standards for pedestrian accommodations and ADA/AAB accessibility standards.
3. Sloped granite edging on the north side of Belmont Street does not provide adequate protection for pedestrians.
4. RSA members indicated that pedestrians cross Belmont Street outside of crosswalks and were observed using cell phones or texting while walking across Belmont Street. This is prevalent in front of the 7 Eleven where there are no crosswalks on Belmont Street.

**Image 2: Sidewalk obstructed by signal equipment**

1. Relocate signal equipment to provide a minimum five foot wide clear sidewalk.
2. Replace granite sloped edging with vertical granite curbing and add ADA/AAB compliant accessible ramps at crosswalks.
3. Work with Brockton Public Schools to educate students on pedestrian safety.

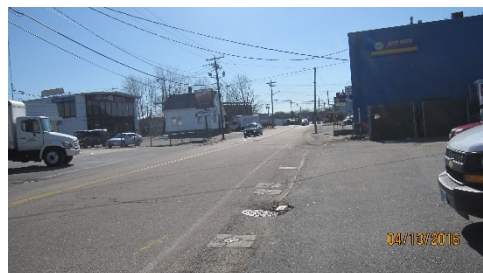
1. Curb cuts throughout the corridor do not meet current MassDOT standards. The numerous curb cuts at 7-Eleven, Sunny's Auto Center and the Shell Gas Station, all located along the south side of Belmont Street, were mentioned at the RSA. The numerous and wide curb cuts make it difficult for motorists to determine where a vehicle may be turning to enter the roadway or turning to enter a driveway.
2. Numerous access points to shopping centers are provided along the north side of Belmont Street and on West Street. This encourages traffic to cut through the shopping centers to avoid Belmont Street. RSA team members asked if the driveways could be consolidated.

**Image 3: Poor access management along Belmont Street**

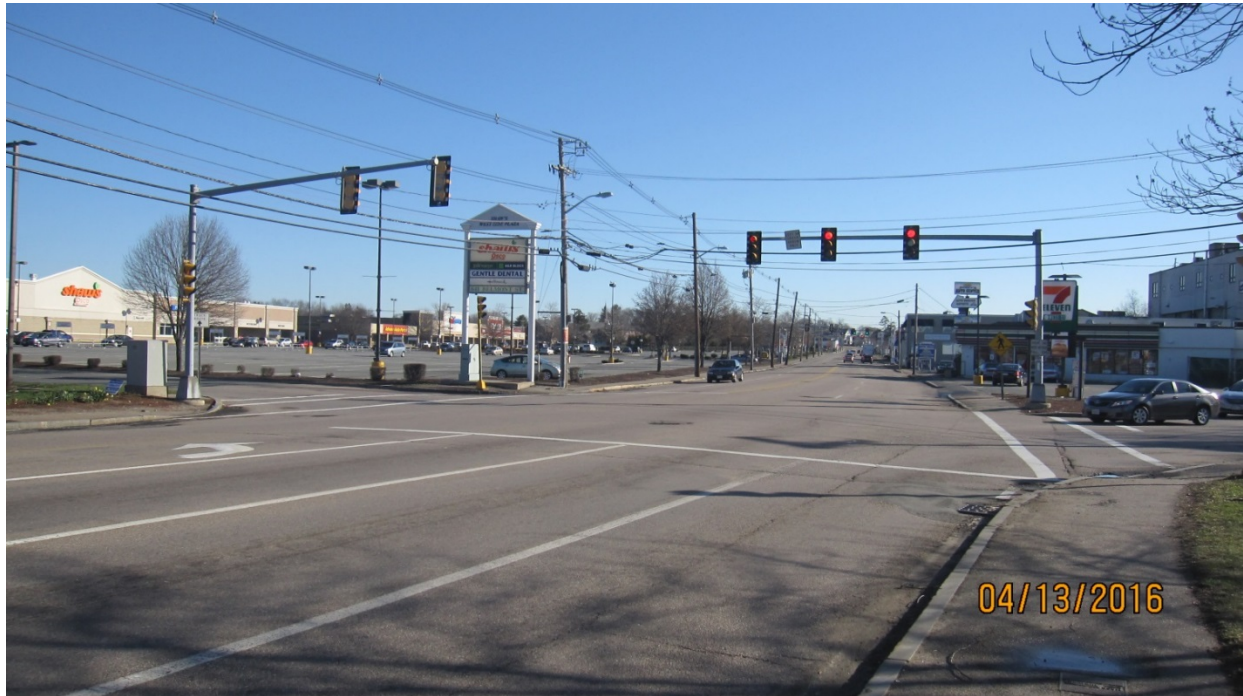
**Image 4: Belmont Street at West Street and West Side Plaza Driveway**

1. Audit team members noted that when motorists turn left from West Street onto Belmont Street (to proceed west) they often incorrectly enter the eastbound left turn lane before merging into the inner westbound departure lane. It was also noted that left turning vehicles from West Street often block southbound through vehicles. These issues are related to the poor alignment of the West Street approach to the intersection.

3. A right turn on red is allowed on all approaches to the intersection. However, motorists were observed not stopping before turning.
4. The signal detectors on Belmont Street appear to be malfunctioning. For instance it was observed that a green indication is given to Belmont Street although a vehicle was waiting on a minor approach with little or no traffic on Belmont Street.

1. Provide adequate pavement markings and signing for the Belmont Street eastbound right turn lane.
2. Consider a “No Turn on Red” restriction for the Belmont Street eastbound right turn lane.
3. Remove the existing crosswalk sign.
4. Test and repair, as necessary, loop detectors on Belmont Street.
5. Remove the SCHOOL pavement marking west of the intersection.

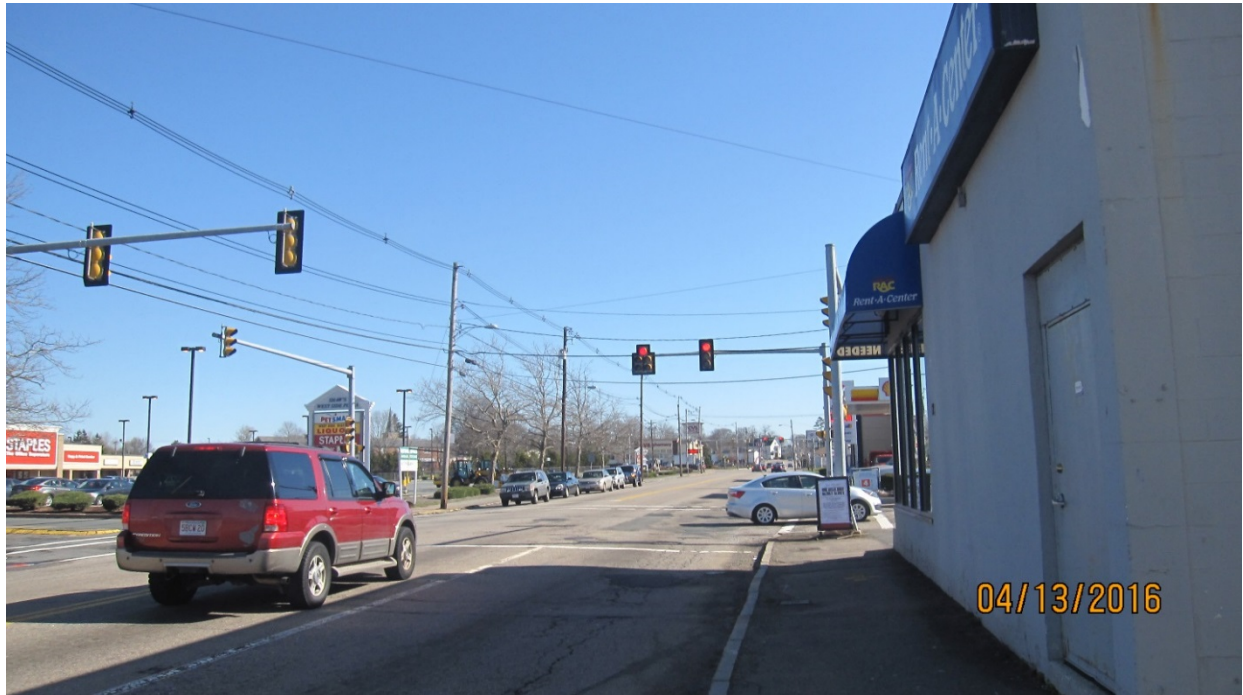
**Image 5: Belmont Street at Forest Avenue/West Side Plaza Driveway**

1. The amount of time a green indication is provided to Belmont Street is shorter than the green time provided to the minor street approaches. The Belmont Street phase ends before the demand on Belmont Street is completely met and without a vehicle on the minor approaches. The audit team noted that six crashes involving vehicles turning left from Belmont Street, all of which resulted in injuries. The short amount of green time given to Belmont Street may be causing motorists to drive aggressively through the intersection, resulting in injury crashes. The short green time provided to Belmont Street may be the result of detectors that are not working properly or an inadequate signal timing plan.

2. Based on the signal permit, a lagging phase is provided to Belmont Street eastbound. Although not observed during the audit, members indicated the phase is occasionally called.

1. The signal detectors on Belmont Street need to be evaluated and possibly repaired.

1. Update pedestrian signal equipment to the latest Accessible Pedestrian Signal (APS) standards, including countdown pedestrian signal heads and pushbuttons.
2. Evaluate the need and feasibility of a crosswalk on the west leg of Belmont Street.

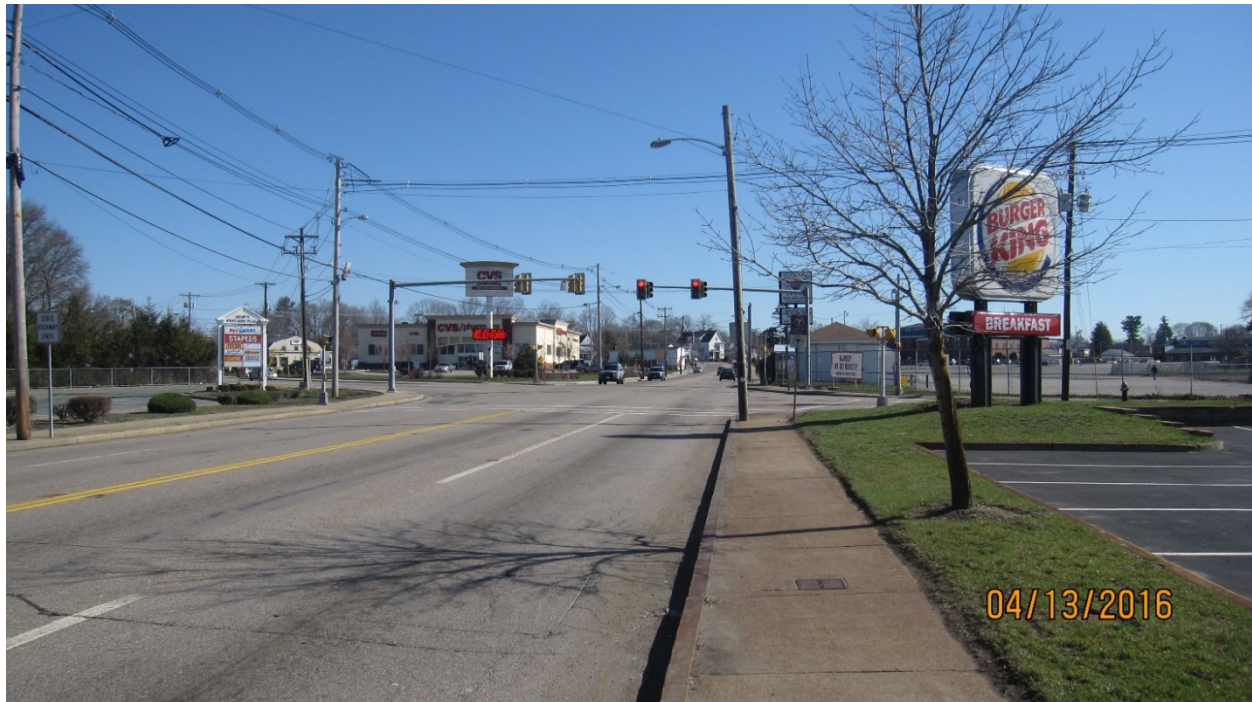
**Image 6: Belmont Street at West Street**

1. There is no control provided at the merge point where vehicles turning right from the channelized westbound Belmont Street right turn enter West Street. Three crashes involved vehicles turning right from Belmont Street westbound onto West Street.
2. There are no advance warning signs to the crosswalk located at the westbound Belmont Street channelized right turn at West Street.
3. The Object Marker sign on the triangular island is not appropriate for that location as it faces both Belmont Street eastbound and West Street northbound traffic.
4. The lane drop on eastbound Belmont Street, which occurs approximately 400 feet east of the intersection, is not adequately marked.
5. Traffic signs at the intersection appear old and are not reflective.

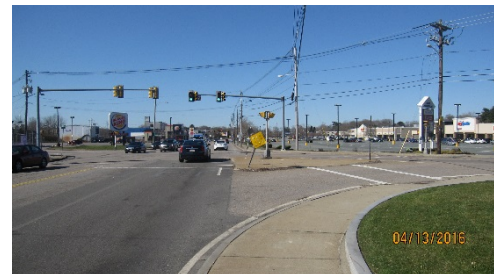
**Image 7 Warning signs missing at crosswalk**

1. Install a YIELD sign and markings at Belmont Street channelized right turn.
2. Replace the Object Marker sign on the triangular island with a Keep Left sign.
3. Provide crosswalk signs at the crosswalk at the westbound Belmont Street channelized right turn at West Street.
4. Consider installing lane-reduction transition markings at the lane drop on Belmont Street, east of the intersection.
5. Inventory and replace, as necessary, all traffic signs which do not have adequate reflective coating.
