# ROAD SAFETY AUDIT

Summer Street (Route 53) at Franklin Street

Town of Duxbury

April 2018

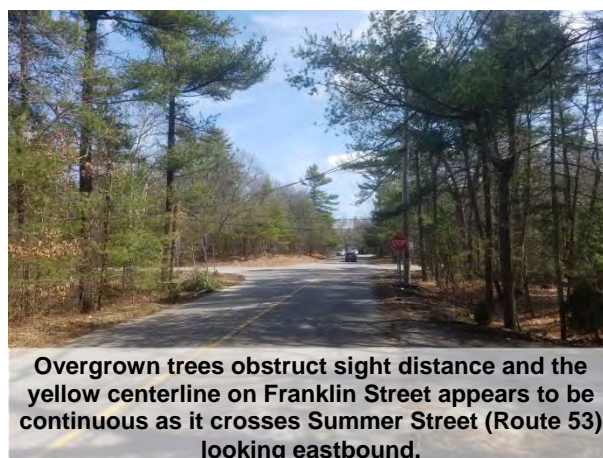
Audit team members noted that there are currently visibility issues at the intersection due to multiple factors: obstructions such as overgrown vegetation and the stockade fence at the southeast corner and the intersection geometry.

Participants noted that overgrown vegetation, including trees, obstruct the ability of drivers to see conflicting traffic as they approach the intersection. This is especially true for eastbound drivers on Franklin Street as they approach Summer Street (Route 53). The trees act as a “buffer” and impact the visibility of Summer Street. It was observed that some tree clearing has occurred at the northwest corner of the intersection, which helps improve sight lines. Participants also reported that sight distance is impacted by the stockade fence at the southeast corner of the intersection for drivers traveling both westbound on Franklin Street and northbound on Summer Street.

Audit team members stated that the current roadway geometry at the intersection contributes to insufficient sight distance for drivers, especially eastbound vehicles on Franklin Street approaching Summer Street (Route 53). Due to the slight increase in roadway grade of Franklin Street, participants noted that Summer Street is not visible until entering the intersection and “sneaks up” on approaching drivers. The roadway geometry appears to create the illusion that Franklin Street is continuous past Summer Street (Route 53), with the yellow centerline on Franklin Street seen as a continuous line across Summer Street (Route 53). Audit team members identified another safety concern due to the downward slope/crest of Summer Street to the north of the intersection. As vehicles travel southbound on Summer Street (Route 53) towards Franklin Street, they are not visible far enough in advance as the crest curve on Summer Street obscures approaching vehicles. These observed sight distance issues are supported by the

crash data, which shows the majority of crashes occurring in the far side of the intersection for Franklin Street traffic; 65% of eastbound angle crashes and 71% of westbound angle on Franklin Street occur when passing the second leg of Summer Street (Route 53). In addition, several of the narratives found in the crash data reveal that the eastbound/westbound driver never saw the southbound driver traveling down Summer Street (Route 53).

- Continue vegetation maintenance to prevent overgrowth obstructing sight distance.
- Determine right-of-way to inform necessary tree trimming.
- Consider raising the roadway elevation of Summer Street (Route 53) within the intersection to provide vertical separation and make the roadway more apparent.

- Evaluate the potential for sight line easements at the intersection corners to improve sight distance.
- Consider removal or relocation of the stockade fence on the southeast corner to improve sight distance, in conjunction with the property owner.

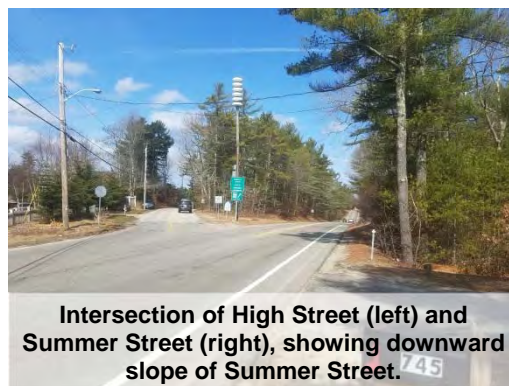
The intersection geometry was also observed by participants to be problematic where High Street intersects Summer Street (Route 53) north of Franklin Street. Participants noted that the roadway alignment suggests that High Street is the continuous street, rather than Summer Street (Route 53). Another noted issue was that drivers heading south on High Street come to a rolling stop into Summer Street before quickly turn left onto Franklin Street eastbound. Participants noted that this turn from High Street to Summer Street is treated as a yield by drivers rather than a stop due to the soft angle. There is also a lack of a stop line at the High Street approach.

Intersection of High Street (left) and Summer Street (right), showing downward slope of Summer Street.

- Consider realigning High Street at its intersection with Summer Street (Route 53) to square off High Street, making Summer Street the apparent through street.

- Evaluate the feasibility of converting High Street to one-way northbound to prevent rolling stops into Summer Street.
- Evaluate the feasibility of implementing a left turn restriction from Summer Street (Route 53) to High Street.

- Consider adding a stop line for the High Street approach to Summer Street (Route 53) to reinforce the stop condition at this approach.

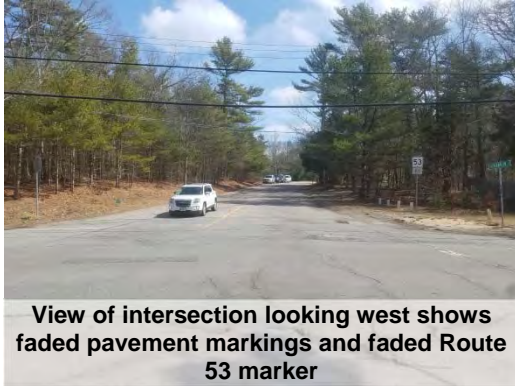
**View of intersection looking west shows faded pavement markings and faded Route 53 marker**

Audit team members noted that the pavement markings and signage at the intersection are ineffective. On Franklin Street, participants pointed out that STOP signs are placed ahead of the stop bars at the intersection, increasing the likelihood of drivers coming to a stop too early, and rolling into the intersection. It was also noted by participants that approaches to the intersection are wide, forcing STOP signs to be located further from the intersection. On the eastbound approach, the view of the STOP sign is obstructed by overgrown vegetation and a utility pole. Throughout the intersection, audit team members observed faded pavement markings, including the

stop bars, shoulder lines on Summer Street, and crosswalk.

Audit team members expressed desire for improved signage in terms of both quality and placement, but to avoid sign clutter. For example, participants identified that the Route 53 markers are faded and obstructed by vegetation overgrowth. Participants also noted a lack of Route 53 markers prior to the intersection, and that adding them could help warn drivers of the upcoming intersection. Additionally, participants noted that there are two Pedestrian Crossing (W11-2) signs next to missing crosswalk markings across Summer Street (Route 53) south of the intersection. It was also noted by participants that the area has little pedestrian traffic, although a jogger was observed during the audit. Team members also noted that residents requested MassDOT District 5 to repaint the crosswalk and add pedestrian signs, indicating potential demand for pedestrian accommodations at this intersection. Audit participants also suggested that the relative lack of adequate advance warning signs approaching the intersection from all directions contributes to the intersection geometry issues by not providing adequate information to approaching drivers. Specifically, participants were not satisfied with the placement of the existing Route 53 markers within the intersection.

- Consider reapplying existing pavement markings to increase retroreflectivity and durability.
- Consider installing fog lines on both Franklin Street approaches to enhance the presence of Summer Street (Route 53) to approaching traffic.

- Consider replacing the existing route markers for Route 53 and adding advanced guide signs for Route 53 on both Franklin Street approaches.
- Consider restriping the crosswalk across Summer Street to enhance visibility.

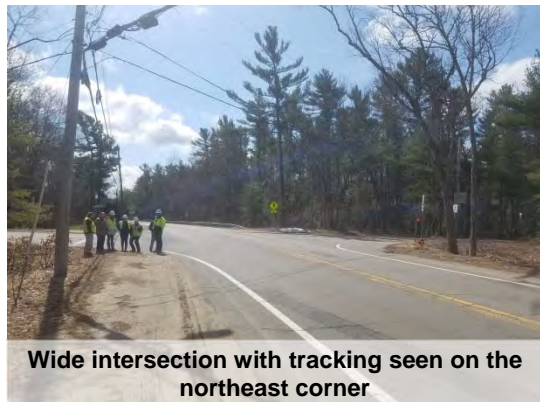
Audit team members noted that the existing intersection is very wide, and it was noted that the wide intersection also creates wide turning radii. Team members noted that the shoulders on Summer Street (Route 53) are also wide. Drivers may have trouble judging the intersection width as they approach. Additionally, participants observed that Summer Street (Route 53) is hidden from view from Franklin Street; it is not apparent how large the intersection is in reality. The width of the intersection was also noted as a potential challenge to pedestrians at the existing crosswalk, along with a lack of pedestrian facilities. Additionally, participants observed inconsistent lighting,

with only one luminaire on the northeast side of the intersection and another luminaire at High Street.

Participants also identified the guardrail on the southeast corner of the intersection along Summer Street (Route 53) as a safety issue. The end of the guardrail closest to the intersection is buried. An audit participant identified that the buried end of the guardrail was the cause of a rollover accident, although this is not explicitly presented in the crash data.

- Consider narrowing the travel lanes on Summer Street (Route 53) and Franklin Street by shifting edge line markings and/or reducing pavement width to encourage slower speeds.
- Consider reducing the amount of pavement in the intersection by reducing the radii at corners, depending on evaluation of truck exclusion routes and commercial traffic.
- Consider installing pedestrian ramps and other pedestrian amenities at the existing crosswalk.

- Evaluate existing night lighting and consider upgraded lighting to enhance visibility of the intersection.
- Consider upgrading the guardrail on the southwest corner of the intersection along Summer Street by installing an impact attenuator at the buried end.
- Consider installing speed feedback signs for drivers to promote reduced speeds.
- Consider installing a flashing intersection warning beacon to alert drivers of the intersection
- Evaluate the feasibility of placing a truck exclusion on Franklin Street east of the intersection.
