ROAD SAFETY AUDIT

Route 18 (Bedford Street) from
Whitman Street to Central Square

Town of East Bridgewater

May 14, 2014

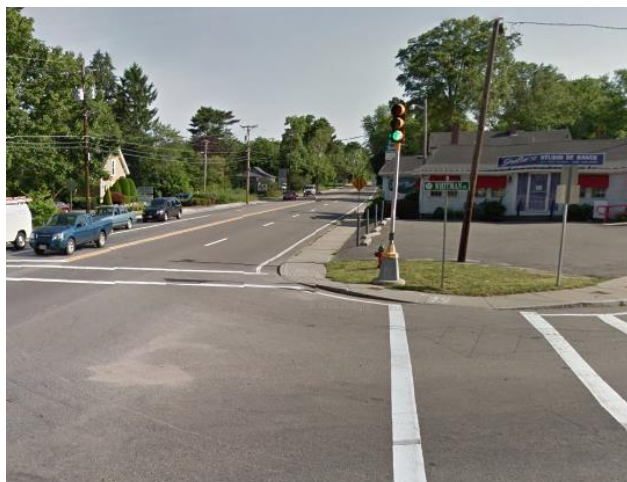
Crash data provided by the East Bridgewater Police Department and summarized by MassDOT show 33 crashes occurred at the intersection for the three year period from 2011 to 2013. A crash data summary and a collision diagram are included in the Appendix. The most prevalent crash type were angle crashes, including 13 angle crashes between a northbound through vehicle and a vehicle departing Whitman Street. A closer look at these crashes reveals that most involved red light running, and several involved a driver who claimed to not see the red light. It was noted during a review of online imagery that the mast arm for northbound Route 18 traffic was replaced with a temporary post mounted signal. Local officials noted that the traffic signal constructed included a mast arm with overhead signals, and it was surmised that this mast arm was struck, knocked down, and subsequently replaced with a single post-mounted signal head at the mast arm foundation on the right side of the roadway. This signal head was supplemented by an existing post-mounted signal head on the left side of the roadway. Audit participants suggested that signal visibility issues created by the lack of overhead signals contributed to the crash history. MassDOT Highway Division District 5 noted that the mast arm was knocked down in July 2009 and replaced in July 2013. This includes the majority of the crash study period; it should be noted that no angle crashes occurred between a northbound through vehicle and a Whitman Street vehicle following re-erection of the mast arm.

Signal Post (June 2012)

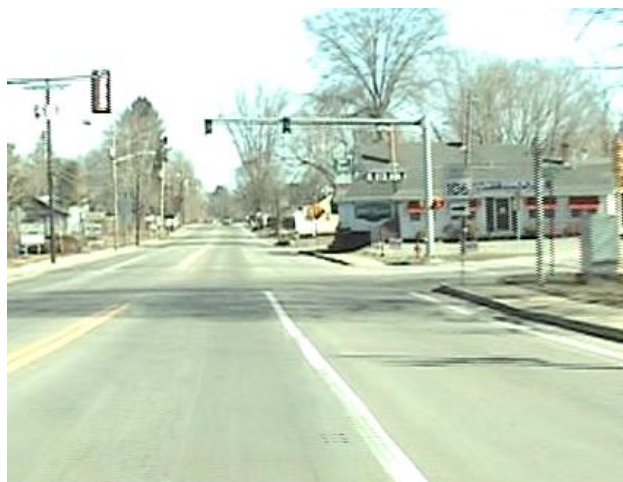
Mast Arm (April 2014)

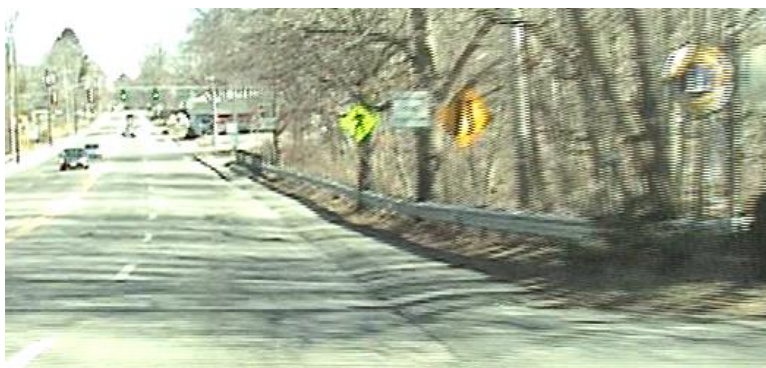
- The aforementioned pedestrian warning sign, merge sign and a “Right Lane for Right Turn” sign on the northbound approach are closely spaced and create sign clutter for the approaching motorist. The “Right Lane for Right Turn” sign may incorrectly suggest to drivers that the right lane is for right turning traffic only, a message that is supported by the merge sign.

Sign Clutter approaching Whitman Street

- Review traffic distribution and operation to determine if an exclusive right turn lane is warranted. New turning movement counts should be obtained to determine current demand. If an exclusive right turn lane is needed, existing “Right Lane for Right Turn” signage should be replaced with a “Right Lane Must Turn Right” sign, and markings should be revised to warn of the trap lane condition. This is a short-term, low cost improvement that includes traffic counts, traffic analysis, and the potential for signage and marking improvements.

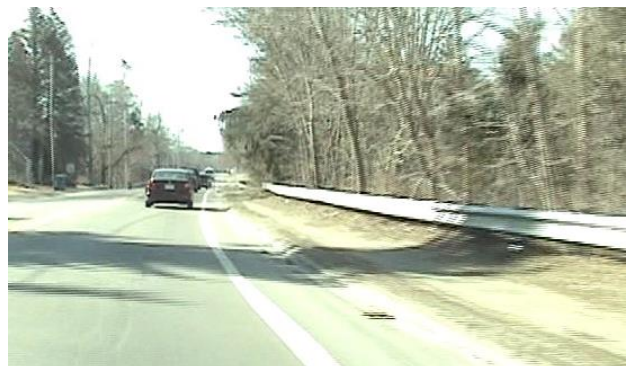
Worn path indicates pedestrian use

signage and do not have receiving sidewalks with wheelchair ramps on both sides of the roadway. A worn path along the west side of Route 18 where no sidewalk is present indicates that pedestrian demand exists along the corridor.

- Provide sidewalks along both sides of Route 18 between Whitman Street and Central Square. The demand for pedestrian facilities is evident by the worn path along the west side of Route 18, as well as by the presence of the high school and commercial abutters. Sidewalks should be provided along both sides of the roadway to achieve adherence with current MassDOT standards. This is considered a long-term, high cost improvement that forms the basis for the proposed reconstruction project.

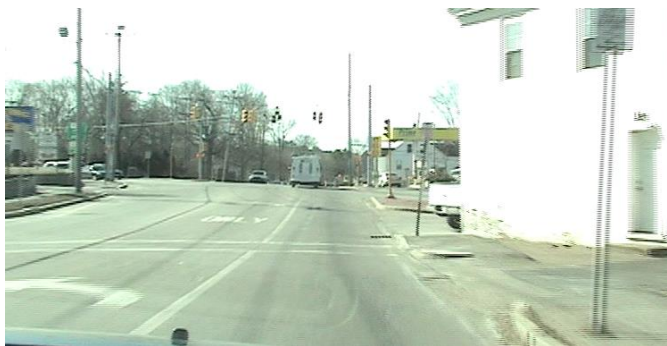
- Mid-block Crosswalk – Crosswalks on the west leg of Central Street and on the north leg of Route 18 cross mid-approach rather than after the stop line within the intersection limits. This location creates an unexpected condition for approaching drivers, and one rear-end crash departing the intersection was attributed to a vehicle stopping for a pedestrian.

Crosswalk across the north leg of Route 18
