ROAD SAFETY AUDIT

Washington Street (Route 138) at Purchase Street and
Turnpike Street at Purchase Street

Municipality of Easton

April 2018

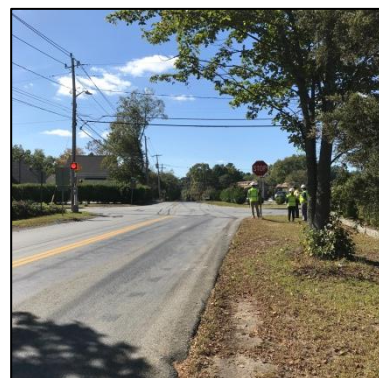
Safety Issue: Lack of Advanced Warning Signs

On Turnpike Street northbound approaching Purchase Street, there is a lack of warning signs indicating the presence of an intersection ahead. On the southbound approach, there is a “reduce speed ahead” sign before the posted 30 MPH speed limit sign, but no warning of the potential to cross moving traffic. There are “Stop Ahead” warning signs on the Purchase Street westbound and eastbound approaches to the intersection.

Purchase Street westbound approach to the Turnpike Street/Purchase Street intersection.

Enhancements: Improve visibility at the intersection by installing

overhead beacons and adding advanced warning on the northbound and southbound Turnpike Street approaches.

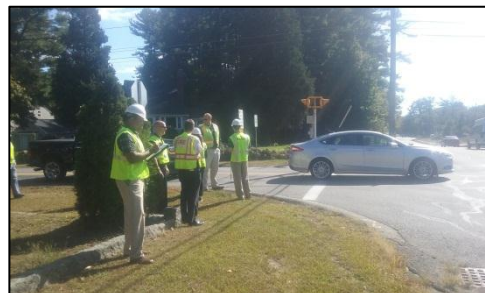
Safety Issue: Lack of Sight Distance on the Purchase Street Approach Due to Vegetation and Parking on Turnpike Street

Sight distance for vehicles approaching the intersection on the stop-sign controlled Purchase Street westbound approach is obscured by the presence of vegetation along the east side of Turnpike Street.

Purchase Street westbound approach looking south toward Turnpike Street

Enhancements: Improve visibility at the intersection by trimming back vegetation on the southwest corner of the intersection, adjust stop bars, and adjust the height of signs. In addition, restrict or prohibit parking on Turnpike Street.
