ROAD SAFETY AUDIT

Washington Street (Route 53) at Pleasant Street

Town of Pembroke

June 26, 2014

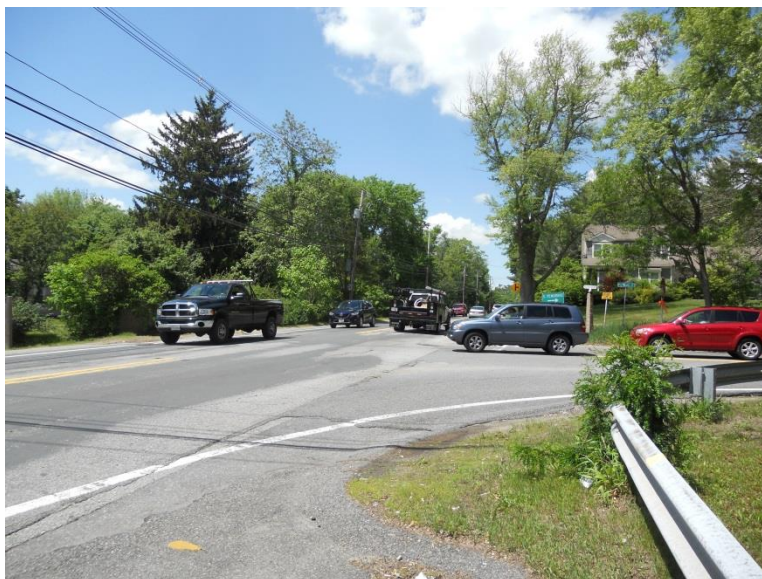
**Washington Street (Route 53) at Pleasant Street
(looking north)**

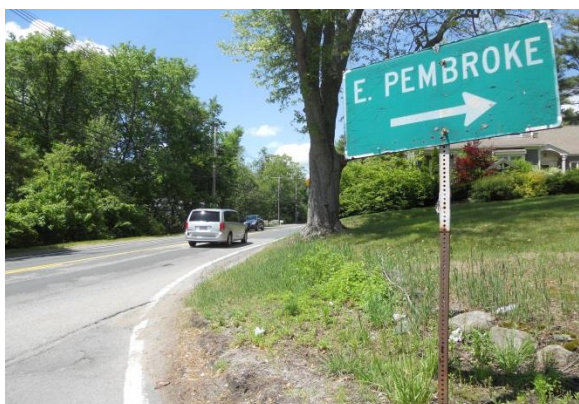
- **Vegetation & Visibility** – Overgrown vegetation further restricts visibility along both Route 53 and Pleasant Street. Overgrowth of trees along Pleasant Street blocks visibility of Stop Ahead and STOP signs for drivers approaching Route 53, and a large tree on the northeast corner of the intersection reduces visibility for vehicles turning left (and looking right) from Pleasant Street. Local officials noted that the Town of Pembroke would be willing to trim vegetation along Pleasant Street, even though the intersection is under MassDOT jurisdiction; it should be noted that the Pleasant Street approach is under town jurisdiction, making it the town’s responsibility to clear vegetation. The tree on the northeast corner and the slope of the adjacent residential property also reduce visibility of Pleasant Street for drivers approaching southbound on Route 53. Reduced visibility may be a contributing factor in the 14 angle crashes involving vehicles departing Pleasant Street.

Tree on northeast corner restricts visibility (looking north)

- Trim vegetation along Pleasant Street. This is a short-term, low cost improvement to increase visibility of existing signage.
- Remove tree on the northeast corner of the intersection to improve visibility for drivers exiting Pleasant Street. It was noted that the tree will be removed as part of project widening. The tree can be removed now as a short-term, low cost improvement to increase visibility.

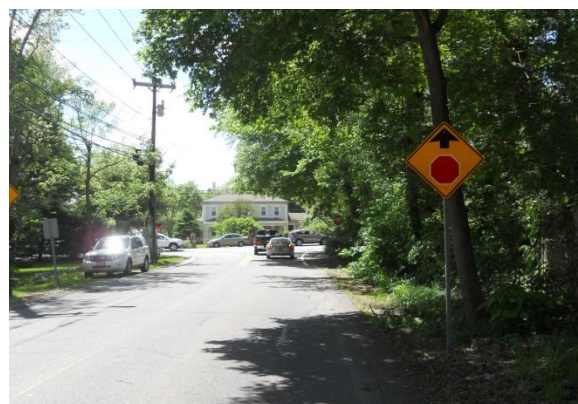
Vegetation on Pleasant Street blocks STOP sign visibility

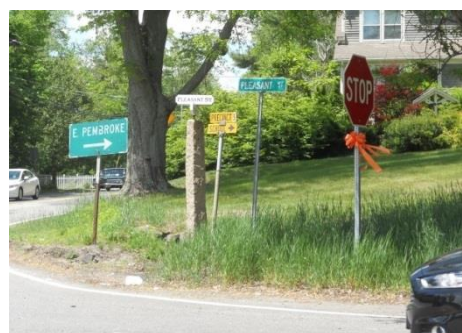
- Sign clutter is a potential issue both along Route 53 approaching the intersection, and on the northeast corner of the intersection. The number of signs creates a visual clutter that reduces the driver’s ability to receive all the information presented when approaching the intersection.

Sign clutter on northeast corner

- Review signs and remove inappropriate, incorrect or ambiguous signage. The number of existing signs on the Route 53 approaches and on the northeast corner of the intersection reduces their effectiveness. This is a short-term, low cost improvement.

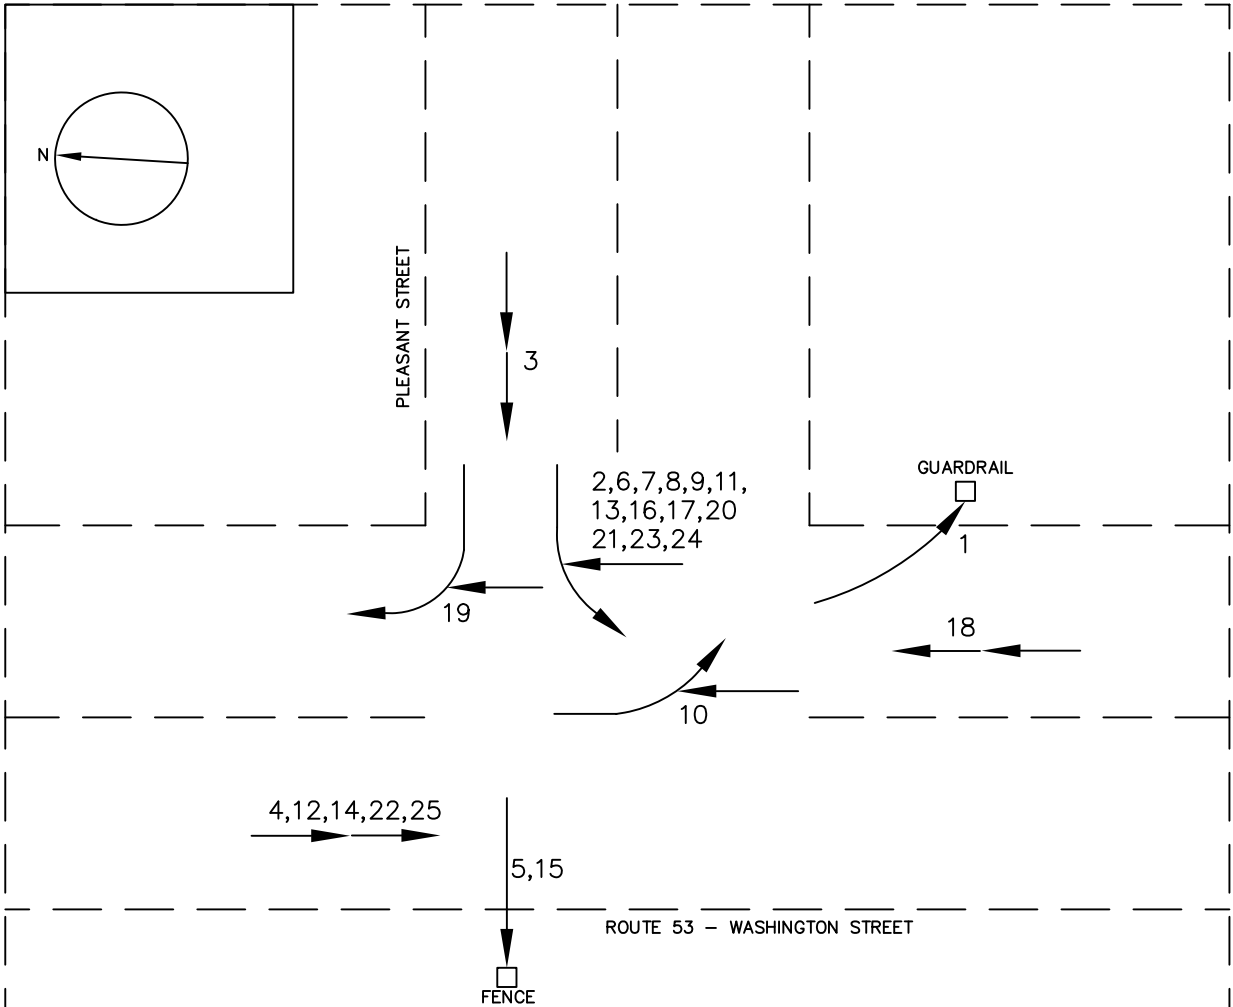
TITLE:
COLLISION DIAGRAM
WASHINGTON ST.
(RTE. 53) AT
PLEASANT ST.

Crash data provided by the Pembroke Police Department and summarized by CHA show 25 crashes occurred at the intersection from 2011 through 2013. A collision diagram and crash summary are included in the Appendix. The most prevalent crash type were angle crashes, comprising 60% of all crashes. Thirteen of the 15 angle crashes at the intersection were between a vehicle turning left from Pleasant Street and a northbound through vehicle on Route 53. One angle crash involved a southbound left turning vehicle and a northbound through vehicle, while another as between a vehicle turning right from Pleasant Street and a northbound through vehicle.

Seven rear-end crashes occurred at the intersection: five southbound, one northbound, and one westbound on Pleasant Street. Southbound rear-end crashes are likely related to stopped left-turning vehicles, where drivers traveling southbound along Route 53 are not expecting to encounter a stopped vehicle. There was one rear-end crash on both the northbound and Pleasant Street approaches. Two crashes involved Pleasant Street vehicles that ran through the intersection and struck the fence bordering the property directly across from the Pleasant Street approach. Local officials noted that the property owner has constructed a second fence as a buffer due to frequent vehicle strikes. One crash involved an errant left-turning vehicle that struck the guardrail on the southeast corner of the intersection.
