# ROAD SAFETY AUDIT

Route 53 (Washington Street) High Crash Locations  
at Route 139 (Schoosett Street)  
and Route 14 (Congress Street)

Town of Pembroke

April 29, 2016

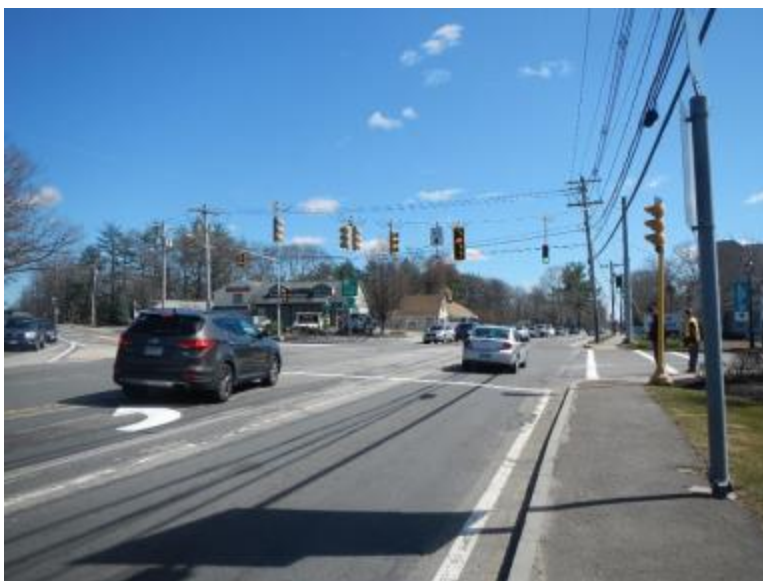
Observations on the day of the audit revealed that through vehicles generally favor the left lane, with the right lane accommodating right turns to Schoosett Street. The southbound approach provides a left turn lane to Schoosett Street, and a shared lane for through vehicles and for right turns to Pointe Plaza. Schoosett Street westbound provides a left turn lane to Route 53 southbound which is under signal control, and a right turn to Route 53 northbound which is under yield control.

**Route 53 at Route 139 (looking south)**

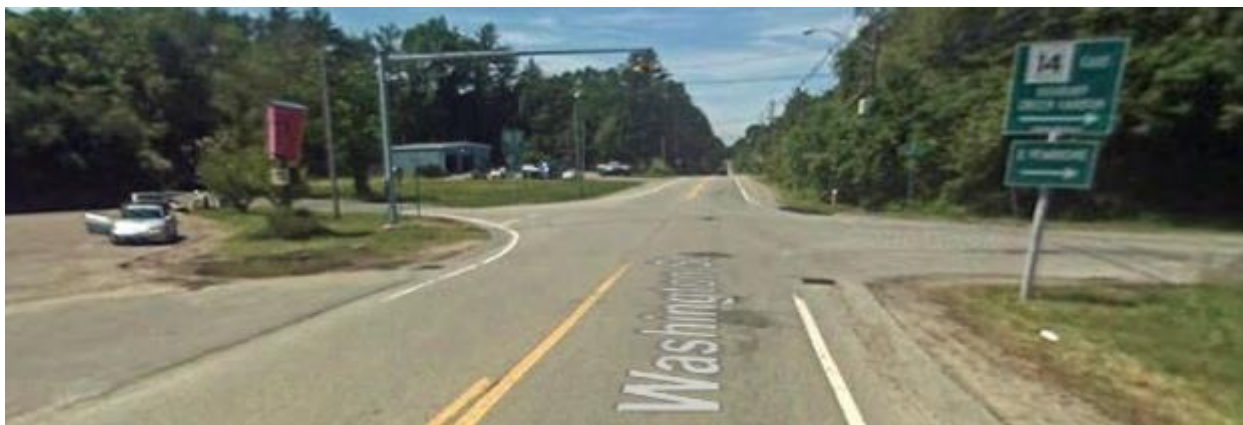
**Route 53 at Congress Street (looking north)**

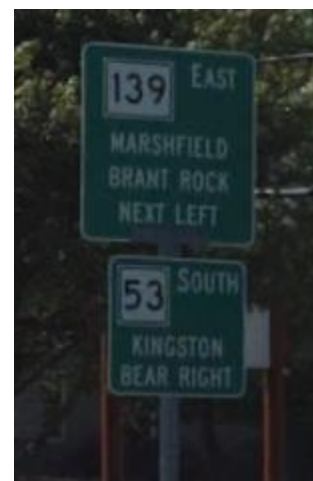
- Guide Signs – Two observations were related to D6/D8 guide signage provided at the intersection.
  - The D8 sign for Route 53 southbound has a direction of “Bear Right” as shown at right, although the Route 53 southbound through movement is aligned as a straight through movement at the intersection.

**Bear Right on  
sign legend**

- Replace D8 sign for Route 53 southbound to incorporate an up arrow, indicating a straight through movement. Discussion at the RSA suggested replacing the misleading “BEAR RIGHT” legend, but revision to maintain conformance with MassDOT standards for a through movement would require

revising the sign legend and layout, suggesting the need for replacement. This is a short-term, low cost improvement.

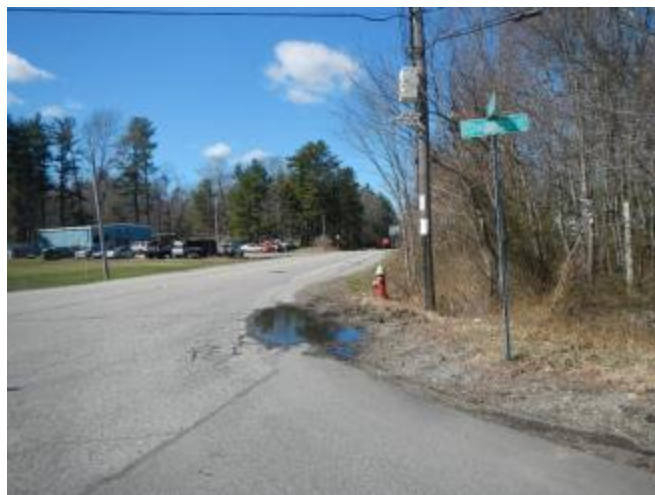
- Visibility – Overgrown vegetation on the northeast corner restricts visibility for drivers departing Congress Street westbound. This is a likely contributing factor in the three crashes between a westbound vehicle and a southbound vehicle.

**Vegetation growth on northeast corner**

- Trim vegetation and remove overgrowth on the northeast corner of the intersection. Audit participants suggested that this can be done within the SHLO. This is a short-term, low cost improvement.
- Coordinate with Marylou's owner to mark and provide internal queuing area for drive-thru patrons. Improving drive-thru queue storage would reduce the potential for vehicles to back up onto Congress Street or Route 53. This is a short-term, low cost improvement.
- Provide speed limit signs along Route 53. Signs should reflect state regulatory speed limits established for the roadway. This is a short-term, low cost improvement.
- Rotate the D6/D8 guide sign on the northwest corner of the intersection to avoid potential confusion for Route 53 northbound drivers. This is a short-term, low cost improvement.

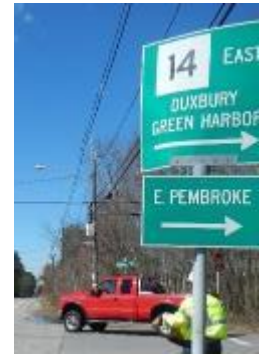
- The D6/D8 sign on the southeast corner of the intersection is damaged. It appears that trucks regularly park along the western edge of Route 53 approaching Congress Street, perhaps to walk across the road to Marylou's, and that trucks cut this corner when turning onto Route 14 eastbound.

**Bent sign corner**

- Replace or repair the D6 guide sign on the southeast corner of the intersection. This is a short-term, low cost improvement.
- Update street name signs at the intersection. Street name signs should be provided on opposite corners, with signs for both Washington Street and Congress Street. Signs should meet current MassDOT and MUTCD mixed case requirements. This is a short-term, low cost improvement.
