# ROAD SAFETY AUDIT

Route 18 (Bedford Street) at  
Auburn Street (Route 14) and Temple Street (Route 27)  
Town of Whitman

March 3, 2015

Prepared By:  
BETA Group, Inc.

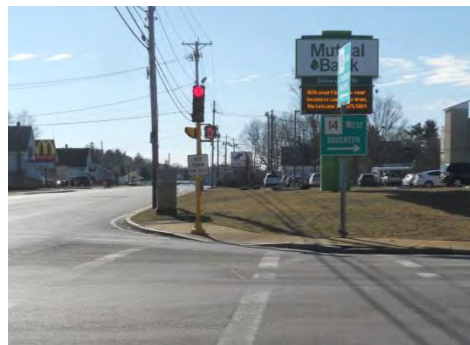
- Pedestrian Accommodations –Pedestrian accommodations are limited at the intersection, especially on the southwest corner where the sidewalk does not extend beyond the Mutual Bank access sidewalk. Pedestrian accommodations, where currently provided, do not consistently meet current ADA standards.

**Sidewalk end on southwest corner**

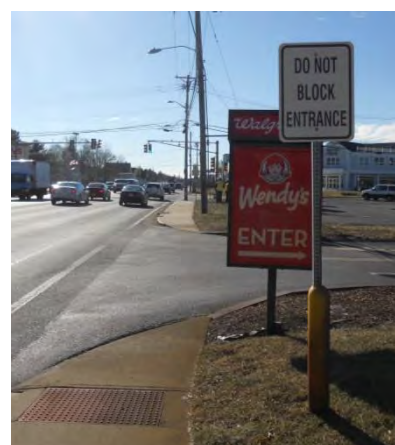
- Wendy’s Signage – The enter and exit signs for Wendy’s on each side of the shared Wendy’s/Walgreens driveway are low and can potentially obstruct an exiting driver’s view of approaching traffic. It is unknown if any crashes involving exiting drivers were related to this issue. It was also noted that a “Do Not Block Entrance” sign is provided approaching this driveway from the north, which is potentially confusing because the driveway accommodates both entering and exiting traffic.

**Low Wendy’s Signage**

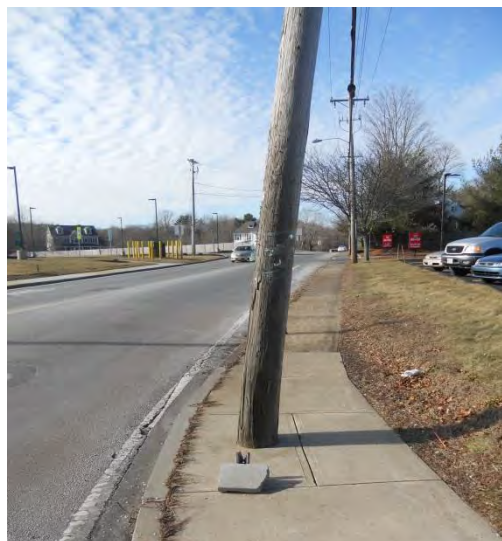
- **Missing Sign** – During the field visit audit participants noticed the stub of a sign post adjacent to Wendy’s on the northwest corner. A review of Google Street View suggests that this sign was a hospital sign with directional arrow and a supplemental plaque for “Signature Healthcare Brockton Hospital”, which is located on Route 123 in Brockton and is accessible from Route 14.
- **Damaged Pole** – A utility pole adjacent to the missing sign shows signs of a vehicle strike and is leaning away from the roadway. It was suggested that the lean is due to the vehicle strike, although the angle of the wires could also create tension that pulls the pole away from the roadway. A review of historical Google Street View imagery reveals that the pole has been leaning since 2008.

**Missing Sign Post and  
Damaged Pole**

- Review preemption equipment locations in conjunction with planned improvements. Detectors should be located to maximize early detection. This is a long-term, low cost improvement.
- Replace sign for Brockton Hospital. The missing sign on the northwest corner of the intersection should be replaced in kind. This is a short-term, low cost improvement.
- Review utility pole locations and condition in conjunction with planned improvements. This is a long-term, potentially high cost improvement if pole replacements and/or relocations are required. This improvement must be coordinated with the affected utility companies.

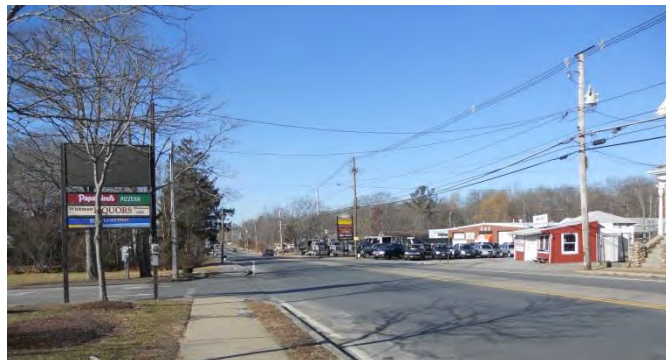
- Visibility exiting the plaza driveway on Temple Street was also noted as a safety concern. This driveway intersects Temple Street at a point where westbound vehicles departing the intersection are merging back into a single lane, but eastbound vehicles are shifting into the two lane approach section. Trees and a utility pole on the west side of the driveway also impact an exiting driver's visibility. Three crashes involved exiting drivers at this location.

**Plaza Exit on Temple Street**

- Visibility – It was noted that visibility is impacted by vegetation at multiple locations.
  - As previously noted, trees impact visibility for drivers exiting the plaza driveway on Temple Street west of the intersection.

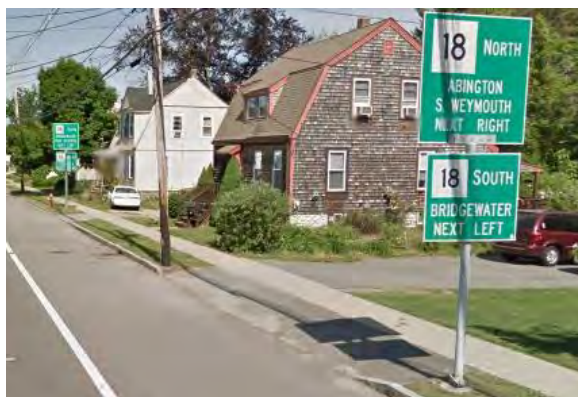
- Inconsistent Signage – It was noted that the D6/D8 guide signage legends on Temple Street westbound approaching Route 18 are inconsistent. The first sign includes Route 18 north on the larger (D6) top sign, and Route 18 south on the smaller (D8) bottom sign. The second sign includes Route 18 south on the larger sign and Route 18 north on the smaller sign. Due to the proximity of the signs, a driver could process part of the legend of the first sign, then process the rest of the legend of the second sign without realizing that the directions have swapped. This could create confusion over direction, destination, or both.

**Temple Street Westbound Route 18 Signage  
(First sign in foreground, second sign in background)**

- Review signs and remove inappropriate, incorrect or ambiguous signage. Despite recommendations for increased signage for specific safety concerns, it was noted that existing signage is sometimes cluttered and ineffective. A complete review of existing signage should be done as part of the project. This is a long-term improvement.

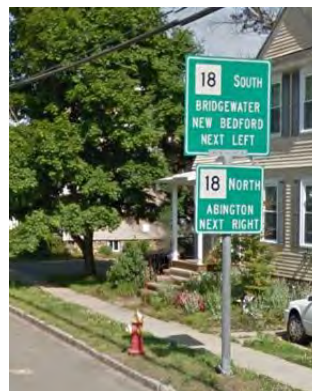
**Detail of second  
sign**
