ROAD SAFETY AUDIT

Intersection of Bay Road, Chestnut Street, Depot Street,
Standish Street, and Washington Street
(Hall's Corner)

Duxbury, Massachusetts

October 16, 2023

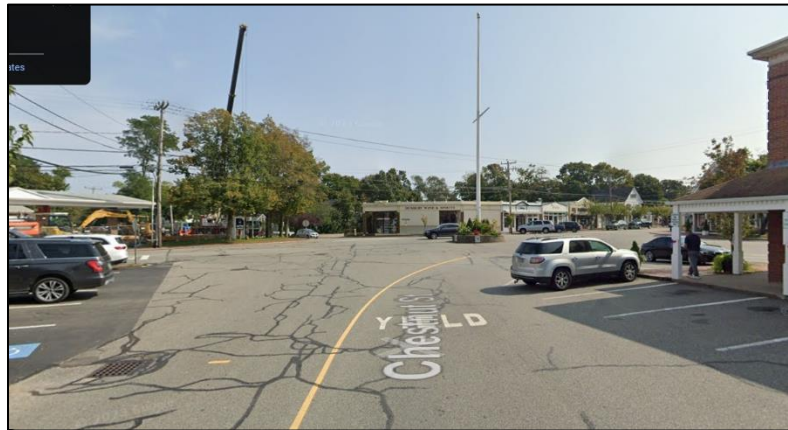
Safety Issue: There is a lack of formalized traffic control and operations leading to driver confusion and conflict as motorists enter the intersection from all five approaches. Although the intersection

has a STOP sign on Bay Road, Standish Street, Washington Street and Depot Street approaches, there is a lack of traffic operation control on the Chestnut Street approach except for a pavement marking on this approach for a YIELD control. The designated angled parking on this Chestnut Street approach encroaches on the travel lane. In addition, the parking spaces and lack of curb delineation result in a lack of location for placement for the YIELD sign on the approach. Vehicles entering the circle on all approaches have only a “keep right” sign at the bottom a short wall around the center flagpole circle to inform of the traffic flow direction around the circle. Tractor trailers lack turning radius for left turn movement as they enter from Chestnut Street to go around the circle and turn left to destinations on Depot Street (Duxbury Marketplace). Crashes have occurred due to the back end of the trailer hitting the circle wall as tractor trailers make this movement. Left turns from Chestnut Street to Depot Street have been observed to happen inside the circle rather than around the center circle.

The only control on the Chestnut Street approach is YIELD pavement markings. The proximity of the angled parking results in no available location to post a YIELD or STOP sign.

Enhancement: Consider a formal Intersection Control Evaluation (ICE) for potential “mini-roundabout” (or other potential traffic control such as signals) and retro-fit the approaches and central circle to include a mountable apron, splitter islands, signage, and pavement markings for yielding and channeling traffic. A gasoline station will be reopening at the northeast corner between Washington Street and Depot Street, which should be considered before making any adjustments. Tighten the inner circle wall thereby making it smaller to prevent the back ends of tractor trailers from hitting during left turn movements from Chestnut Street to Depot Street. In addition, adding bike lane and more pedestrian friendly crossings and spaces would enhance the viability of movement at Hall’s Corner for all users.

Enhancement: Consider temporary control plan using temporary traffic control devices (or flexible delineator posts) to channel traffic entering and through the intersection to evaluate the effectiveness of specific configurations.

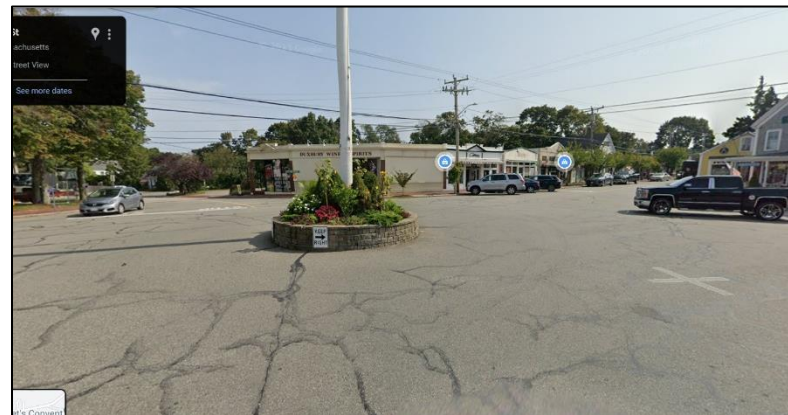
The only control indicating traffic flow direction in the circle is a “Keep Right” sign on the low wall around the flagpole in the center.

Safety Issue: A lack of pavement markings for channeling vehicles entering and passing through the intersection.

Enhancement: Evaluate pavement markings, signs on all approaches, advanced warning, and traffic control, to create a traffic control plan.

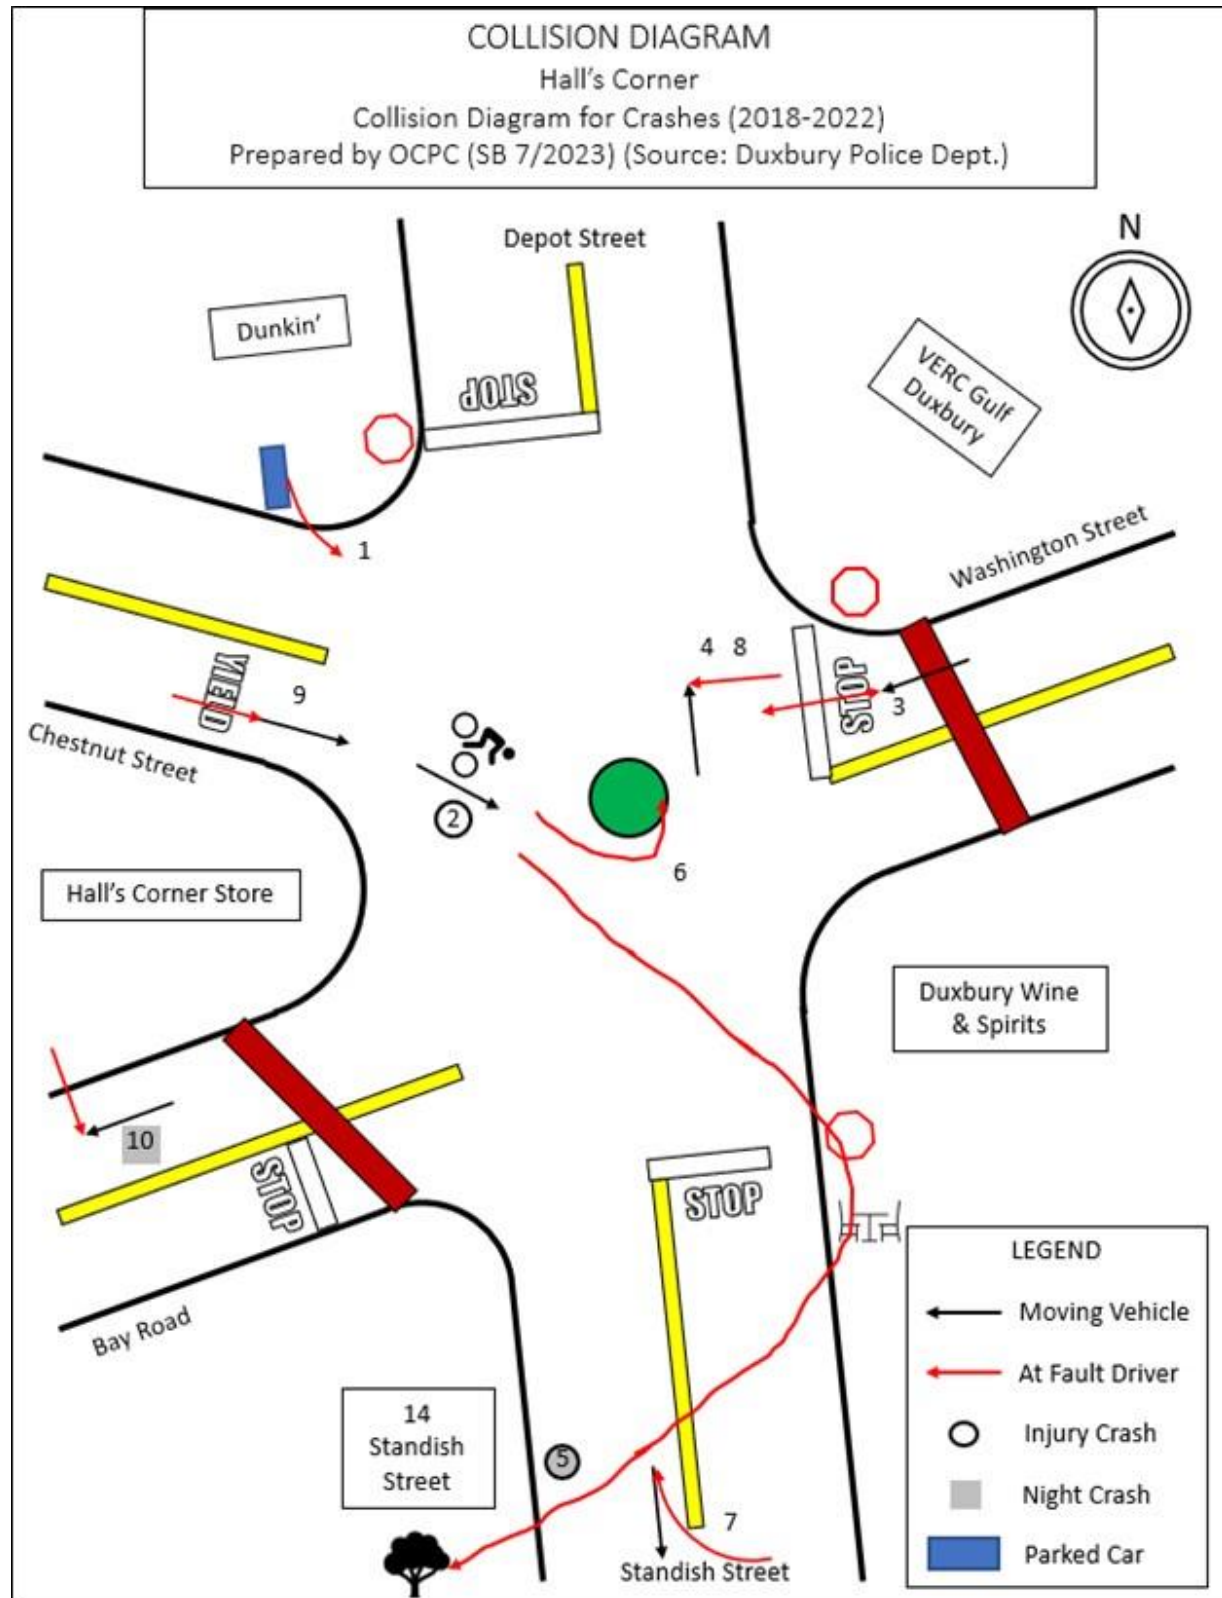
Crash Diagram Ref #	Crash Date <i>m/d/y</i>	Time of Day	Manner of collision Type	Light condition Type	Weather Type	Road Surface Type	Driver Code Type	Comments
1	8/4/18	7:38 PM	Sideswipe, opposite direction	Dusk	Cloudy	Wet	Inattention	V1 was backing out of their parking space and sideswiped V2, which was parked.
2	8/25/18	10:18 AM	Single Vehicle Crash	Daylight	Clear	Dry	No Improper Driving	EB V1 entered the roundabout at the same time as a cyclist, and both collided in the roundabout.
3	3/24/19	2:00 PM	Rear-end	Daylight	Clear	Dry	Inattention	WB V1 entered the roundabout, saw another vehicle entering the roundabout, then backed up into WB V2, who was stopped behind V1.
4	12/20/19	2:34 PM	Rear-end	Daylight	Clear	Dry	Failed to yield right of way	WB V2 struck NB V1, who was already in the roundabout.
5	1/17/20	12:07 AM	Single Vehicle Crash	Dark - lighted roadway	Clear	Dry	Operating Vehicle in erratic, reckless, careless, negligent, or aggressive manner	EB V1 entered the roundabout, drove up on to the curb striking a street sign and bench, then overcorrected and drove into a driveway, coming to a stop crashing into a natural fence.

6	6/13/20	8:18 AM	Single Vehicle Crash	Daylight	Clear	Dry	Made an improper turn	EB V1 entered the roundabout, turned left to go around the flagpole, then attempted to avoid another vehicle and struck the cinderblock structure.
7	7/27/20	6:08 PM	Angle	Daylight	Clear	Dry	No Improper Driving	WB V2 turned right too wide out of a parking lot and sideswiped SB V1.
8	8/5/20	4:34 PM	Sideswipe, same direction	Daylight	Clear	Dry	Failed to yield right of way	WB V2 struck NB V1, who was already in the roundabout.
9	11/14/20	6:42 PM	Rear-end	Dark - lighted roadway	Clear	Dry	Followed too closely	EB V2 rear ended EB V1, who was yielding to traffic and unsure of where to go.
10	6/25/21	11:13 PM	Angle	Dark - lighted roadway	Clear	Dry	Failed to yield right of way	SB V2 pulled out of a parking lot and collided with WB V1.
