ROAD SAFETY AUDIT

Plain Street from the Plain Street/West Street
Intersection to the Plain Street/Morton Street Intersection
Stoughton, Massachusetts

November 28, 2023

Prepared under MassDOT Contract 123116 By:
Old Colony Planning Council
70 School Street, Brockton, MA. 02301

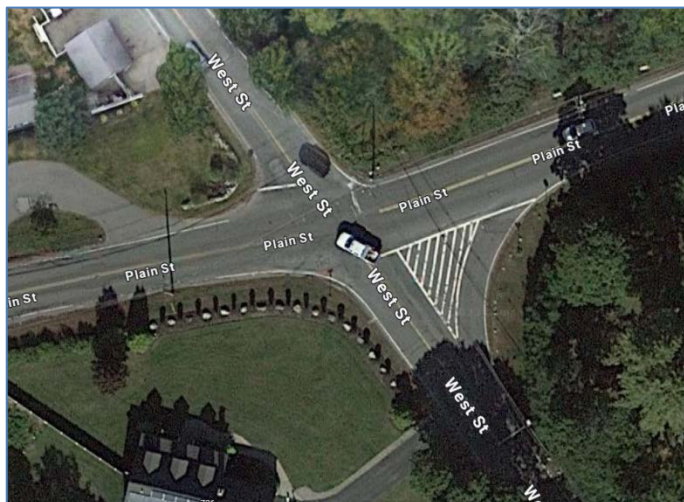
West Street is functionally classified as an urban collector and is under the jurisdiction of the Town of Stoughton. It is a two-lane facility providing north-south access within the western portion of Stoughton, connecting Route 27 to the north with Highland Street to the south to Easton. Plain Street and West Street meet at a skewed angle to form a four-way intersection. The intersection is stop-sign controlled on the West Street northbound and southbound approaches. There is a painted island on the southeast corner of the intersection to channel vehicles turning right from West Street northbound to Plain Street eastbound. The skewed nature of the intersection along with vegetative growth on the northeast corner restricts sight distance for vehicles approaching the intersection. The skewed alignment and paved island interfere with sign placement for the stop signs on the northbound approach. There are three stop signs for the northbound approach including one posted approximately 100 feet behind the stop line before the painted island, and another posted at the end of the right turn at Plain Street at the stop line. There is also one on the northwest corner of the intersection for northbound traffic. School buses turning right from Plain Street westbound to West Street northbound take a wide turn encroaching on the travel lane on West Street southbound due to the radius of the northeast corner of the intersection.

Aerial view of the Plain Street/West Street intersection showing a painted island on the southeast corner.

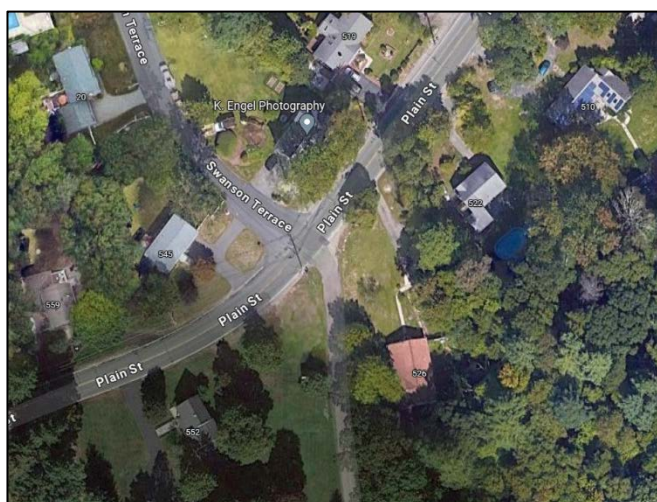
East of the Plain Street/West Street intersection, Plain Street and Swanson Terrace meet at a skewed angle to form a “T” type intersection, although a common driveway at the south side of the intersection presents the intersection as a four-way to serve several residences to the south. The Plain Street eastbound approach to Swanson Terrace has poor vertical and horizontal alignment, creating hinderances to sight distance and a problem for motorists following the road. The crash experience shows that there is a pattern of lane departure crashes on this approach.

Aerial view of the Plain Street/Swanson Terrace intersection.

Field observations by OCPC staff also show that there is a lack of sight distance for southbound vehicles on the Swanson Terrace approach looking west toward traffic on coming on Plain Street due to the sharp

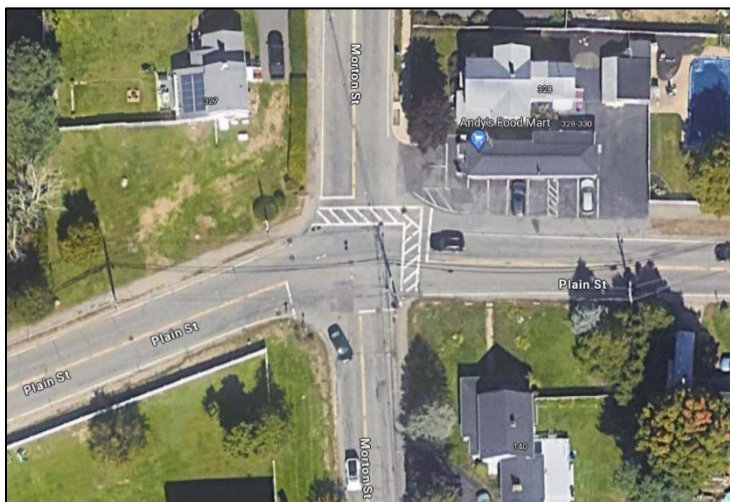
Aerial view of the Plain Street/Morton Street intersection.

south. The Plain Street eastbound approach is skewed as it intersects Morton Street. A convenience store is located on the northeast corner of the intersection, with on-site head-in style parking. Vehicles entering the spaces from the west or reversing out of the spaces for both directions interfere with operations at the intersection. There is no curb or raised sidewalk on the Plain Street westbound approach adjacent to the store parking area to separate the travel lane from the on-site parking. In addition, according to field observations by OCPC staff, the sight distance on the Plain Street eastbound approach is limited looking north toward Morton Street due to the skewed angle that Plain Street intersects Morton Street and the pine hedge row that fronts the property on the corner lot.

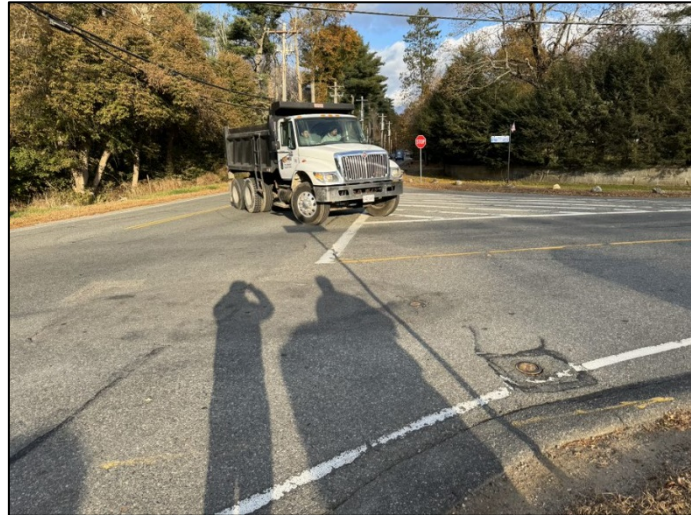
Safety Issue: Poor intersection alignment, inadequate intersection geometry, and tight turning radii.

Vehicles taking a left turn from Plain Street westbound to West Street southbound sometimes drive on the painted island to make the turning move due to the alignment of the intersection. In addition, the poor alignment and turning radii cause school buses and heavy vehicles to take wide right turns from Plain Street westbound to West Street northbound encroaching on the travel lane on West Street southbound as it approaches the intersection.

Photo above shows a left turn from Plain Street westbound to West Street southbound encroaching on the painted island. Also shown is the stop sign at the end on the painted island on the West Street northbound approach.

Enhancement: Reconstruct and realign the intersection providing proper turning radii and installing a mountable median island on the West Street northbound approach and a mountable island replacing the painted island on the southeast corner of the intersection that channels West Street northbound right turns.

Enhancement: Consider overhead flashing beacons, flashing red on the West Street approaches and flashing yellow on the Plain Street approaches.

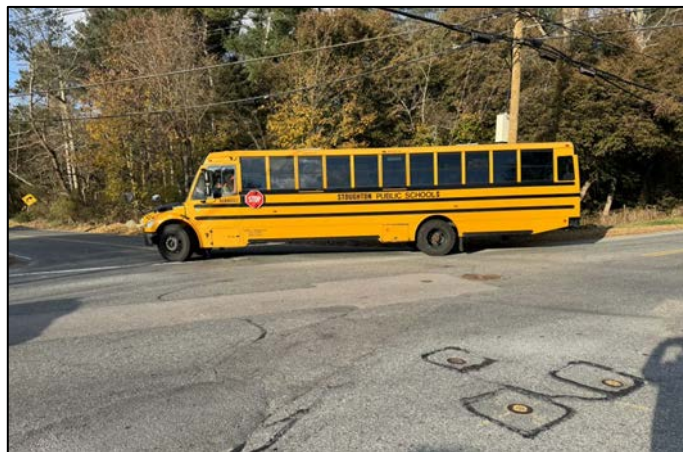
Safety Issue: Stop Sign placement, lack of stop lines and pavement markings.

Currently, there are three stop signs on the northbound approach: one located before the painted island, another at the end of the painted island adjacent to the channelized right-turn lane, and one located on the other side of Plain Street.

The above photo shows a school bus taking a wide turn due to tight turning radii and utility pole location on the northeast corner of the intersection.

Enhancement: Reconstruct and realign the intersection providing proper turning radii and installing a mountable median island on the West Street northbound approach and a mountable island replacing the painted island

on the southeast corner of the intersection that channels West Street northbound right turns. Remove the stop signs posted on the northbound approach prior to the island and on the other side of Plain Street and replace with one stop sign posted adjacent to the stop line on the mountable island that replaces the painted island.

Enhancement: Consider Intersection Control Evaluation (ICE) to address traffic control and sign location and to evaluate alternative intersection geometries.

Enhancement: Consider posting a “Stop Sign Ahead” warning sign (MUTCD W3-1) on the West Street northbound approach.

Enhancement: Place new centerline, edge line striping, and stop line pavement markings throughout the intersection.

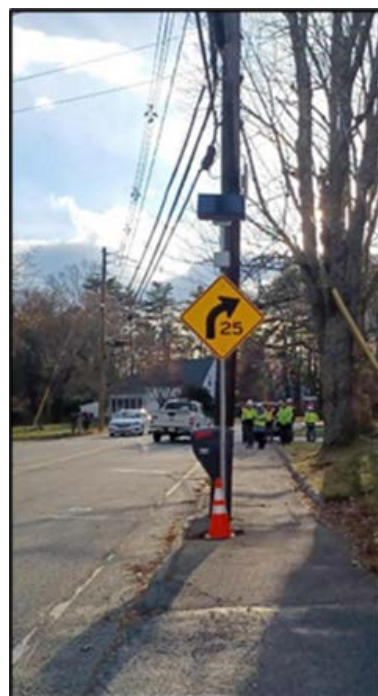
Photo above shows the recent improvements to Plain Street at Swanson Terrace on the EB and WB approaches with advance flashing warning signs for 25 MPH through the curve.

Enhancement: Consider adding chevrons on Plain Street in the westbound direction through the curve past Swanson Terrace.

Enhancement: Monitor the crash experience over the next three years to discern the effectiveness of the recent town improvements to Plain Street at Swanson Terrace (chevrons and the flashing 25 MPH warning signs).
