ROAD SAFETY AUDIT AND TRAFFIC STUDY

Palmer Road (Route 58) at Center Street

Municipality of Plympton, MA

June 18, 2024

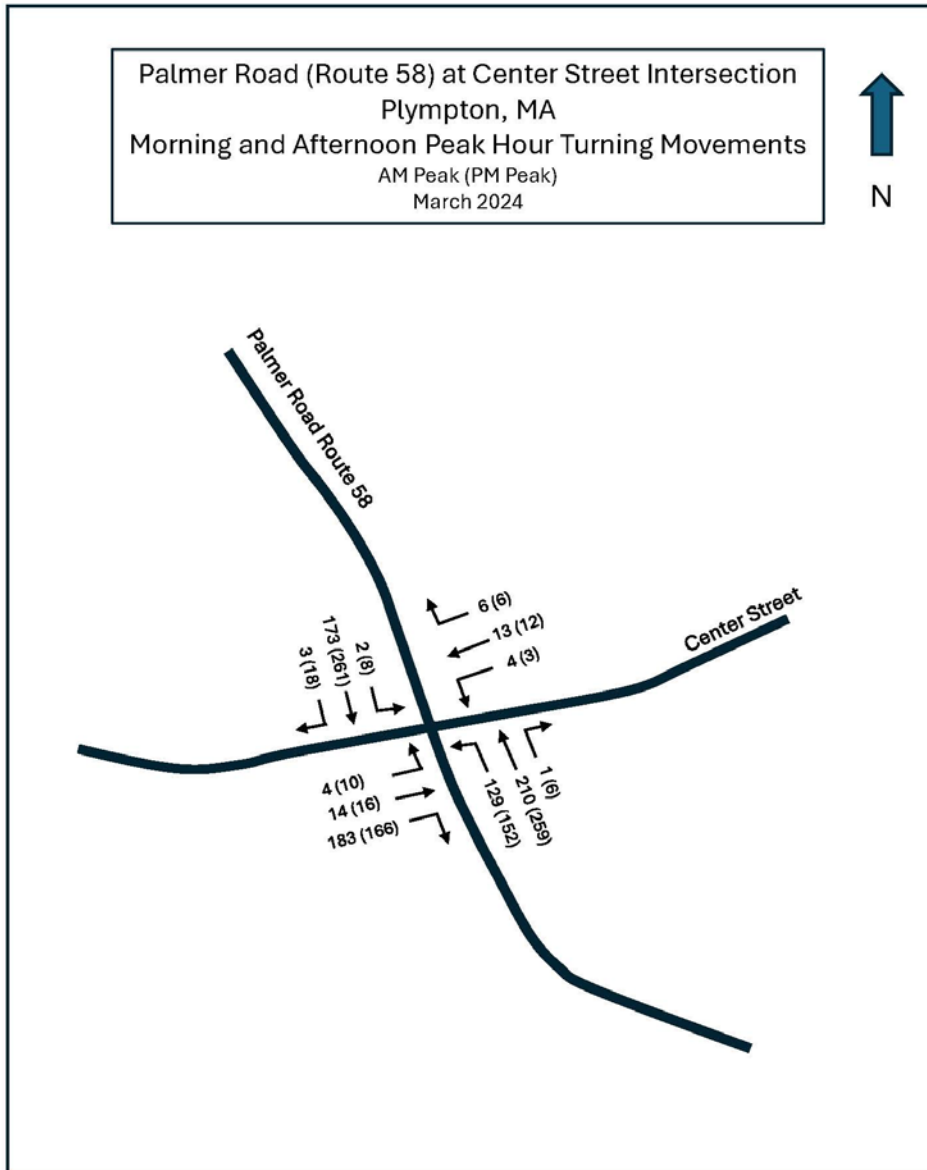
Figure 2: Turning Movement Counts

Turning movement counts were conducted for OCPC by a consultant for a twelve-hour period (7:00 am to 7:00 pm, 3/27/24) to determine the AM and PM peak hours on a weekday and to conduct traffic signal warrant analyses based on the methodology in the *Manual of Uniform Traffic Control Devices* (MUTCD). The peak hour turning movement counts (TMC) were used to determine the intersection levels-of-service (LOS) for a two-way stop control based on the Highway Capacity Manual (utilizing SYNCHRO software). The AM and PM peak hour TMCs for the Route 58/Center Street intersection are shown in Figure 2. These counts show high peak hour volumes for the Route 58 northbound and southbound through movements and for the Route 58 northbound left turns and the Center Street eastbound approach right turns. Consistent with the ATR counts, the TMCs show light traffic in and out of the east leg of Center Street. Based on discussions with the Plympton Highway Department, Center Street is used as a popular alternative route between Route 58 in Plympton and Route 106 in Halifax. Center Street west of the Route 58/Center Street intersection is part of a cut-through route that bypasses the Route 106/Route 58 intersection in Halifax, which can become congested during the peak commute times with long queues and long delays.

Signal Warrant and all-way stop analyses were conducted for the Route 58/Center Street intersection according to the methodology spelled out in the *Manual on Uniform Traffic Control Devices* (MUTCD). Warrant analyses are a preliminary step in the installation of traffic signals or an all-way stop. The MUTCD states, “Warrants are not a substitute for engineering judgment. The fact that a warrant for a particular traffic control device is met is not conclusive justification to install or not install all-way stop control.” The MUTCD states that an engineering study should be the basis for the decision to install an all-way stop or traffic signals. In addition, the MUTCD states that alternatives should be considered when considering the installation of a traffic signal such as flashing beacons, roundabouts, warning signs, and others (full list in Section 4B.03 of the MUTCD). The MUTCD states, “The safe and efficient movement of all road users is the primary consideration in the engineering study to determine whether to install a traffic control signal or to install some other type of control or roadway configuration. The purpose of the engineering study is to evaluate all the factors that are relevant to a specific location. The satisfaction of a warrant (or warrants) is one of the relevant factors in the engineering study, but it is not intended to be the only factor or even the overriding consideration.” Based on the MUTCD warrant analyses methodology, utilizing the 12-hour data from the intersection turning movement count, the Route 58/Center Street intersection satisfies Warrant 1, Eight-Hour Vehicular Volume and Warrant 2,

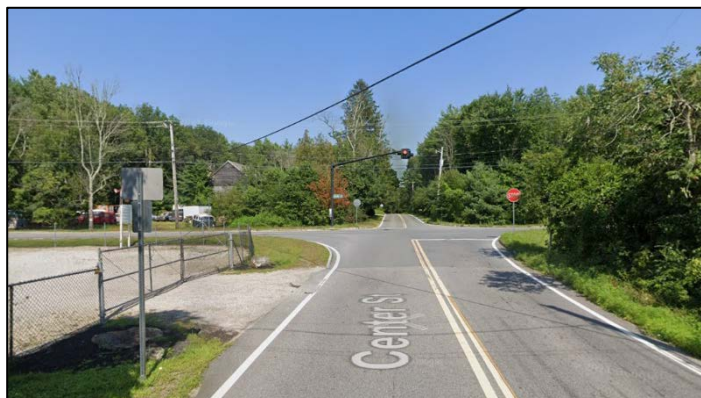
Safety Issue: Intersection geometry, the back wheels of heavy vehicles are going over the curb on the Center Street Eastbound approach when taking a right turn to Route 58 southbound due to a tight turning radius.

The Center Street Eastbound approach to the Palmer Road (Route 58) intersection.

Enhancement: Consider redesigning and reconstructing the intersection geometry including adding channel islands for the Center Street Eastbound approach and an acceleration lane on the Route 58 southbound receiving lane. This would help facilitate the high volume of right-turns from Center Street eastbound to Route 58 southbound.

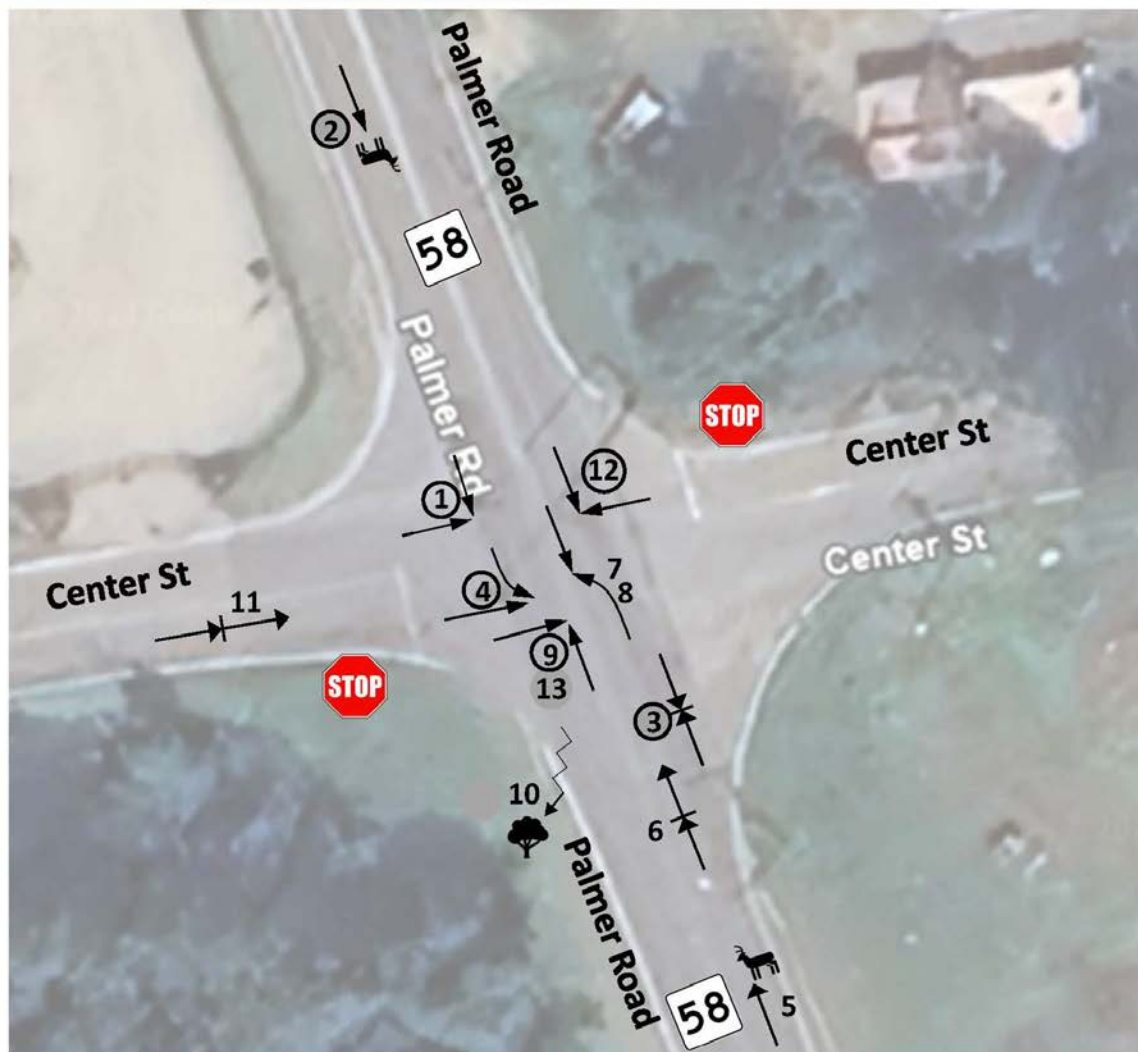
COLLISION DIAGRAM

Diagram ID	Year	Time of Day	Light Conditions	Weather Conditions	Road Surface	Manner of Collision	Driver Contributing Type	Severity	Citation	Abbreviated Narrative
1	6/11/2018	10:45	Daylight	Clear	Dry	Angle	Operating Vehicle in Erratic Manner	Injury	Yes	Eastbound V2 failed to stop at the stop sign and collided with southbound V1.
2	10/19/2018	18:49	Dark- roadway not lighted	Clear	Dry	Single Vehicle Crash	No Improper Driving	Injury	No	V1 was traveling southbound when a deer entered the roadway. V1 struck the deer who ran off into the woods.
3	1/14/2019	17:27	Dark-lighted roadway	Clear	Dry	Head on	Glare	Injury	No	Southbound V2 crossed over the double yellow line due to glare and struck northbound V1 head on.
4	7/7/2019	13:21	Daylight	Clear	Dry	Rear-end	Failed to Yield Right of Way	Injury	Yes	V1 was traveling eastbound and failed to yield for traffic. V1 struck southbound V2, causing V2 to cross into the northbound lane and hit northbound V3.

5	7/25/2019	11:09	Daylight	Clear	Dry	Single Vehicle Crash	No Improper Driving	PDO	No	V1 was traveling northbound when a deer ran out into the road, striking V1 before running off into the woods.
6	6/18/2020	16:22	Daylight	Clear	Dry	Rear-end	Followed Too Closely	PDO	Yes	V2 was traveling northbound attempting to turn left onto Center Street. Northbound V1, following too closely, rear ended V1.
7	8/13/2021	15:45	Daylight	Clear	Dry	Angle	Made an Improper Turn	PDO	Yes	V1 was traveling northbound and made a left turn onto Center Street, colliding with southbound V2 who had the right of way.
8	9/11/2021	12:28	Daylight	Clear	Dry	Angle	Failed to Yield Right of Way	PDO	No	V2 was traveling northbound and made a left turn onto Center Street, colliding with southbound V1 who had the right of way.
9	9/20/2021	14:27	Daylight	Clear	Dry	Angle	Failed to Yield Right of Way	Injury	Yes	V1 was traveling eastbound and failed to stop at the stop sign. V1 struck northbound V2, causing V2 to roll over, strike a utility pole, and land on its roof.

10	12/24/2021	20:14	Dark- roadway not lighted	Cloudy	Dry	Single Vehicle Crash	Unknown	PDO	Yes	V1 was traveling southbound, missed the right turn onto Center Street, left the roadway, and crashed into a tree. The driver of V1 fled the scene.
11	6/21/2022	14:18	Daylight	Clear	Dry	Rear-end	Followed Too Closely	PDO	Yes	V1 and V2 were both traveling eastbound towards the intersection. V1 was distracted, following too closely, and rear ended V2.
12	5/8/2023	16:52	Daylight	Clear	Dry	Angle	Failed to Yield Right of Way	Injury	No	V2 was traveling westbound, failed to yield to traffic, and collided with southbound V1.
13	11/20/2023	17:23	Dark-lighted roadway	Clear	Dry	Angle	Failed to Yield Right of Way	PDO	Yes	V2 was traveling eastbound, failed to yield to traffic, and collided with northbound V1.
