ROAD SAFETY AUDIT

Avon Center

Main St. (Route 28) at East High St and West High Street to
Main Street (Route 28) at East Main Street and West Main Street

October 9, 2024

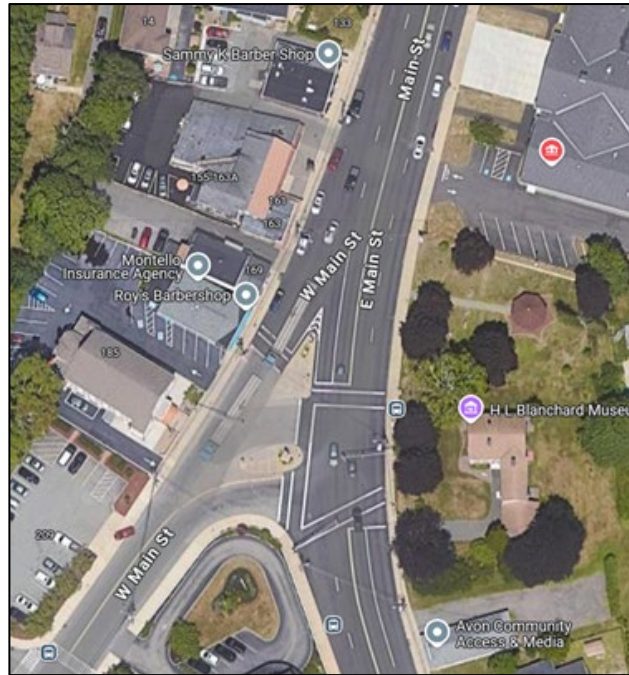
The West Main Street/East Main Street (Route 28)/Main Street (Route 28) Intersection.

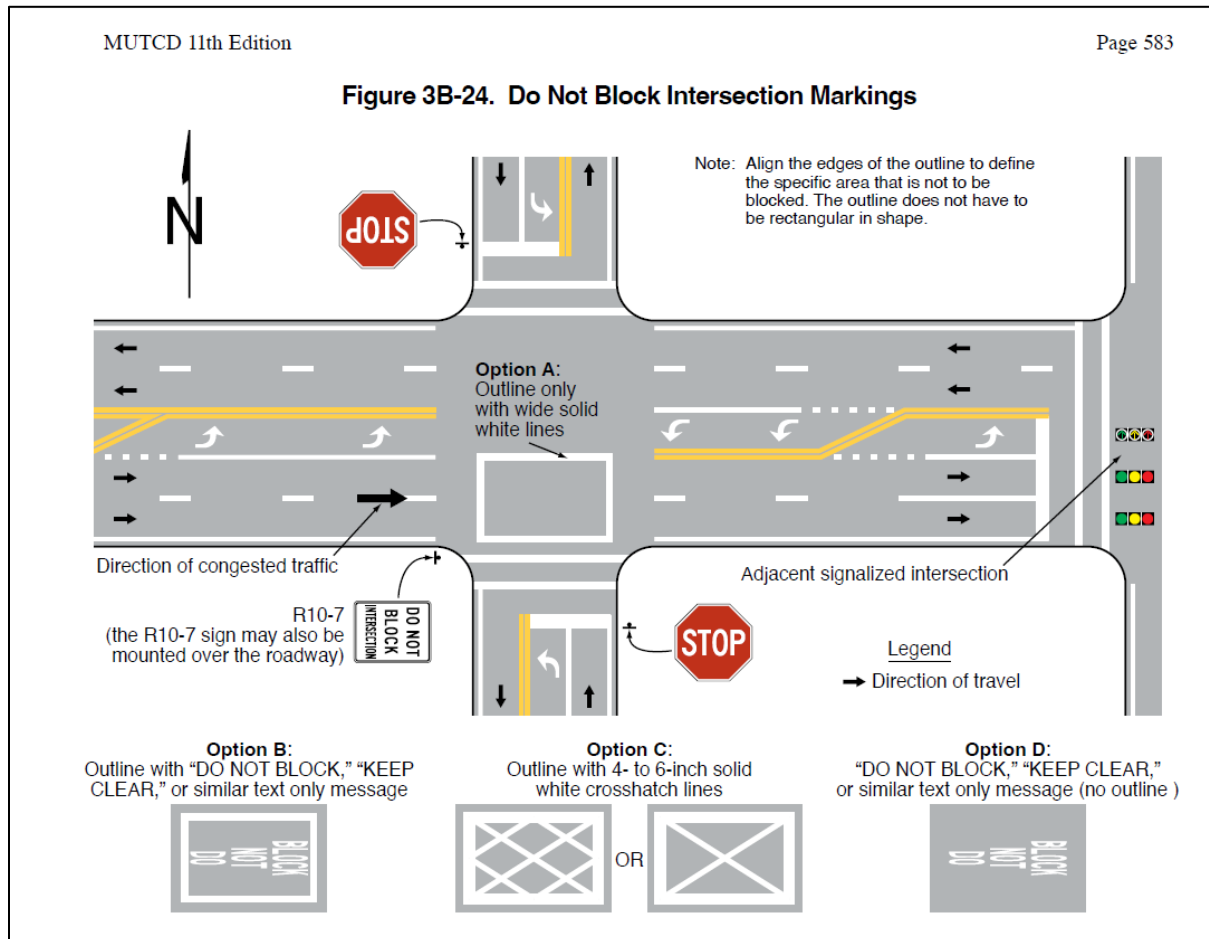
Figure 2: MUTCD Do Not Block Intersection Markings

Safety Issue: The North Main Street (Route 28)/Main Street (Route 28)/East High Street/West High Street intersection has an emergency pre-emption for emergency vehicles exiting the fire station that is located in the fire station, but lacks the pre-emption mounted on the signal equipment that communicates via infrared transmitters mounted on emergency vehicles. In addition, vehicles stop in front of the Firehouse exit on the northbound approach when stopped for a red light.

Enhancement: Evaluate installing pavement markings (MUTCD Figure 3B-24) “Do Not Block Intersection” markings to Route 28 Main Street at the Fire Department curb cut along with signage indicating not to block the intersection.

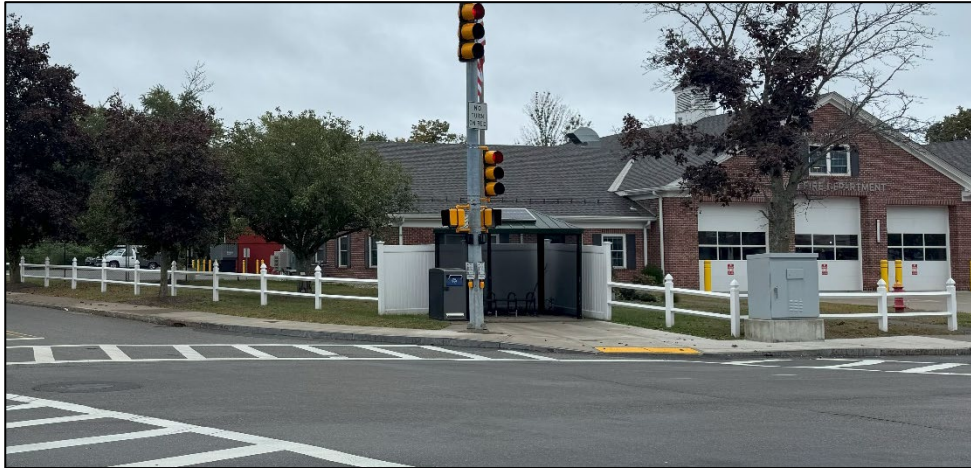
Safety Issue: The Bus stop on the southeast corner if the intersection is hidden by a fence and the signal cabinet and is not an accessible bus stop.

Bus Stop at the southeast corner of the Main Street (Route 28)/East High Street/West High Street intersection.

Enhancement: Remove fence to improve visibility and access

Move the BAT bus stop to the existing MBTA stop located next to the fire station. Consolidating stops creates a centralized hub, more convenient and efficient for riders transferring between BAT and MBTA services. This would eliminate the need for separate stops and reduce confusion for users.
