ROAD SAFETY AUDIT

Pembroke Street (Route 27) at Lake Street and Station Street

Kingston, Massachusetts

May 11, 2021

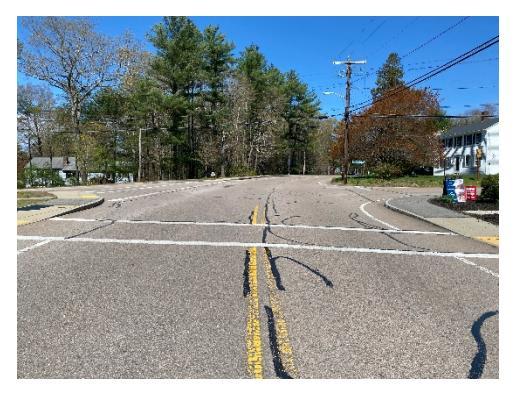
Horizontal Curvature of Pembroke Street (Route 27): There is a rather long curvature of Route 27 that begins west of the intersection and continues eastward through the intersection. Drivers approaching from the west have reduced sight lines of the intersection, and drivers entering from Lake Street and especially Station Street have restricted views of traffic approaching from the west.

Image 1: Curvature of Route 27 restricts sight lines to the west. Utility pole on northwest corner is vulnerable to traffic.

Potential Safety Enhancements: In the short-term, the Town should consider clearing vegetation in the right-of-way on the northwest corner, and further consider working with property owners to clear vegetation on private property that may be

restricting sight lines. Options for relocating utility pole on northwest corner, which not only blocks sight lines but is also vulnerable to being struck by a vehicle, should be explored. Long term, reconstructing the intersection with either a roundabout or traffic signal may mitigate sight line challenges.
