ROAD SAFETY AUDIT

Randolph Street and Richard A. Fitts Drive (Route 139) at Chestnut Street and Old Randolph Street Abington, Massachusetts

April 6, 2021

Prepared by Old Colony Planning Council
Through the Old Colony MPO
FFY 2021 Unified Planning Work Program:
Under Contract with MassDOT

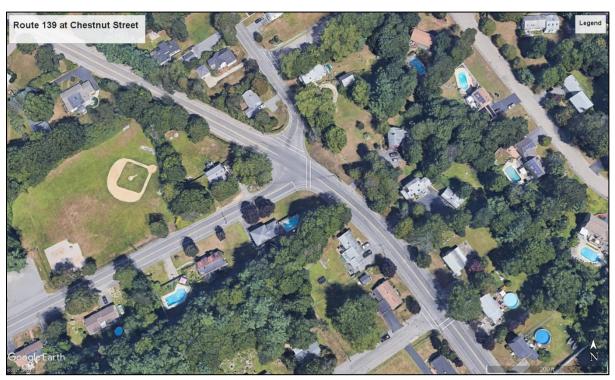
Figure 1: Locus Map

The intersection of Randolph Street / Richard A Fitts Drive (Route 139) at Chestnut Street and Old Randolph Street is a four-legged, unsignalized intersection located in north central Abington. The intersection has a skewed geometry, with Old Randolph Street arriving at Route 139 slightly to the north of opposing Chestnut Street (see aerial image in Figure 1). The following roadways form the intersection:

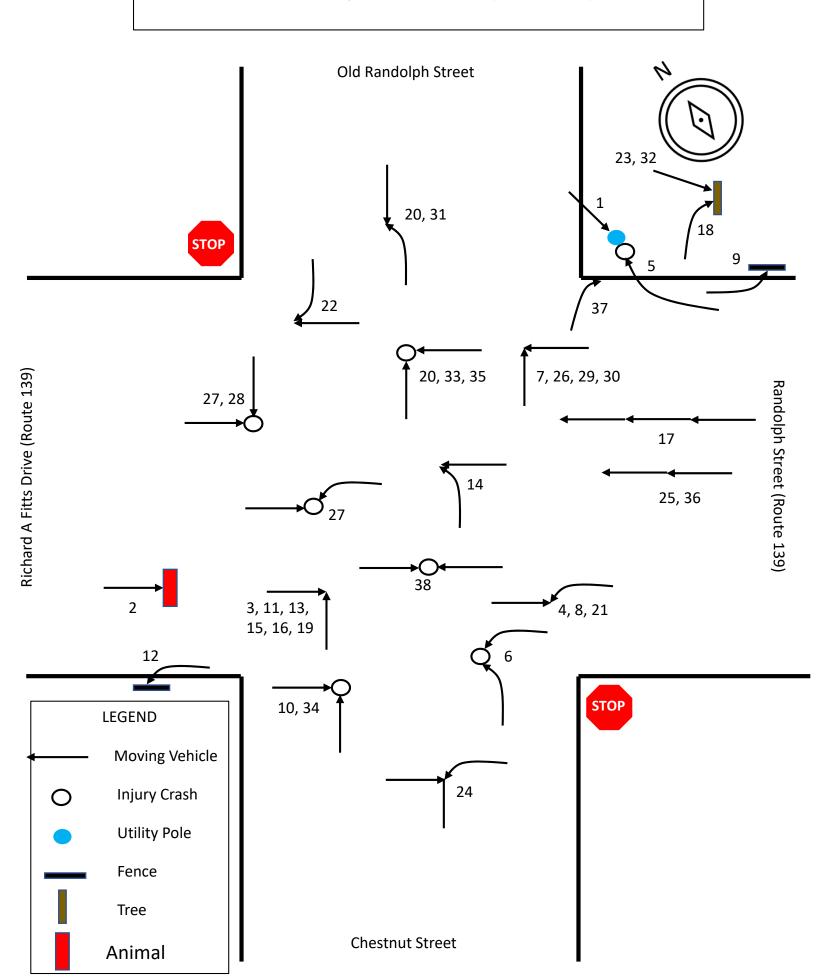
COLLISION DIAGRAM

Randolph St (Route 139) & Chestnut/Old Randolph St Collision Diagram for Crashes (2017-2020)
