ROAD SAFETY AUDIT

Harrison Boulevard Corridor

Town of Avon

August 22, 2014

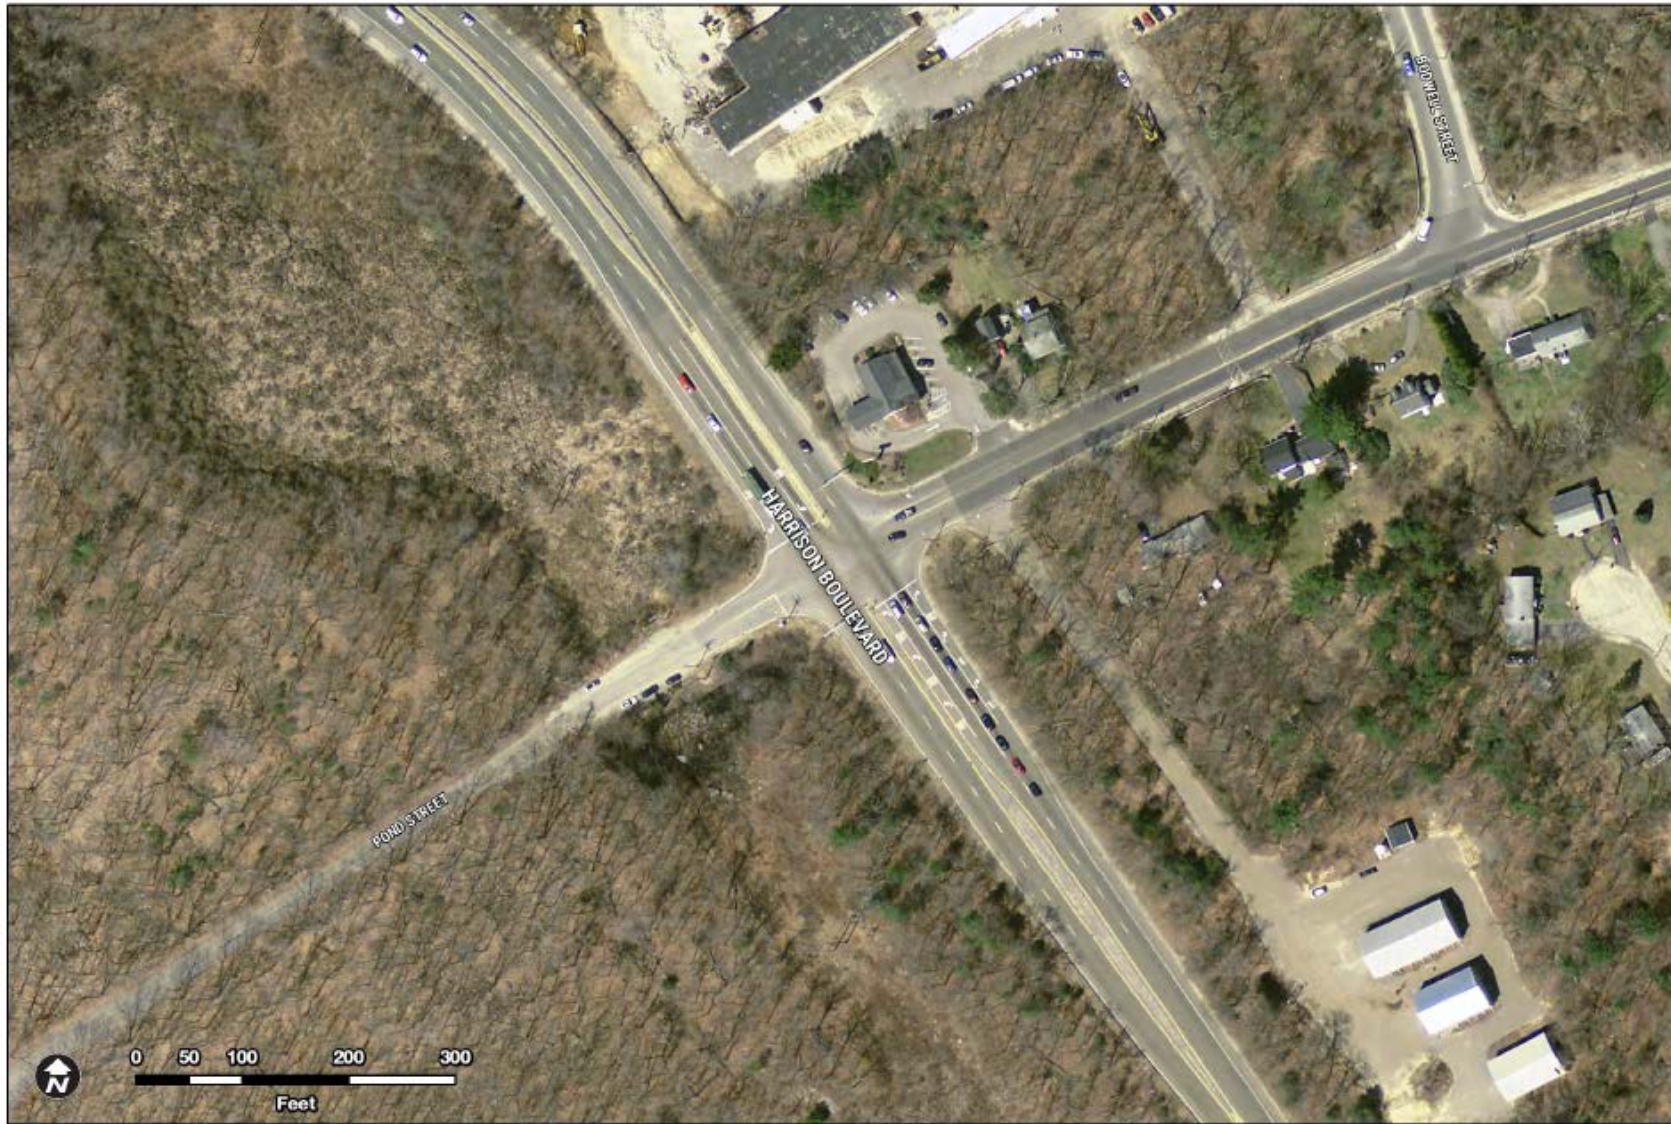
Figure 2 – Harrison Boulevard at Pond Street

The intersection of Harrison Boulevard and Pond Street is a four-way signalized intersection, as shown in **Figure 2**. Pond Street is an urban minor arterial that is owned by the Town of Avon. The southern leg of Pond Street provides access to D.W. Field Park with restricted vehicular access by a gate which is locked between 9pm and 10am. Vehicles were observed to park along the southern leg of Pond Street. The Northbound Pond Street approach provides one travel lane. The eastbound Harrison Boulevard approach provides an exclusive left-turn lane, two through lanes, and an exclusive right-turn lane. The eastbound exclusive left-turn and right-turn lanes are approximately 215 feet in length. The southbound Pond Street approach provides a shared left-turn/through lane and an exclusive right-turn lane. The westbound Harrison Boulevard approach provides an exclusive left-turn lane, two through lanes, and an exclusive right-turn lane. The westbound exclusive left-turn and right-turn lanes are approximately 150 feet in length. The Harrison Boulevard approaches have overhead-mast-arm mounted signal equipment, while the Pond Street approaches have pedestal-mounted signal equipment. There are no pedestrian accommodations at this intersection although these users have been observed crossing Harrison Boulevard.

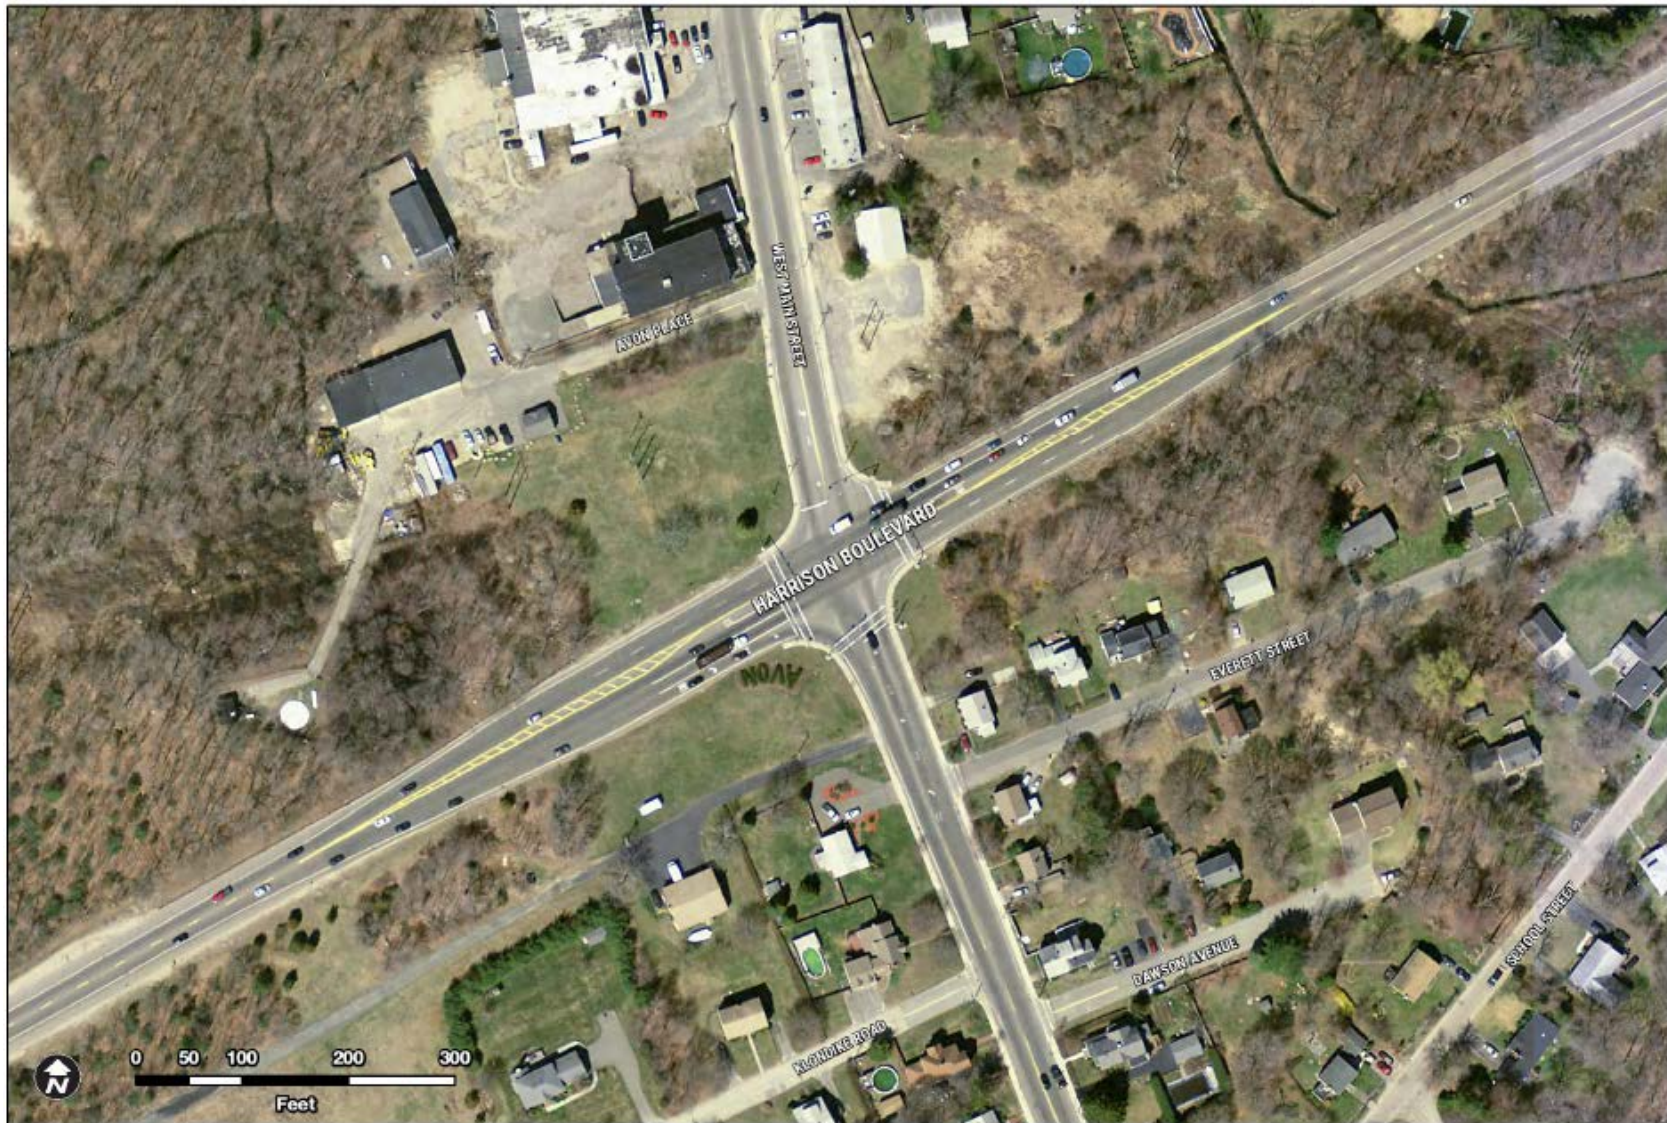
Figure 3 - Harrison Boulevard at West Main Street

The intersection of Harrison Boulevard and West Main Street is a four-way signalized intersection, as shown in **Figure 3**. West Main Street is an urban minor arterial owned by the Town of Avon. The northbound West Main Street approach provides an exclusive left-turn lane and a shared through/right-turn lane. The eastbound Harrison Boulevard approach provides an exclusive left-turn lane, two through lanes, and an exclusive right-turn lane. The eastbound exclusive left-turn lane is approximately 55 feet in length and the exclusive right-turn lane is approximately 140 feet in length. The southbound West Main Street approach provides an exclusive left-turn lane and a shared through/right-turn lane. The Westbound Harrison Boulevard approach provides an exclusive left-turn lane, one through lane, and a shared through/right-turn lane. The westbound exclusive left-turn lane is approximately 70 feet in length. All approaches have overhead mast-arm mounted signal equipment. Crosswalks and pedestrian indications are provided across the eastern, western, and southern legs of the intersections. ADA accessible curb ramps with detectable warning panels are provided at the intersection. The RSA team noted that this intersection has heavy pedestrian volumes.

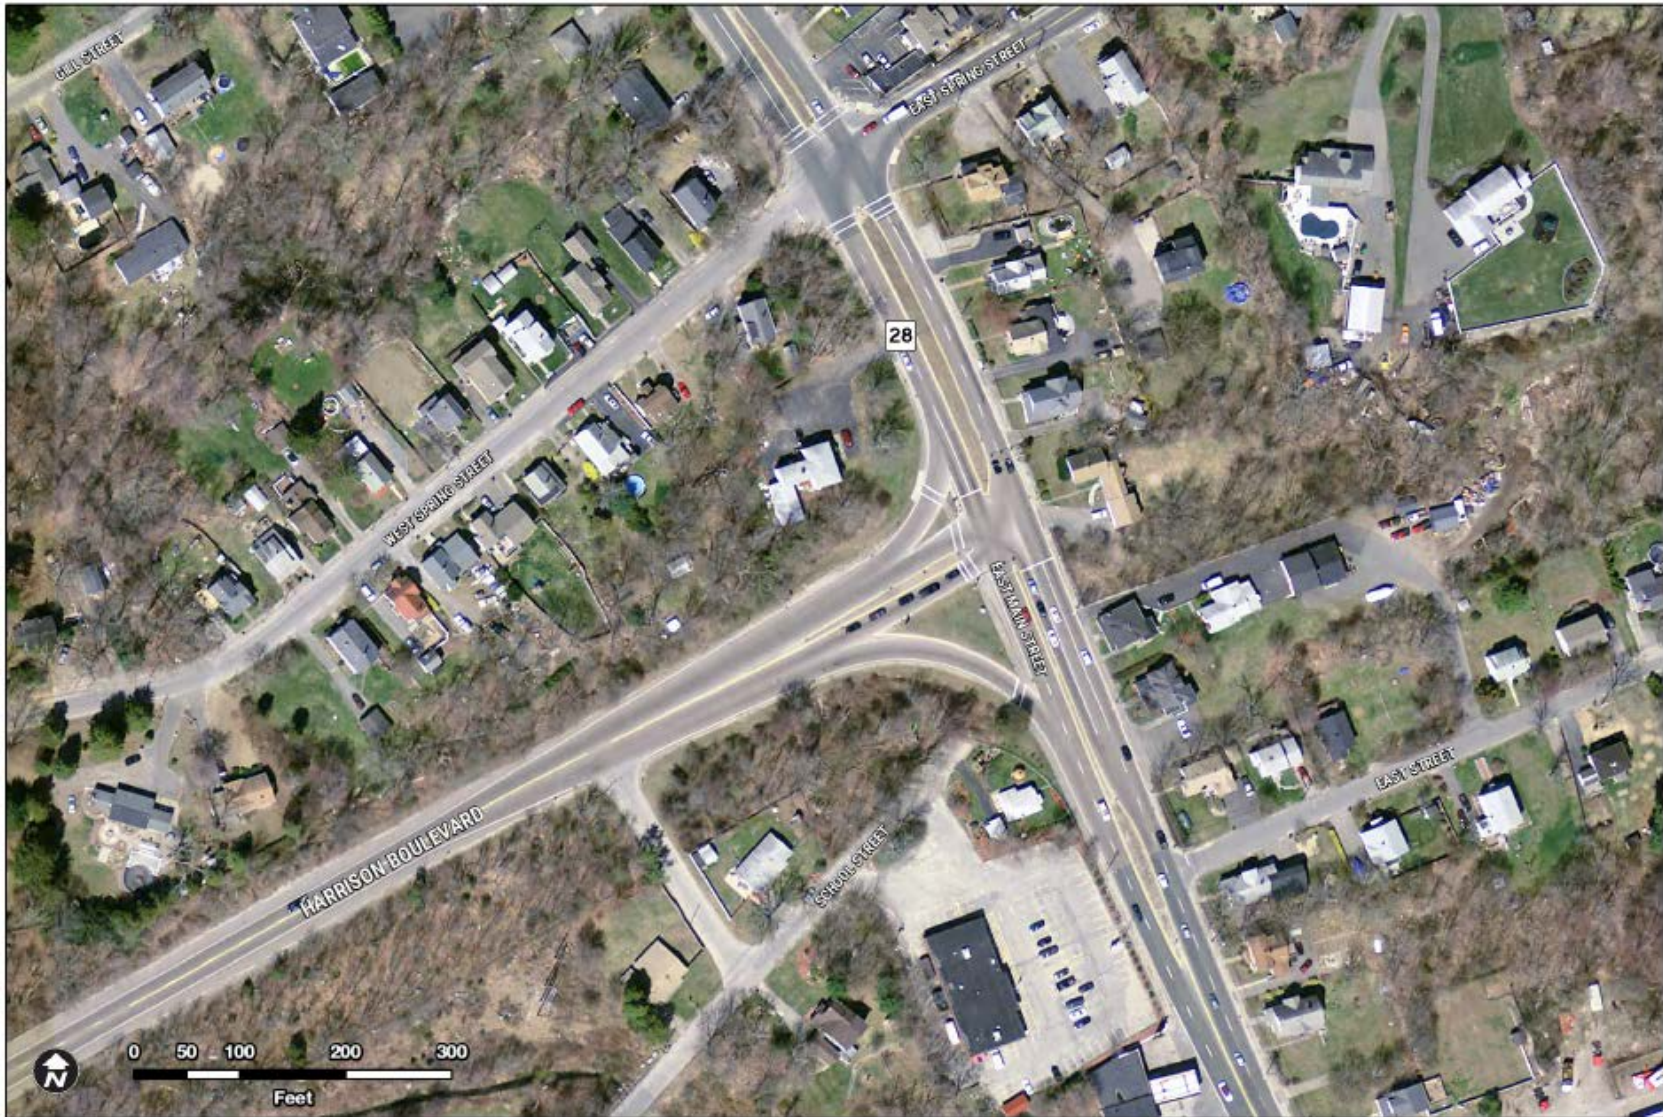
Figure 4 - Harrison Boulevard at East Main Street

The intersection of Harrison Boulevard and East Main Street is a signalized “T” intersection as shown in **Figure 4**. East Main Street is designated as Route 28 and is an urban principal arterial. East Main Street is owned by MassDOT. Harrison Boulevard terminates at this intersection. The northbound East Main Street approach provides an exclusive left-turn lane and two through lanes. The eastbound Harrison Boulevard approach provides an exclusive left-turn lane that is signal-controlled and a right-turn slip lane that is yield-controlled. The southbound East Main Street approach provides a through lane and a right-turn slip lane that is uncontrolled. The East Main Street approaches have overhead-mounted signal equipment with Harrison Boulevard having post-mounted signal equipment within the line of sight of the signalized approach. Crosswalks are provided across the Harrison Boulevard lanes but no pedestrian indications are provided. ADA accessible curb ramps with detectable warning panels are provided at the intersection. The audit team noted that the grass medians are not currently maintained.

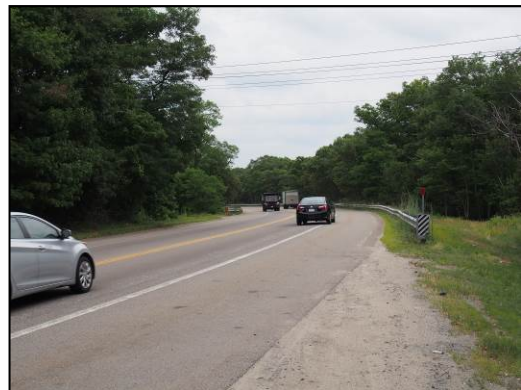
The Harrison Boulevard corridor has two large curves between the Route 24 on- and off-ramps and West Main Street. Between the Route 24 on- and off-ramps and Pond Street, the roadway has two travel lanes in each direction and a raised median. Between Pond Street and West Main Street, the roadway drops to a single travel lane in each direction and has a long horizontal curve approximately ½ mile in length. The audit members noted that all of the fatalities that occurred in the last nine years occurred on this

stretch of roadway. The types of crashes that typically occur are single vehicle and head-on collision crashes.

With no street lights, the audit members noted the roadway is dark. The roadway is delineated with a centerline and edge lines but there were no observed reflectors. Audit members noted that the multiple transitions between the two lane section and the four lane section create unnecessary merges and vehicle conflicts. During the audit, a member recommended installing recessed pavement reflectors on the edge lines for the Harrison Boulevard corridor to increase visibility of the roadway alignment. MassDOT does not typically install recessed pavement reflectors on edge lines due to hazards for bicyclists and maintenance concerns.

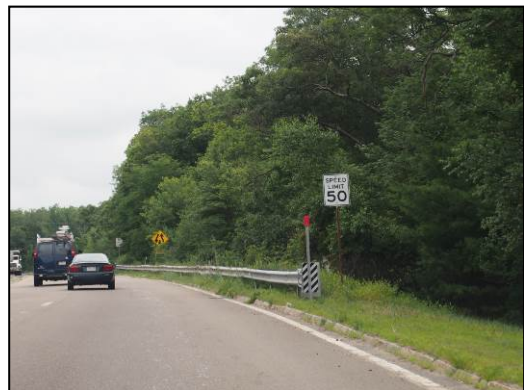
Figure 6 - 50 MPH speed limit sign

The audit members noted that based on the Commonwealth of Massachusetts speed regulations, several existing posted speed limit signs are missing. In addition, the speed limits between the intersections are relatively high for a two lane roadway.

During the audit, team members discussed the potential of adding signal ahead warning signs with advisory speed placard as a method to reduce speeds at signalized intersections along the corridor. The discussion determined that due to lack of enforceability, a corridor-wide speed study was preferred.

1. Based on the Commonwealth's speed regulations for Harrison Boulevard, install R2-1 speed limit signs along the corridor where they are missing. This is a short-term, low-cost enhancement.
2. As a long-term project, consider conducting a speed study for Harrison Avenue to determine appropriate speed regulations.

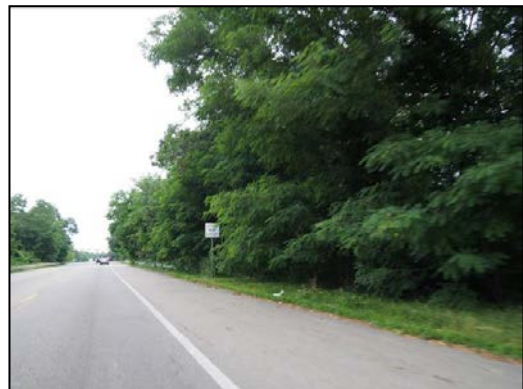
The audit members noted that along Harrison Boulevard the adjacent vegetation is overgrown. In several locations the vegetation is blocking signs or roadway sight lines.

Figure 7 - Vegetation along the north side of Harrison Boulevard partially obstructing sign visibility

1. Trim or consider clearing vegetation to improve sight lines and sign visibility along Harrison Boulevard.

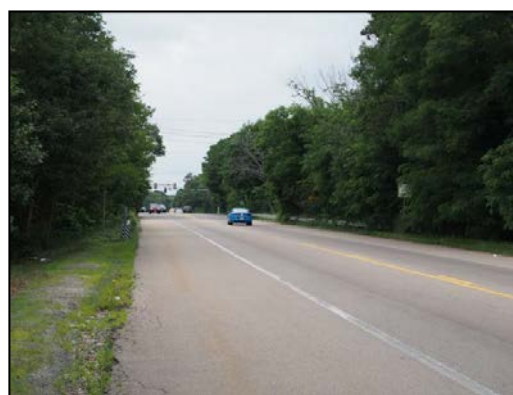
The audit members noted that along Harrison Boulevard bicyclists have been observed. Currently, shoulders are provided but narrow at the signalized intersections, forcing cyclists to merge with vehicle traffic. No crashes were reported that included a bicyclist; however, audit members noted that bicycling along the corridor is a safety issue where shoulders narrow.

Figure 8 - Segment of Harrison Boulevard including wide shoulders

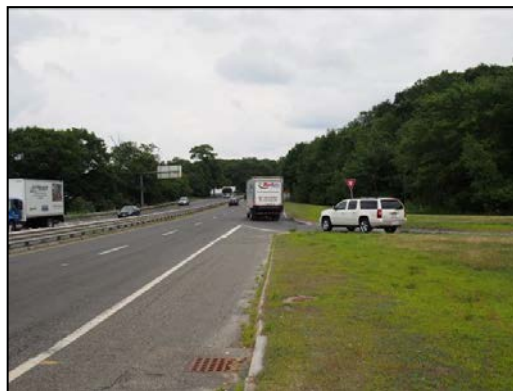
The audit team noted that crashes typically occurred on the Harrison Boulevard Westbound to Route 24 Northbound on-ramp and the Harrison Boulevard Eastbound to Route 24 Southbound on-ramp. The crash data did not reflect these observations. The audit team did note that crashes on the ramps typically occur during the daylight and involve trucks.

Figure 9 - Route 24 northbound exit ramp terminus at Harrison Boulevard

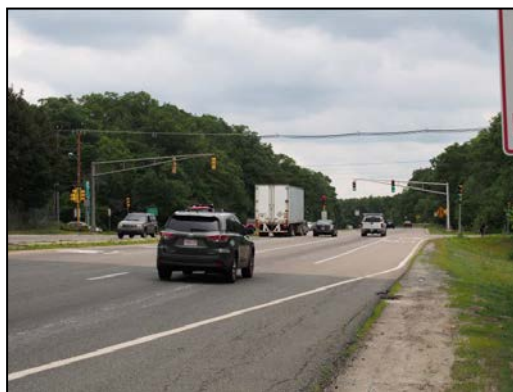
At the intersection of Harrison Boulevard and Pond Street, Harrison Boulevard widens to accommodate turn lanes. The crash data shows several sideswipe and turning collisions; observations by audit members indicate that vehicles are making last minute lane changes to travel in their intended direction.

In addition, the Harrison Boulevard eastbound approach has a high left turning volume. The queue length tends to extend beyond the existing left turn pocket. Team members noted the difficulty weaving into the left turn lane when exiting from Route 24 northbound, which is exacerbated by the heavy eastbound through volume combined with the short distance between the ramp and the end of the queue.

Figure 10 - Harrison Boulevard southbound approach to Pond Street

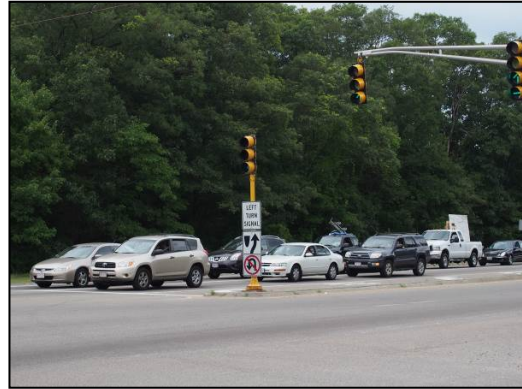
The ‘No U-turns’ sign is located on the far side of the intersection on the signal post. In addition to the ‘No U-turn’ sign, LEFT TURN SIGNAL and KEEP RIGHT signs are posted on the signal post. RSA members noted that the current placement of the R3-4 may not be visible to a driver until they are mid-turn or not at all because of the two additional signs above it.

Figure 11 - Signs mounted to the signal pedestal in the median

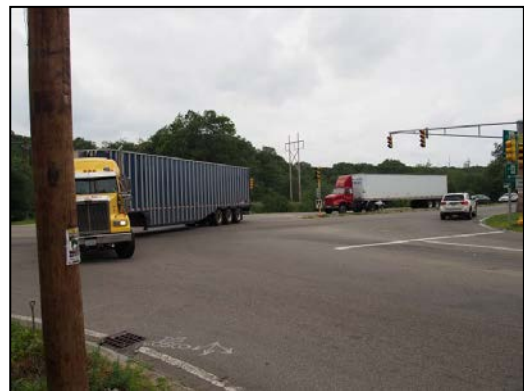
The Harrison Boulevard corridor between Route 24 and Pond Street has a high percentage of heavy vehicles. The heavy truck route is from Harrison Boulevard eastbound to Pond Street northbound and Pond Street southbound to Harrison Boulevard westbound. The heavy vehicles are accessing the industrial area off Bodwell Street. As a result, the audit team noted that the pavement quality for those movements is poor and rutting. The quality of pavement may cause drainage issues and reduced traction under braking. One crash occurred on this approach under icy conditions, which may be due to the poor pavement quality.

Figure 12 - Large trucks turning left into Pond Street

The audit team noted that trucks have been observed parking on the Pond Street southbound right lane to access the Bank of America located on the northwest corner of the intersection of Harrison Boulevard and Pond Street. Parked trucks at this location partially or entirely block the right turn lane, potentially causing weaving issues for approaching vehicles.

1. Repair pavement quality in Harrison Boulevard's eastbound left-turn lane and Pond Street southbound approach.
2. Install R7-1 NO PARKING signs on the Pond Street southbound approach to eliminate trucks parking in this location.

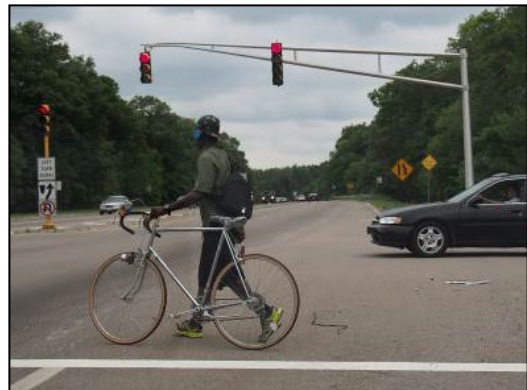
Figure 13 - Pedestrian walking a bicycle across the intersection with no crosswalk

1. Install crosswalks, curb ramps with detectable warning panels, pedestrian indications, and accessible pushbuttons across the Harrison Boulevard eastbound approach to provide fully accessible crosswalks.
2. Extend Pond Street west side sidewalk to the intersection of Harrison Boulevard to provide pedestrian access to DW Field Park.

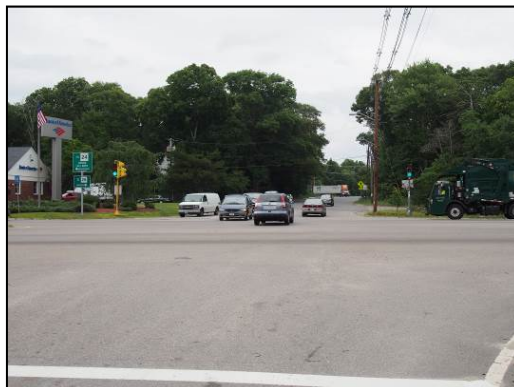
The audit team noted that the traffic signals on the Pond Street approaches are post-mounted on the corners and not overhead in line with the approach lanes, as recommended in the MUTCD. This may have been a factor in a crash where a southbound driver ran a red light and caused a crash within the intersection.

Figure 14 - Pond Street eastbound approach with pedestal mounted signals

1. Upgrade Pond Street traffic signals to overhead mast-arm mounted signals to provide signal indications aligned with the approach lanes, as recommended in the latest version of the MUTCD.

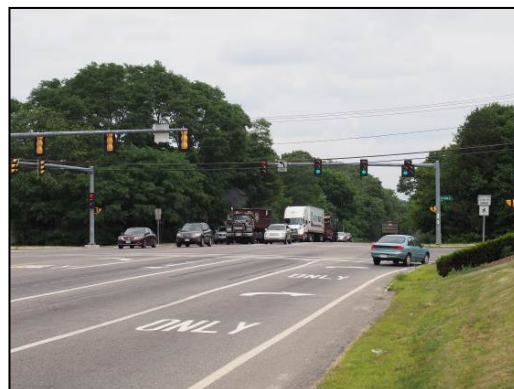
Queue lengths on the eastbound through lane often extend beyond the existing eastbound left turn lane, resulting in impatient drivers who sometimes cross the double yellow centerline to bypass stopped through vehicles and access the left turn lane. While there are no reported crashes related to this issue, the centerline violations are a safety hazard for oncoming westbound vehicles.

Figure 15 - Harrison Boulevard eastbound approach to West Main Street

1. Evaluate all-red signal clearance phase to ensure clearance time is sufficient. Evaluate loop detectors design speed to reduce dilemma zone.
2. Repair pre-emption equipment to improve response times for emergency vehicles traveling to nearby incidents.
3. Consider extending the left turn lane to allow vehicles to bypass average through-lane queues.

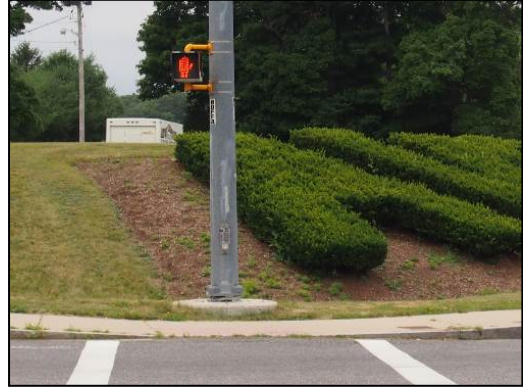
The intersection of Harrison Boulevard and West Main Street has crosswalks, curb ramps with detectable warning panels, and pedestrian indications. The audit team noted that there is a heavy pedestrian movement across Harrison Boulevard. No pedestrian crashes were reported in the crash data.

Figure 16 - Pedestrian signal indication and crosswalk

1. Upgrade pedestrian signals to provide countdown indications and accessible push buttons.
2. Evaluate the pedestrian signal clearance time for MUTCD-compliance.
3. Consider installing pedestrian median refuge islands to provide a protected waiting area for pedestrians that do not make it across during the pedestrian phase.

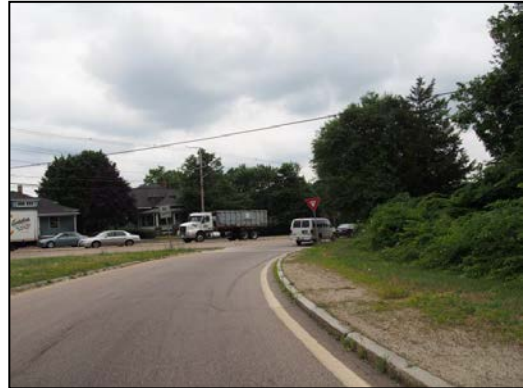
The crash data analysis noted that 35 percent of the crashes at the intersection with East Main Street were rear-end crashes of vehicles traveling on the slip lane from Harrison Boulevard to East Main Street southbound. The audit team noted that with the yield-controlled approach, drivers may be anticipating that the vehicle in front of them has cleared the intersection while they are looking back for a gap in traffic.

Figure 18 - Right turn slip lane on the Harrison Boulevard eastbound approach
