Road Safety Audit Main Street, Brockton

Old Colony Planning Council 70 School Street Brockton, MA 02301

September, 2009

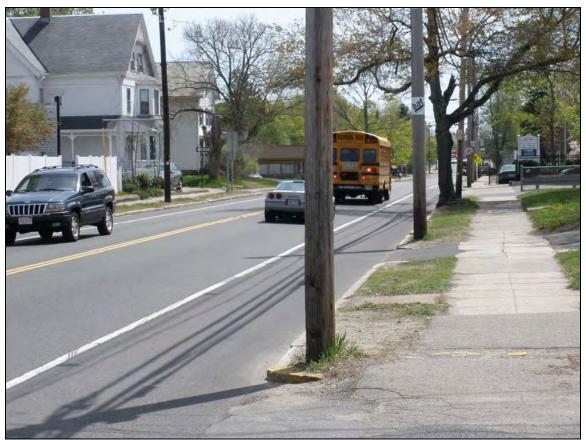
Main Street looking southbound toward the Campello Campus.

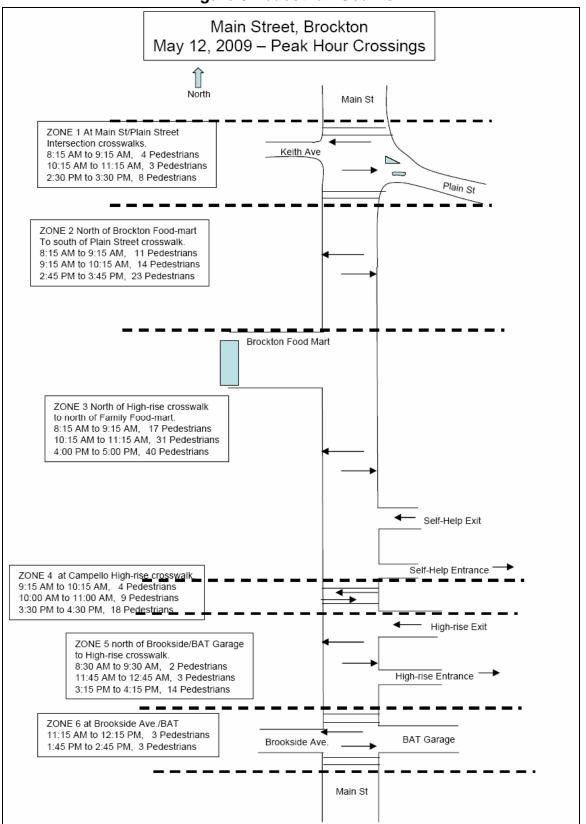
Figure 3 Pedestrian Counts

The study area was divided into six zones for the purpose of counting the volume of pedestrians crossing Main Street between 8 AM and 5 PM during an average weekday (one day between Monday and Friday). The pedestrian count was conducted on Wednesday, May 12, 2009, on a sunny, warm day that was favorable for pedestrian traffic.

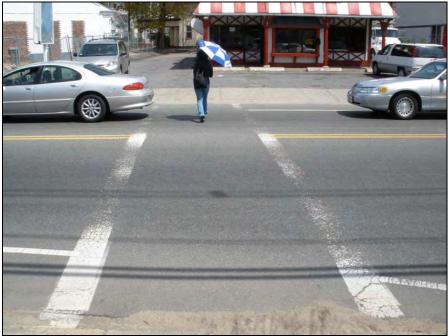
Pedestrian crossing Main Street at the Clifton Street crosswalk

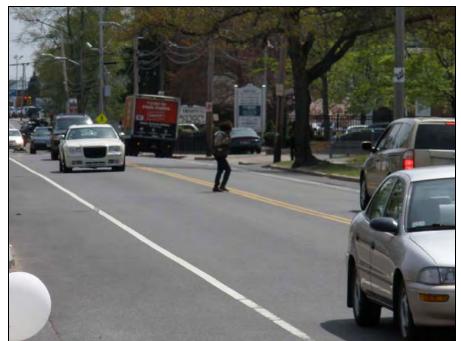
Main Street looking south, with a pedestrian (talking on cell phone) crossing Main Street at BAT stop, just south of convenience store

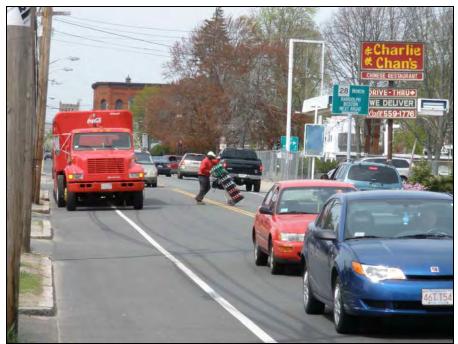
Main Street looking north, with a soda truck parked as the driver crosses through traffic to make a delivery.

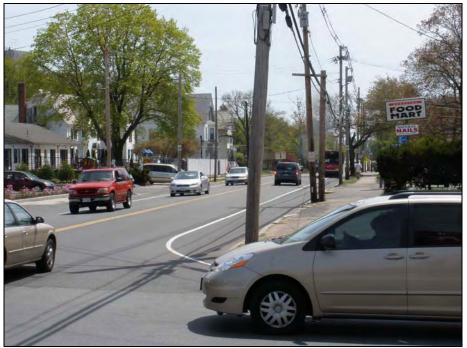
Main Street looking south from Clifton Street showing a lack of adequate gaps for crossing the street or letting side traffic enter the traffic stream.

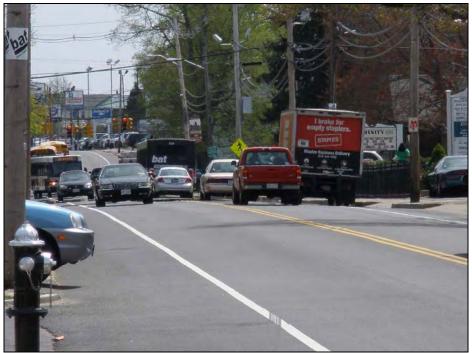
Main Street looking southbound at crosswalk in front of the Campello High Rise. A truck is parked along the road for deliveries.

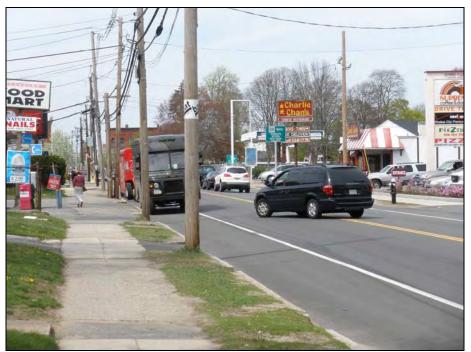
Main Street looking northbound toward convenient store, with a pedestrian walking on the sidewalk, trucks parked near curb openings are blocking views as cars enter adjacent properties.

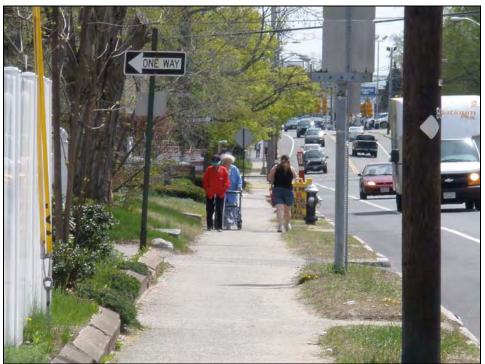
Main Street looking southbound with pedestrians walking along the sidewalk.

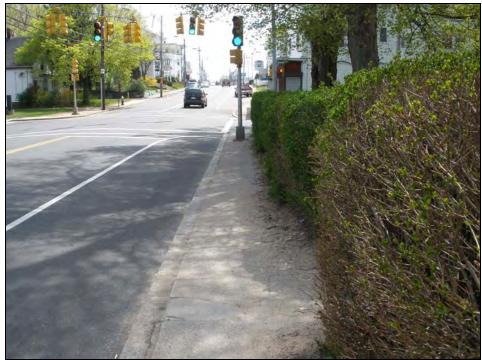
Main Street looking south at Brookside Avenue shows hedges blocking the sidewalk.

- Sidewalks along Main Street are in generally good condition with a four to five foot
	cement walkway and a three foot grass buffer and curb. Approximately 30 to 50 feet of the
	sidewalk along the east side of Main Street is blocked by vegetation just north of the
	Brookside Ave. intersection (as shown previously in this report.)
	-Pedestrian activity is heavy along Main Street, especially during good weather, although
	the volumes fall short of warranting a mid-block pedestrian actuated signal.

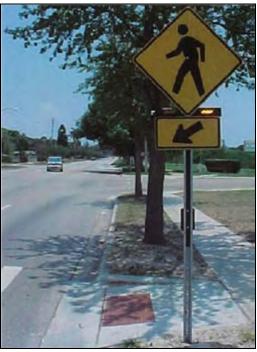
Rectangular Rapid Flashing Beacons (RRFB) are flashing lights on pedestrian crossing signs at crosswalks that are actuated by the pedestrian via a push button. These flashing lights bring better visibility to the motorists that pedestrians are using the crosswalk.

Flashing lights on the W-11 sign (Rectangular Rapid Flashing Beacons - RRFB), used in conjunction with a crosswalk. These lights are pedestrian push-button actuated.

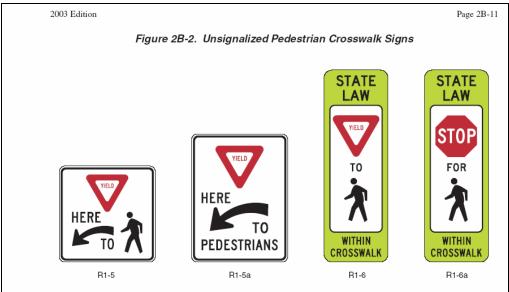
Figure 5 Pedestrian crosswalk signs (MUTCD)

Figure 5 shows the MUTCD standard signs, regulatory and warning, used in conjunction with crosswalks. Figure 6 shows MUTCD standards for the placement of the R1-5 sign, and the yield markings that are recommended for the Campello High Rise crosswalk. Further enhancements for crosswalks include a textured crosswalk and bump outs that would block vehicles from using the shoulder to go around vehicles in front of them that are stopped for pedestrians. Figure 7 shows signs from the MUTCD to encourage crosswalk use and discourage jay-walking.

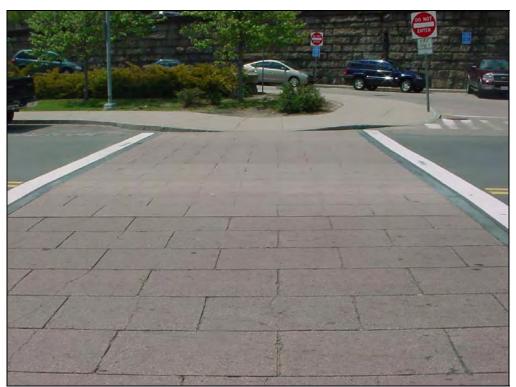
Textured crosswalks Commercial Street, Brockton at Police Station and BAT Centre

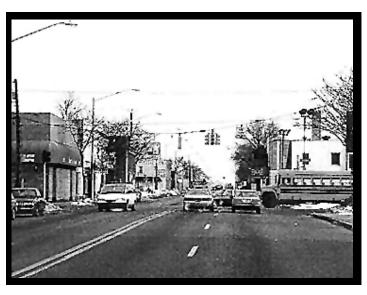
Before

This is a photo of an intersection in Grand Rapids, Michigan, before a road safety audit was conducted. The two traffic signal heads are hung on a diagonal span of wire and only one head is over the travel lanes. There are two lanes approaching the intersection separated by a dashed white pavement marking.

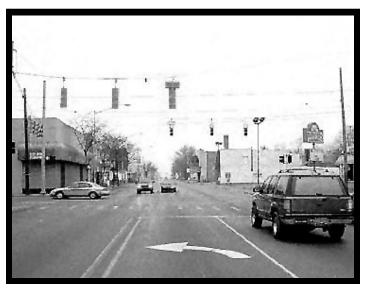
After

This is the same intersection after a road safety audit was conducted. The traffic signals are now hung on a box span of wire and they are now able to be hung directly over the travel lanes. Now there are three traffic signal heads, two for the through lane and one for the left turn lane. Pavement markings now show a separate left-turn lane at the intersection.
