ROAD SAFETY AUDIT

Montello Street (Route 28) at East Nilsson Street

Brockton, MA

September 2019

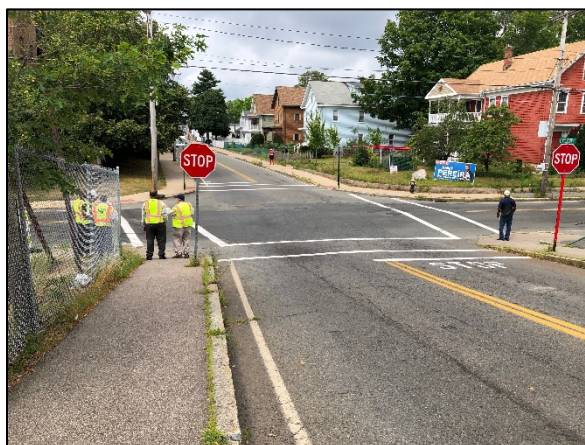
The East Nilsson Street westbound approach has a descending grade as the road is raised above the railroad tracks.

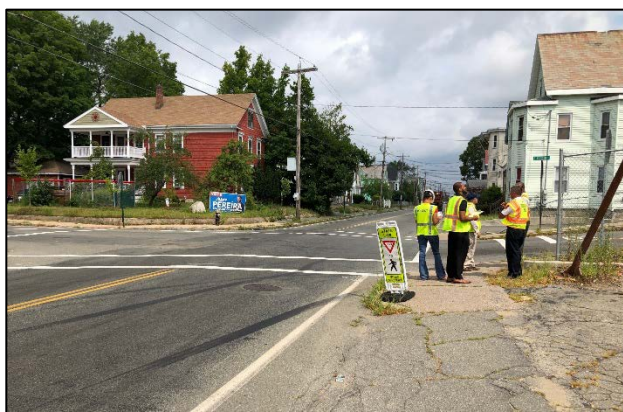
Safety Issue: The sight distance on the minor street East Nilsson Street eastbound and westbound approaches is limited.

Vehicles approaching the intersection on both the eastbound and westbound minor street East Nilsson Street approaches is limited, especially looking northbound. Vehicles on the westbound approach pull ahead of the stop line in order to look for vehicles headed southbound on Montello Street toward the intersection. Vehicles on the East Nilsson Street eastbound approach also must pull ahead of the stop line to view vehicles headed southbound on Montello Street toward the intersection. Vegetation on the northwest corner of the intersection (next to a house on the corner) blocks sight lines for East Nilsson eastbound vehicles.

Vegetation on the northwest corner of the intersection (next to a house on the corner) blocks sight lines for East Nilsson eastbound vehicles.

Enhancement: Request permission of the homeowner of the property on the northwest side of the intersection to trim the vegetation back to improve sight lines looking north to Montello Street.
