ROAD SAFETY AUDIT

Three Intersections in North Brockton:

Brockton, MA

January 2019

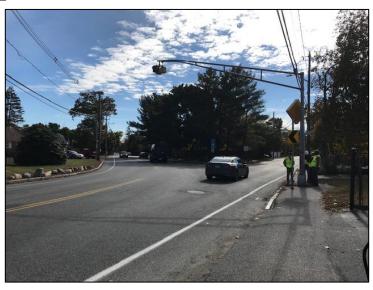
The southbound North Quincy approach to the North Cary/North Quincy intersection, showing overhead flashing beacon, chevrons, and flashing warning signs (facing vehicles approaching from North Quincy westbound).

There are flashing warning signs on the North Quincy westbound approach. North Cary Street and North Quincy Street form a "Y" type intersection in North Brockton. Vehicles approaching the intersection southbound on North Quincy traveling to North Cary are actually traveling straight through. These vehicles make this movement with little change in speed. If this was a conventional intersection, these movements, from North Quincy southbound to North Cary Street, would be right turns and the vehicles would be at slower speeds to make a right turn. North Quincy Street has four feet shoulders on both sides of the road.

Enhancement: Add additional chevrons on the southbound and northbound approaches.

Enhancement: Add temporary barriers (surface mounted delineators) to channel southbound North Quincy traffic, which will create deflection, thereby slowing traffic traveling to North Cary Street, and keep traffic in the travel lane on North Quincy Street.

Enhancement: Extend the guard rail along the west side of North Quincy Street to protect residences along the side of the road from vehicles exiting the travel lanes.

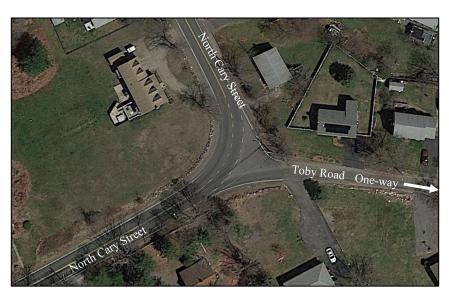
The North Cary Street/Toby Road intersection, North Cary Street curves sharply through the intersection and Toby Road is a one-way street eastbound (away from the intersection).

makes a sharp curve through the intersection. Based on automatic traffic counts conducted by OCPC, there are approximately 4,689 vehicles per day on North Cary Street just north of the North Cary Street/Toby Street intersection.

Enhancement: Extend the existing guardrail on North Cary Street south to the utility pole.

Enhancement: Add chevrons on the northbound and southbound North Cary Street approaches to the intersection.

Enhancement: Utilize temporary barriers to accentuate turning radius to Toby Street.

Enhancement: Install overhead flashing beacons (flashing yellow on the North Cary northbound and southbound approaches) to improve intersection visibility.

Enhancement: Reconstruct and realign the intersection to improve turning radius to Toby Street.
