ROAD SAFETY AUDIT

West Elm Street
High Crash Locations between West St and Warren Ave
City of Brockton

November 30, 2012

Prepared For:
MassDOT Highway Division

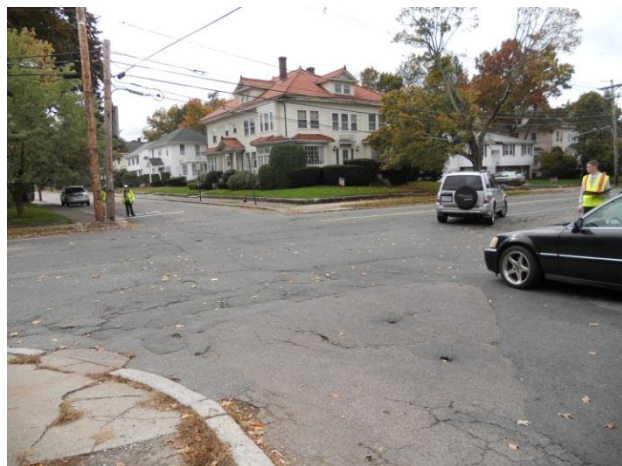
West Elm Street at Moraine Street

West Elm Street and Moraine Street form a 4-legged unsignalized intersection, with Moraine Street under STOP control. Moraine Street serves as a cut-through between Pleasant Street to the north and Belmont Street to the south. Land use in the area is primarily residential.

West Elm Street and Moraine Street each provide a single general purpose lane in each direction at the intersection. Moraine Street has an offset alignment at West Elm Street.

Pavement markings at the intersection consist of a double yellow centerline and white edge lines for West Elm Street and painted stop bars with STOP word markings for Moraine Street. No centerline or edge line markings are provided on Moraine Street. A wide shoulder/parking lane is provided along the north side of West Elm Street from Ash Street past Moraine Street to West Street; it was noted that this parking lane is wider than the travel lane and may appear to be a second travel lane for drivers unfamiliar with the area. Stop signs are provided on both sides of Moraine Street on both the northbound and southbound approaches. On-street parking is allowed along West Elm Street in the vicinity of Moraine Street; it is unclear if parking is allowed along Moraine Street, although no signage is present indicating parking restrictions. It should be noted that No Parking signage is sporadic and in poor condition along the entirety of West Elm Street, and that the absence of signing is not a clear indicator that no City ordinance exists restricting parking in any specific area.

No marked crosswalks are provided at the intersection. Continuous sidewalks are provided on both sides of West Elm Street throughout the study corridor, and are separated from the edge of roadway by a grass strip with mature trees in the vicinity of Moraine Street. Paved sidewalks are provided on both sides of Moraine Street south of West Elm Street; no sidewalks are provided north of West Elm Street, although there is a worn gravel path for pedestrian use along the east side of Moraine Street. Handicap ramps are provided at the intersection despite the lack of marked crosswalks, but are generally in poor condition and do not meet ADA and MassDOT guidelines.

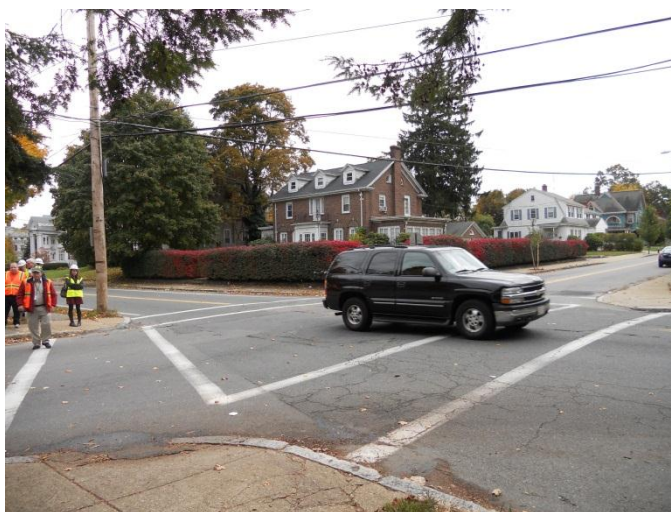
West Elm Street at Ash Street

West Elm Street and Ash Street form a 4-legged unsignalized intersection, with Ash Street under STOP control. Ash Street serves as a cut-through between Pleasant Street to the north and Belmont Street to the south. Land use in the area is primarily residential.

West Elm Street and Ash Street each provide a single general purpose lane in each direction at the intersection. Pavement markings at the intersection consist of a double yellow centerline and white edge lines for West Elm Street and double yellow center lines and painted stop bars with STOP word markings for Ash Street. The wide parking lane along West Elm Street begins at Ash Street. Stop signs are provided on

both sides of Ash Street on both the northbound and southbound approaches, although the right side Stop sign for the southbound approach is set back approximately 10 feet from the stop line. On-street parking is allowed along both sides of West Elm Street west of Ash Street, accommodated on the north side within the aforementioned wide shoulder. No Parking signs are sporadically posted on both sides of West Elm Street east of Ash Street. It is unclear if parking is allowed along Ash Street, although no signage is present indicating parking restrictions.

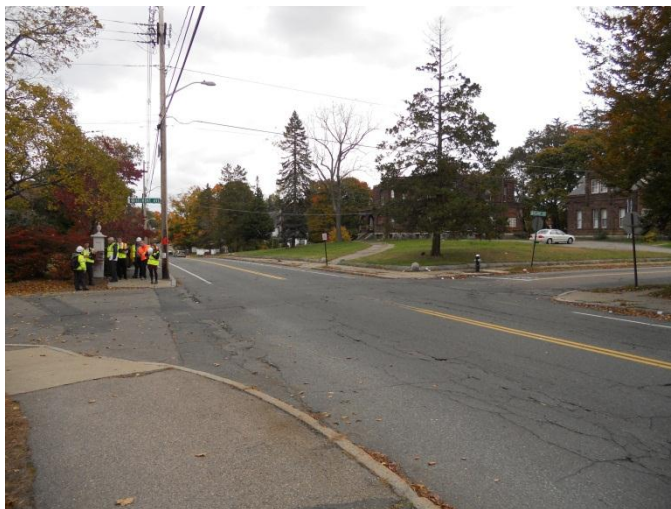
West Elm Street at Belmont Avenue

West Elm Street and Belmont Avenue form a 4-legged unsignalized intersection, with Belmont Avenue under STOP control. Belmont Avenue serves as a cut-through between Pleasant Street to the north and Belmont Street to the south. Land use in the area is primarily residential, except for the Universalist Unitarian Church on the northwest corner of the intersection.

West Elm Street and Belmont Avenue each provide a single general purpose lane in each direction at the intersection. Pavement markings at the intersection consist of a double yellow centerline and white edge lines for West Elm Street and double yellow center lines and painted stop bars with STOP word markings for Belmont Avenue. Stop signs are provided on both sides of Belmont Avenue on both the northbound and southbound approaches, although the right side Stop sign for the northbound approach is set back approximately 15 feet from the stop line. On-street parking is restricted along West Elm Street in the vicinity of Belmont Avenue. It is unclear if parking is allowed along Belmont Avenue, although no signage is present indicating parking restrictions.

No marked crosswalks are provided at the intersection. Continuous sidewalks are provided on both sides of West Elm Street throughout the study corridor. Continuous sidewalks separated from the edge of roadway by a grass strip are provided on both sides of Belmont Avenue south of West Elm Street, and a continuous sidewalk is provided on the west side of Belmont Avenue north of the intersection. Apex-style handicap ramps are provided at the intersection despite the lack of marked crosswalks, but are generally in poor condition and do not meet ADA and MassDOT guidelines.

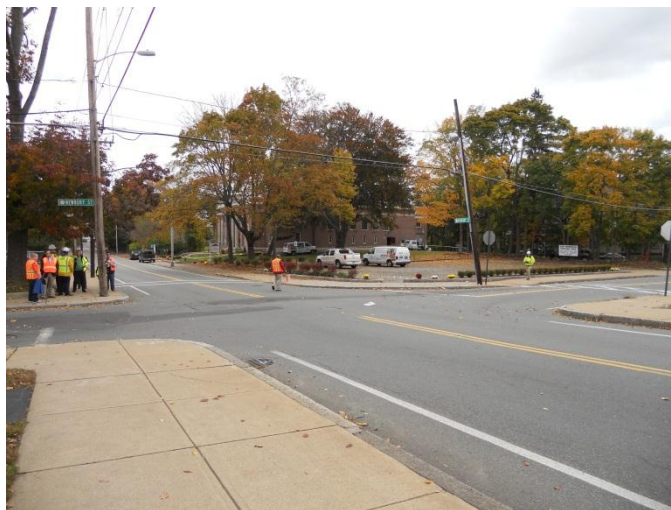
West Elm Street at Newbury Street

West Elm Street and Newbury Street form a 4-legged unsignalized intersection, with Newbury Street under STOP control. Newbury Street serves as a cut-through between Pleasant Street to the north and Belmont Street to the south. Land use in the area is primarily residential, with some institutional and government land uses in the vicinity. A four-story apartment building is located on the northeast corner of the intersection, with the Plymouth County Registry of Deeds immediately to the east. New Life Christian Church is on the southwest corner, and a parking area for the Brockton War Memorial Building is located on the southeast corner. The War Memorial Building is adjacent to the parking area east of the intersection.

West Elm Street and Newbury Street each provide a single general purpose lane in each direction at the intersection. Newbury Street has an offset alignment at West Elm Street. Pavement markings at the intersection consist of a double yellow centerline and white edge lines for West Elm Street. Crosswalks are set back on all four approaches, and the Newbury Street approaches have two stop lines – a stop line with STOP word marking before the crosswalk, and a stop line adjacent to the stop sign after the crosswalk. This creates a confusing scenario for approaching motorists. A double yellow centerline is provided on the northbound Newbury Street approach but is missing from the southbound approach. Stop signs are provided on both sides of Newbury Street on both the northbound and southbound approaches, but are set back from the stop line in both directions. Stop signs on the southbound approach are set approximately five feet in advance of the stop line, while signs on the northbound approach are approximately fifteen feet in advance of the stop line. On-street parking is restricted along the north side of West Elm Street in the vicinity of Newbury Street and from Newbury Street to Warren Avenue. On-street parking is restricted on the south side of West Elm Street west of Newbury Street, with sporadic signage restricting parking east of Newbury Street to Warren Avenue. It is unclear if parking is allowed along Newbury Street, although no signage is present indicating parking restrictions.

As previously mentioned, crosswalks are provided across all four legs of the intersection, with separate ramps for each crosswalk on all four corners. All ramps are concrete and appear to be in good condition. Continuous sidewalks are provided along both sides of both intersecting streets.

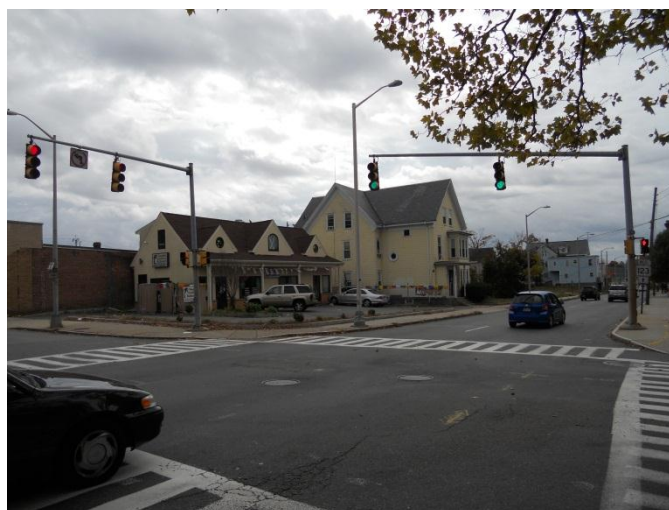
West Elm Street at Warren Avenue

West Elm Street and Warren Avenue form a 4-legged intersection under traffic signal control. Warren Avenue is one-way southbound through the intersection, while West Elm Street is two-way west of the intersection and one-way eastbound east of the intersection. Warren Avenue is an Urban Minor Arterial that carries Route 123 westbound, a National Highway System roadway, through the intersection. Land use is varied in the area, with the Brockton Assembly of God church on the southwest corner, a Caribbean restaurant (#76 Warren Avenue) on the southeast corner, a law office on the northeast corner, and the BB Russell Alternative School, a Brockton public school, on the northwest corner. Operations at the intersection are also impacted by the Boys and Girls Club, which is adjacent to the Assembly of God Church on the west side of Warren Avenue south of West Elm Street.

West Elm Street provides a single general purpose lane in each direction west of the intersection. East of the intersection, West Elm Street provides a wide, undefined lane eastbound with an adjacent parking lane on the right side. The roadway appears wide enough for two lanes of operation and ultimately is striped as two lanes at its approach to Main Street approximately 750 feet east of Warren Avenue. Warren Avenue southbound provides a three lane approach, with an exclusive right turn lane to West Elm Street westbound, a southbound through lane, and a shared lane for southbound through vehicles and left turning vehicles. Warren Avenue departing the intersection is striped as two through lanes, with a wide unmarked right shoulder that is noted to be used for parking maneuvers for pickup and drop-off of children at the Boys and Girls Club. The traffic signal provides basic three-phase operation, with a phase for West Elm Street eastbound, a phase for Warren Avenue, and an exclusive phase for pedestrians.

Pavement markings at the intersection consist of a double yellow centerline, white edge lines and a painted stop bar for West Elm Street west of Warren Avenue. West Elm Street east of Warren Avenue has no markings except for the parking lane. The Warren Avenue southbound approach has arrow markings for each lane, but no ONLY word markings for the exclusive right turn lane. The lanes on this approach appear to be approximately ten feet in width, and no edge line markings are provided. Warren Avenue departing the intersection has a single broken white lane line separating the two travel lanes. On-street parking is restricted along both sides of West Elm Street in the vicinity of Warren Avenue, and is restricted along the Warren Avenue southbound approach.

Ladder-type crosswalks are provided across all four approaches. Apex-style handicap ramps are provided on all four corners, but may not meet current ADA and MassDOT guidelines. Continuous sidewalks are provided on both sides of both intersecting streets. Pedestrian pushbuttons and pedestrian signals are provided on all corners, although it was noted that a pushbutton on the northeast corner was not working on the day of the audit.

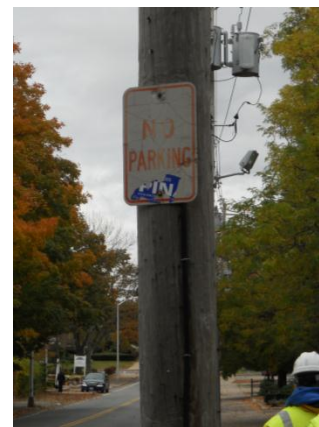
- **Signage** – Existing No Parking signage along the corridor is faded, missing or obstructed by foliage. Other signs (including stop signs) are faded and do not meet current retroreflectivity standards. Trees obstruct both advance and direct visibility of stop signs on some approaches.

Faded No Parking Sign

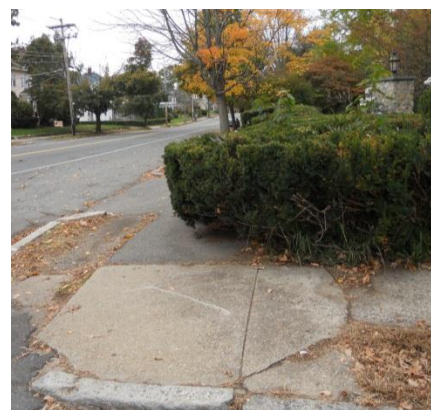
- Overgrowth – Vegetation overgrowth along the sidewalk and tree roots impacting the sidewalk surface were cited as a safety concern along the entire corridor.

Vegetation encroaching on existing sidewalk

- Trim overgrowth along sidewalks. Shrubs and trees overhanging existing sidewalks should be trimmed as a short-term, low cost improvement.
- Replace sidewalks and handicap ramps. It was noted that sidewalks and handicap ramps will be reconstructed as part of proposed improvements. Existing sidewalks are in poor condition, with heavy cracking and upheaval from tree roots in some areas. This is a mid-term, high cost improvement.

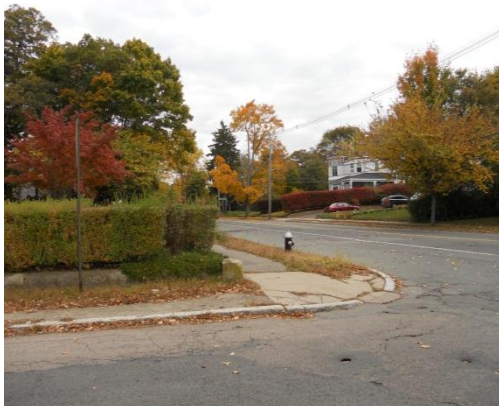
- Visibility – Hedges along both the northwest and northeast corners of the intersection block visibility for vehicles departing Moraine Street southbound. This is a likely factor in angle crashes involving southbound vehicles.

Moraine Street looking east on West Elm Street

- Trim hedges on the northwest and northeast corners of the intersection. Existing vegetation blocks visibility for vehicles departing Moraine Street southbound. It was noted by City of Brockton personnel that City ordinances limit the height of hedges and roadside object to 3 ½ feet for a distance 25 feet from the back of the sidewalk. The City should enforce this ordinance at this location as a short-term measure.

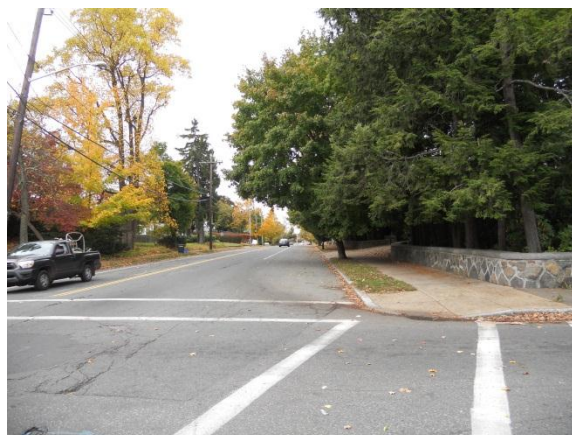
Wide shoulder on West Elm Street (looking from Ash Street)

- Wide Shoulder – The wide shoulder/parking lane west of Ash Street past Moraine Street to West Street may create confusion for drivers unfamiliar with the area who may think that it designates a second travel lane.
- Pedestrian Accommodations – The lack of crosswalks was cited as a safety concern, as well as the non-compliant handicap ramps.

- Modify pavement markings to clarify that the wide shoulder between Ash Street and West Street is a shoulder/parking lane rather than a travel lane. A tapered marking starting at the curb line departing Ash Street would clarify that this area is a shoulder. This is a short-term, low cost improvement. It was noted that the proposed improvements introduce proper pavement marking tapers for this wider shoulder as a mid-term improvement.

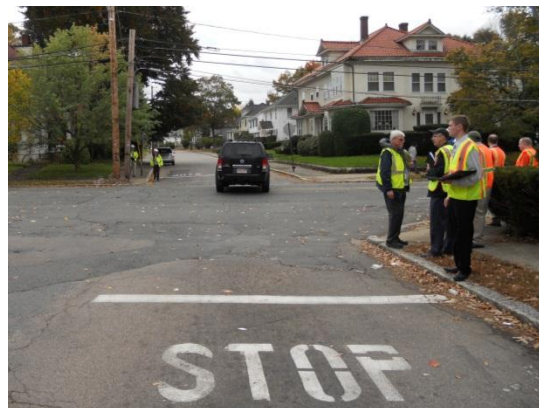
- Skewed Approaches – The Moraine Street legs of the intersection are skewed and do not clearly line up with each other, which may cause conflicts between crossing vehicles if they do not correct for the offset alignment.
- Pavement Markings – Although not discussed at the audit, the lack of a double yellow center line on Moraine Street is a safety concern, especially given the offset alignment of the Moraine Street approaches.

Skewed Moraine Street approaches

- Apply a double yellow centerline on Moraine Street. This is a short-term, low cost improvement.
- Limited right-of-way is available for geometric modifications that would correct the skewed alignment of the Moraine Street approaches. It was noted that this could be accomplished by eliminating a sidewalk, but decided that pedestrian connectivity is too important in the area to consider such a modification.

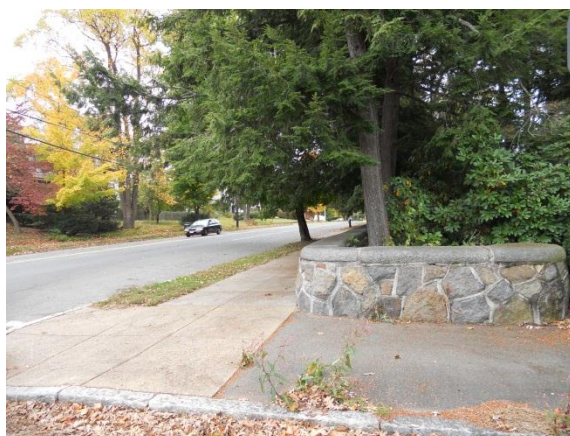
- Visibility – Hedges, a stone wall and mature trees on the northwest corner and a mature tree on the northeast corner block visibility for vehicles departing Ash Street southbound. Hedges on the southeast corner are also a concern for Ash Street northbound vehicles. The variance in width of West Elm Street on each side of Ash Street exacerbates visibility concerns for Ash Street southbound. Visibility concerns are a likely factor in angle crashes at the intersection.
- Stop Sign – The Stop sign for the Ash Street northbound approach is set back approximately 10 feet from the stop line, which may cause confusion over where it is appropriate to stop.

Ash Street looking west on West Elm Street

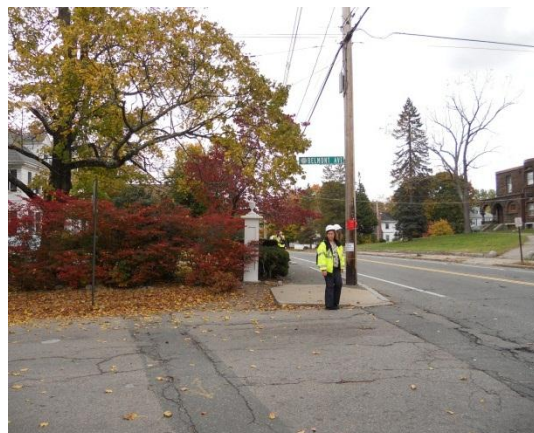
- Visibility – Shrubs and a decorative pillar on the northeast corner create visibility restrictions for vehicle departing Belmont Avenue southbound. This is a likely factor in angle crashes involving southbound vehicles.
- Uphill Grade – The uphill grade of the Belmont Street southbound approach was noted as a safety concern, as it exacerbates existing visibility concerns and may create problems with braking and pavement

Belmont Avenue looking east on West Elm Street

friction due to the older pavement surface, especially during wet, snowy or icy conditions.

- The uphill grade was noted as a safety concern, but further discussion amongst audit participants determined that modifications to the roadway grade are impractical at this location. Improvements to the pavement surface will benefit braking and friction for Belmont Street vehicles.

- Review utility pole alignment along West Elm Street. It was noted that utility poles, as presently aligned, create a sight obstruction for vehicles looking east from Belmont Avenue southbound. This potential sight obstruction should be reviewed to determine if pole relocation is feasible as part of the proposed improvements as a mid-term measure.

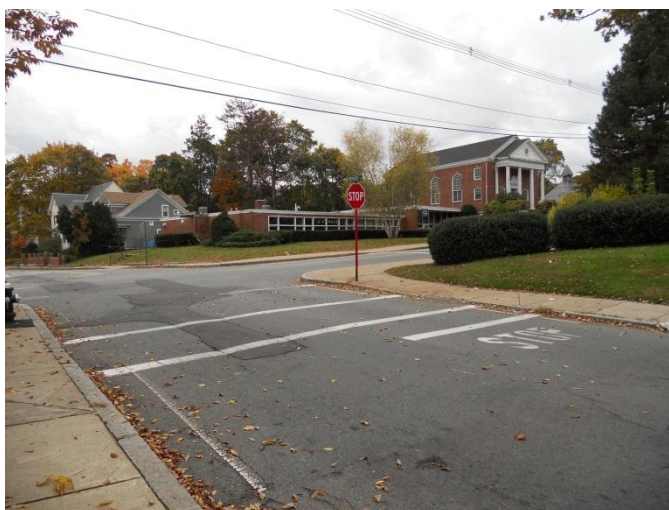
- Crosswalks – Existing crosswalks are setback from the intersection corners on all four approaches. The setback crosswalks on the Newbury Street approaches have a stop line both before and after the crosswalk, which may create confusion over where it is appropriate to stop. The setback crosswalks on West Elm Street are in an unexpected position and may surprise a driver who has turned from the side street, not expecting to encounter a pedestrian in a crosswalk at that location. This may have been a factor in the single pedestrian crash at the intersection.

Dual Stop lines and set back Stop signs on Newbury Street southbound approach

- Reset the stop signs on both Newbury Street approaches to coincide with the painted stop line. This is a short-term, low cost improvement.
- Limited right-of-way is available for geometric modifications that would correct the skewed alignment of the Newbury Street approaches. It was noted that this could be accomplished by eliminating a sidewalk, but decided that pedestrian connectivity is too important in the area to consider such a modification.

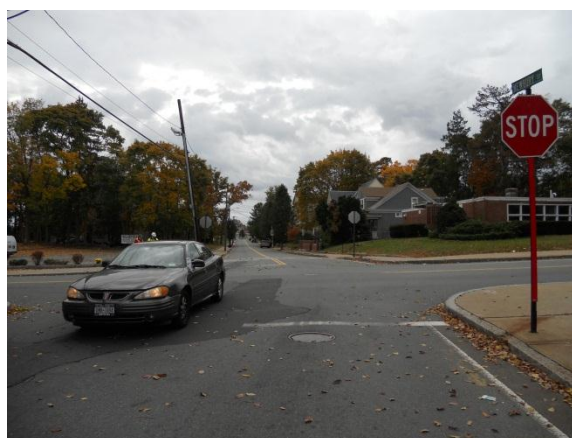
- Pedestrian Accommodations – In addition to crosswalk concerns, the lack of compliant handicap ramps were noted as a safety concern.
- Stop Sign – Stop signs are not aligned with the stop bar on either Newbury Street approach. The stop signs on the southbound approach are set approximately five feet in advance of the stop line, while signs on the northbound approach are approximately fifteen feet in advance of the stop line.
- Skewed Approaches – The Newbury Street legs of the intersection are skewed and do not clearly line up with each other, which may cause conflicts between crossing vehicles if they do not correct for the offset alignment.
- Pavement Markings – Although not discussed at the audit, the lack of a double yellow center line on the north leg of Newbury Street is a safety concern, especially given the offset alignment of the Newbury Street approaches.

Skewed Newbury Street approaches

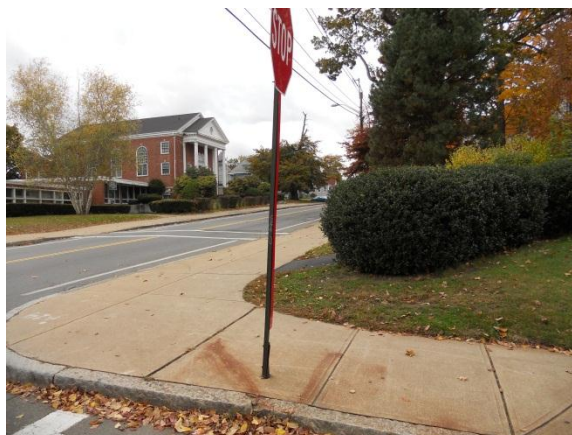
- Visibility – Shrubs and an uphill grade on the northwest corner and a mature tree on the northeast corner create visibility restrictions for vehicles departing Newbury Street southbound. This is a likely factor in angle crashes involving southbound vehicles. The horizontal alignment of West Elm Street and the presence of a crest vertical curve were also cited as a potential visibility restriction.
- Turning Traffic/Pedestrian Activity – Land uses near Goddard Road generate a significant amount of turning traffic and pedestrian activity between Newbury Street and Warren Avenue. A senior housing high-rise apartment building is located on the northwest corner of the intersection of West Elm Street and Goddard Road, with the BB Russell Alternative School occupying the block between Goddard Road and Warren Avenue.

**Newbury Street looking east on
West Elm Street**

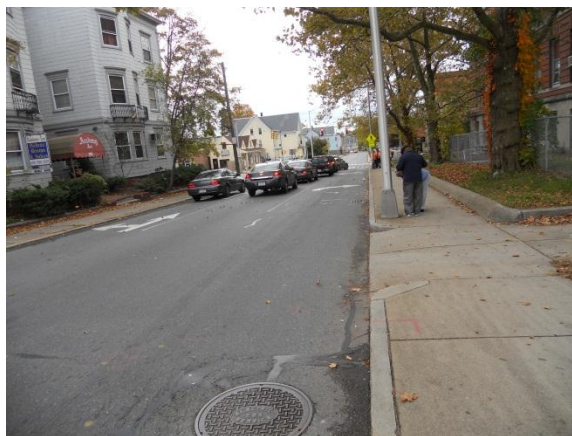
- Lane Control Signage – The lack of lane control signage on both Warren Avenue and Frederick Douglass Avenue was noted as a potential factor in crashes at the intersection. Frederick Douglass Avenue intersects Warren Avenue approximately 1,100 feet north of West Elm Street and has a dual left turn lane to Warren Avenue. Lack of advance indication of lane control on both the left and right sides is a likely factor in the number of angle crashes involving turning vehicles on Warren Avenue, who may assume that the dual left from Frederick Douglass Avenue extends to the Warren Avenue approach at West Elm Street. The lack of signs is especially of concern during peak periods, when queued traffic likely blocks visibility of the existing lane markings.

**Lack of lane control signage on
Warren Avenue approach**

- Install lane usage signage. It was suggested that lane control signage is needed on both Warren Avenue and Frederick Douglass Avenue. It is recommended that R3-8 series graphical signs be provided on Warren Avenue. Signage is recommended on both sides of Warren Avenue so that drivers turning left from Frederick Douglass Avenue are aware that left turns at West Elm are only allowed from the left lane on Warren Avenue. This is a short-term, low cost improvement.

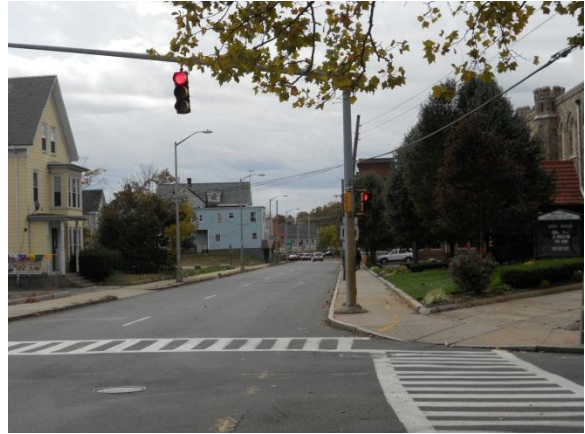
- Boys & Girls Club – It was noted that parents stop along the right side of Warren Avenue south of West Elm Street to drop off and pick up children at the Boys & Girls Club, and that this impacts traffic along this approach. This may also be a factor in rear-end crashes on Warren Avenue.
- Pedestrian Pushbutton – The pedestrian pushbutton on the northeast corner was not working on the day of the audit. Fire department personnel present at the audit noted this and stated that it will be repaired.
- Turning Radius – The tight corner radius on the northwest corner makes it difficult for large vehicles such as fire trucks and buses to make the right turn from Warren Avenue to West Elm Street.

**Warren Avenue departing
West Elm Street**

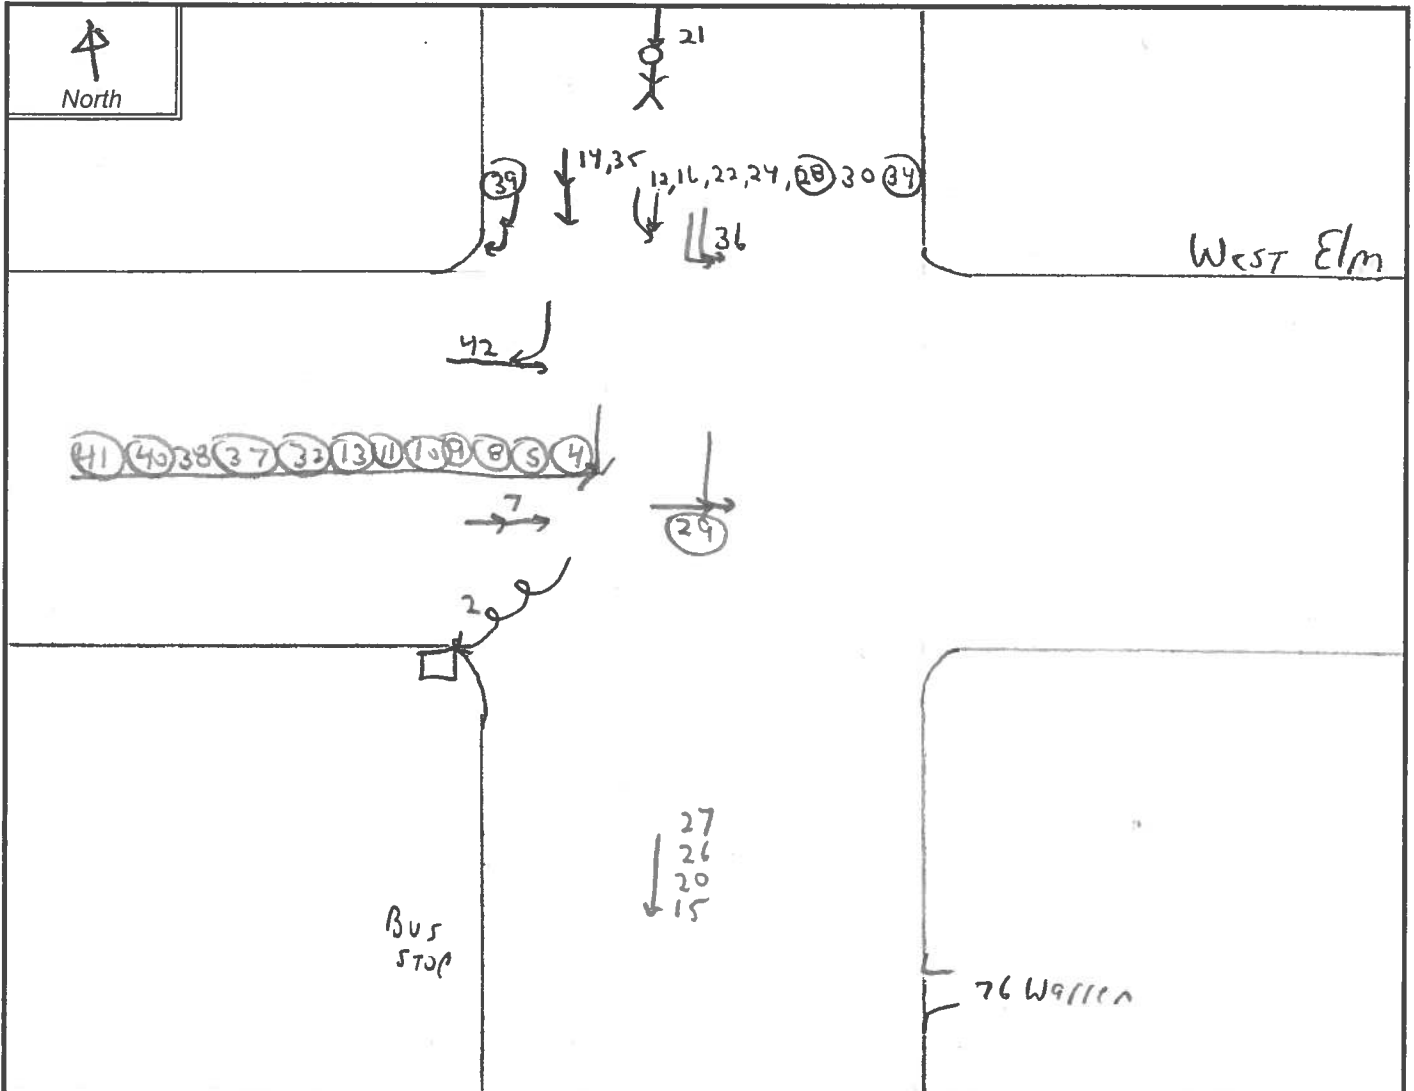
COLLISION DIAGRAM

Rear-end crashes were also a factor in the crash history of the intersection. Two rear-end crashes occurred on the Warren Avenue approach, while four occurred on the departure side of Warren Avenue. The vehicle struck in each of these four crashes was stopped for queued traffic, stopped to turn into the Caribbean restaurant on the southeast corner of the intersection, or stopped for a vehicle turning into the restaurant. One crash involving a pedestrian occurred at the intersection, but it was noted that the pedestrian was walking between stopped vehicles in traffic. A summary of crash data and a collision diagram are included in the Appendix.
