ROAD SAFETY AUDIT

North Main Street (Route 28) at Matfield Street

West Bridgewater, MA

August 2019

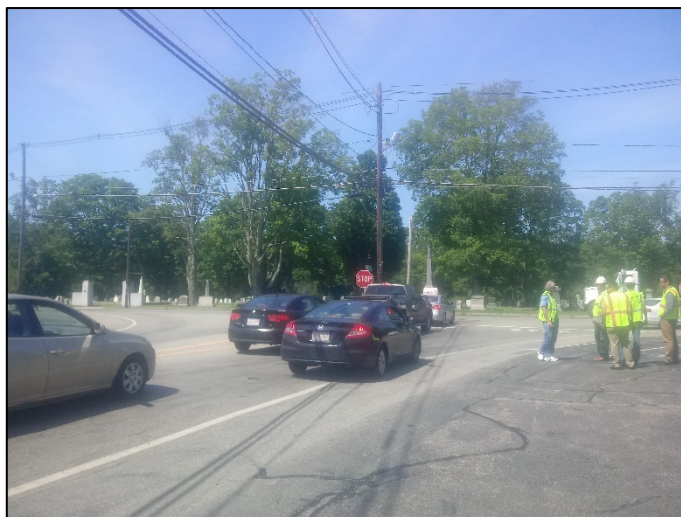
During the morning and afternoon peak hours, traffic entering the intersection on the Matfield Street approach (left turns and right turns), experience congestion and queues during the morning and afternoon peak hours. The queues on Matfield Street are due to a lack of adequate gaps in the North Main Street (Route 28) traffic. The level-of-service (LOS) is at “F” for the Matfield Street critical movement (left turns), creating “forced flow” conditions whereby the Matfield Street traffic forces itself into the North Main Street traffic flow. The North Main Street (Route 28) traffic is forced to slow down to avoid crashes with vehicles entering the intersection from Matfield Street. This forced flow also occasionally leads to

Right turning vehicles on the westbound stop sign controlled Matfield Street approach use the shoulder, which has no curb or sidewalk, as a de-facto right turn lane to bypass traffic waiting to turn left from Matfield Street to North Main Street.

crashes when vehicles cannot stop in time. There is a lack of channelization of vehicles entering the intersection. The paved shoulder and a portion of the restaurant parking lot adjacent to Matfield Street (there is a lack of curbs and sidewalks on the approach), become a “de-facto” right turn lane as right turning traffic use this area to bypass vehicles on Matfield Street waiting to turn left.

Enhancement: Install traffic signals, provide geometric improvements, and add an exclusive left turn lane on the North Main Street southbound approach and exclusive left turn and right turn lanes on the Matfield Street westbound approach. Installing traffic signals at the intersection will reduce delays and queues and improve the LOS to LOS “B” in the morning and “C” during the afternoon peak hour. The intersection satisfies Warrants 1, 2, and 3 of the *Manual on Uniform Traffic Control Devices* (MUTCD). The signal warrant analysis is included in the appendix to this report. Signal heads should be overhead mounted on all approaches. Opticon should be included for emergency vehicle preemption and transit signal priority technologies for buses. In addition, as part of the signalization, would be the inclusion of signal detection to the cemetery access off of North Main Street opposite Matfield Street.

Enhancement: In the short term, as funding and design for signalization is taking place, an overhead flashing beacon can be utilized, (flashing yellow for the North Main Street approaches and flashing red for the Matfield Street approach), to enhance intersection visibility and awareness. In addition, temporary barriers can be utilized to improve channelization and access management in the interim before full intersection reconstruction (adding curbing) and signalization.

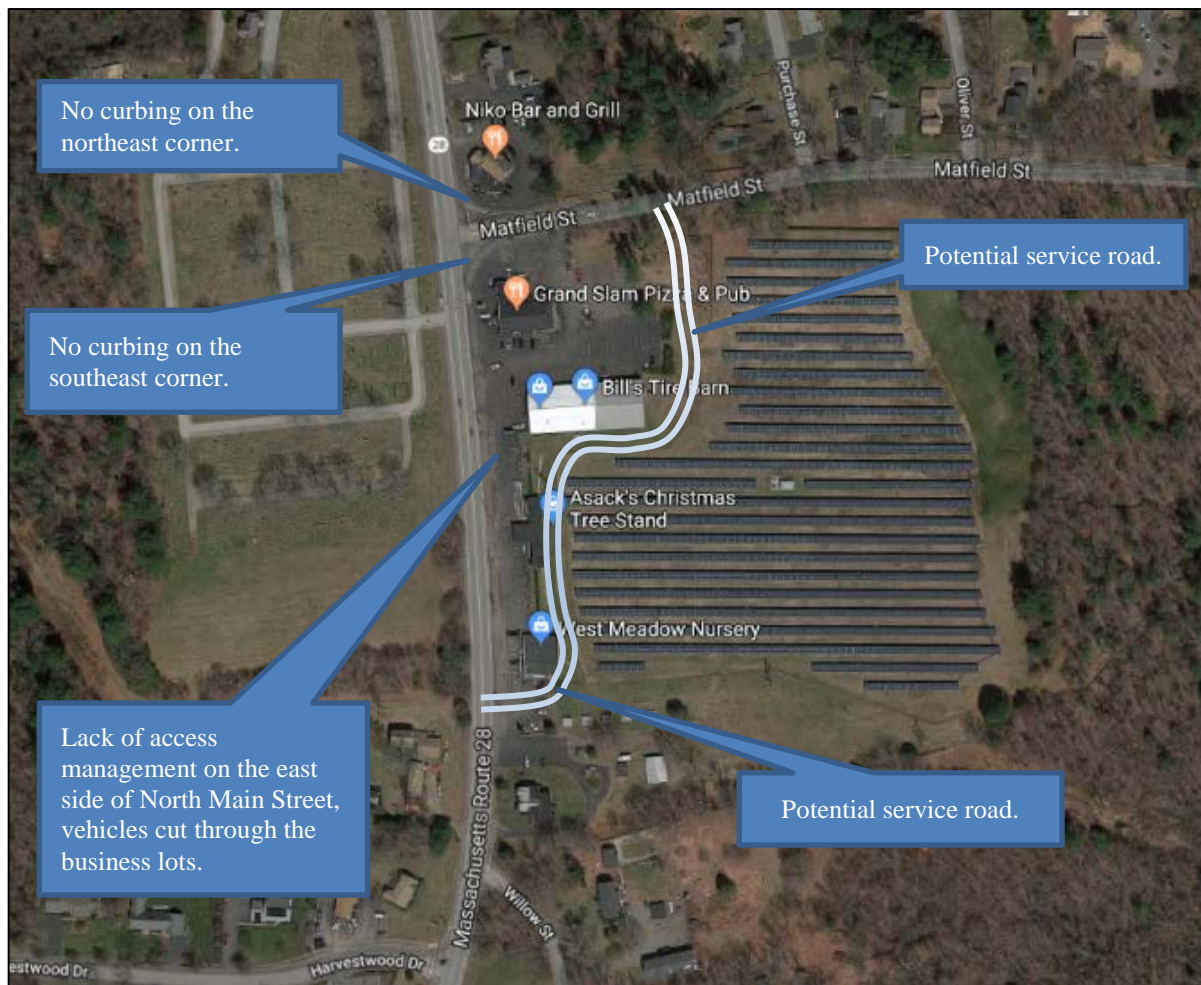
Figure 2. Potential Service Road

Enhancement: Reconfigure access management to adjacent properties. This will require background research in previous State access permits as well as collaboration and cooperation with business and property owners of adjacent properties to reassess property access and internal circulation. There is potential for the establishment of a service road behind the businesses on the east side of North Main Street (Route 28) south of Matfield Street. This road can possibly be constructed behind the buildings between the solar farm and the commercial properties. Figure 2 illustrates the potential for adding a service road.

Enhancement: Reconstruct the intersection to add curbing throughout including sidewalks and reconfigure or remove the island. Adding curbing will square off the intersection preventing northbound right turns from utilizing part of the parking lot to change the turning radius and turning at the corner at high speeds. Improvements to the intersection should include the collaboration and cooperation of local businesses and property owners.
