ROAD SAFETY AUDIT

The Intersection of Canton Street (Route 27) at School Street/Summer Street and the Intersection of Pleasant Street (Route 139) at Lincoln Street

Municipality of Stoughton, MA

June 2018

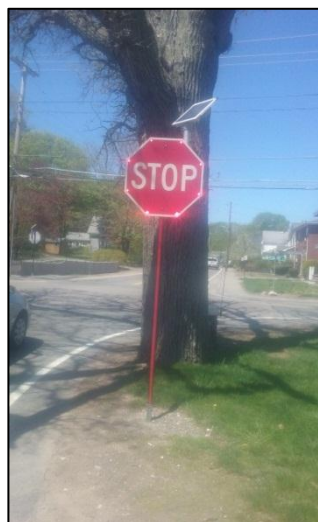
Flashing Stop Sign recently installed by the Town of Stoughton on the westbound approach (there is also one on the eastbound approach)

The Town of Stoughton recently installed flashing stop signs to provide greater awareness of the presence of stop signs on the eastbound and westbound Lincoln Street approaches. Previous crash experience at the intersection showed that motorists on the minor street Lincoln Street eastbound and westbound approaches were failing to stop at the stop signs due to stop sign visibility. Figure 2 shows the intersection location and the surrounding area.

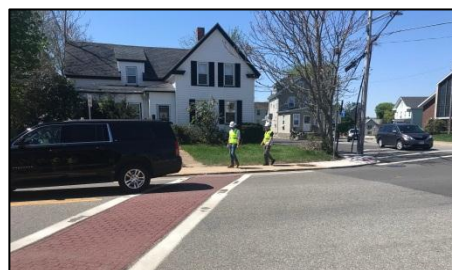
Pedestrian traffic is high, pedestrian crossings need better visual cues for motorists, and curbs lack ADA compliance.

Curbing on the southeast corner of the intersection lacks ADA ramps for the crosswalk at the Canton Street (Route 27)/School Street intersection.

Enhancements: Reconstruct the intersection to ADA compliancy for pedestrians. If traffic signals are installed at the intersection, they should include Accessible Pedestrian Signals (APS), (devices that communicate information about the WALK and DON'T WALK intervals at signalized intersections in non-visual formats to pedestrians.)

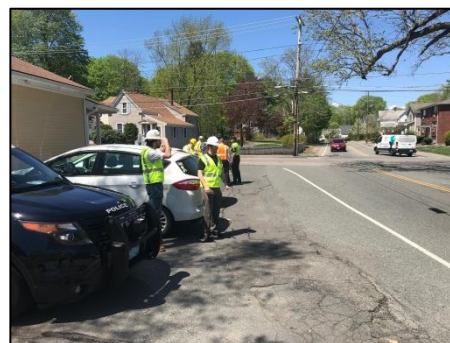
The parking lot for the convenience store on the southeast quadrant of the intersection is open with no curbing. Vehicles on Pleasant Street northbound taking a right turn to Lincoln Street eastbound cut through the parking lot to bypass vehicles waiting to take a left turn from Pleasant Street northbound to Lincoln Street westbound.

Lack of curbing on the south side of Lincoln Street to contain vehicles in the convenience store parking spaces.

Enhancements: Install temporary barriers along Pleasant Street on the east side of the northbound approach and on Lincoln Street to channel vehicles and keep traffic on the road and out of the parking lot. Consider constructing the roadside to add curb along the edge to better define the limits of the shoulder.
