# ROAD SAFETY AUDIT

Pine Street from the Pine Street/York Street Intersection  
to the Pine Street/Pleasant Street (Route 139)  
Intersection

Stoughton, Massachusetts

December 19, 2023

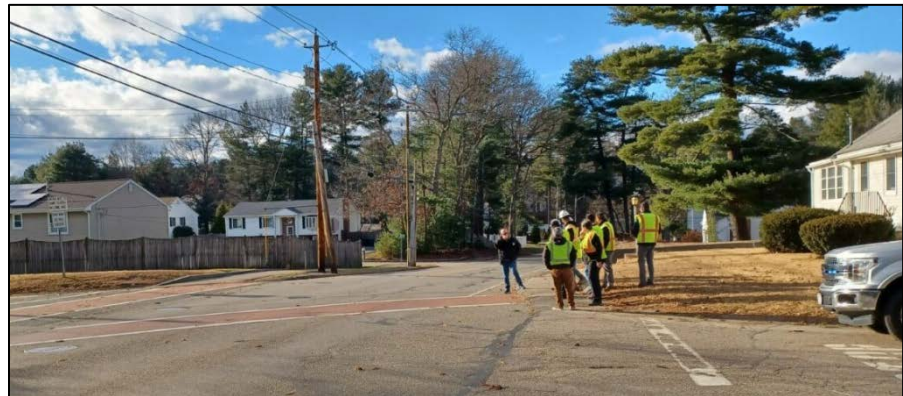
**Safety Issue: Stop Sign Placement.** The Stop Sign, and Stop Line on the Pine Street eastbound approach is set too far back from the intersection.

**Safety Issue: Crosswalk connects diagonally across the intersection.**

The above photo shows the diagonal crosswalk as well as the placement of the sign indicating that the North Drive is one-way out to Pine Street. This photo also shows the location of the Stop Sign in advance of the intersection on Pine Street eastbound, which can be moved closer to the intersection.

**Enhancement:** Consider moving the location of the Pine Street eastbound approach Stop Sign and Stop Line approximately 10 feet closer to the intersection.

**Enhancement:** Consider eliminating the diagonal crosswalk and placing a crosswalk from the southwest corner of the intersection directly to the northwest corner of the intersection across the Pine Street approach. In addition, install ADA compliant ramps on all sidewalks with access to crosswalks.

**Enhancement:** Consider adding a Rapid Rectangular Flashing Beacon (RRFB) at the crosswalk across Pine Street at the Dawe School North Drive.

**Enhancement:** Consider adding an in-street Pedestrian Crossing sign at the crosswalk (“Yield to Pedestrians in Crosswalk”) on Pine Street at the Dawe School North Drive.

**Enhancement:** Evaluate crosswalk striping for more visible striping.

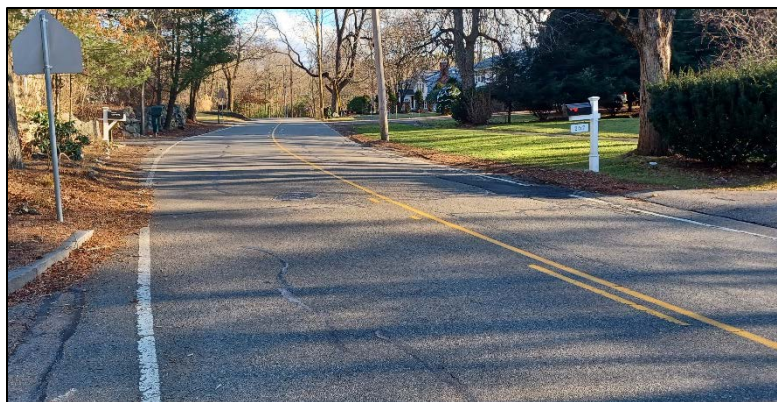
**Photo above shows the Double Yellow Center Line (DYCL) faded and resembling a passing zone.**

**Safety issue: The Double Yellow Center Line (DYCL) is faded and resembles a passing zone, especially on Pine Street East of Ruth Road to Pleasant Street (Route 139).**

**Enhancement:** Evaluate and consider installing chevrons or post-mounted delineators on Pine Street before and through the curve approaching Pleasant Street.

**Enhancement:** Restripe pavement markings on Pine Street (center lines and fog lines) and consider optical speed bars for better visibility.

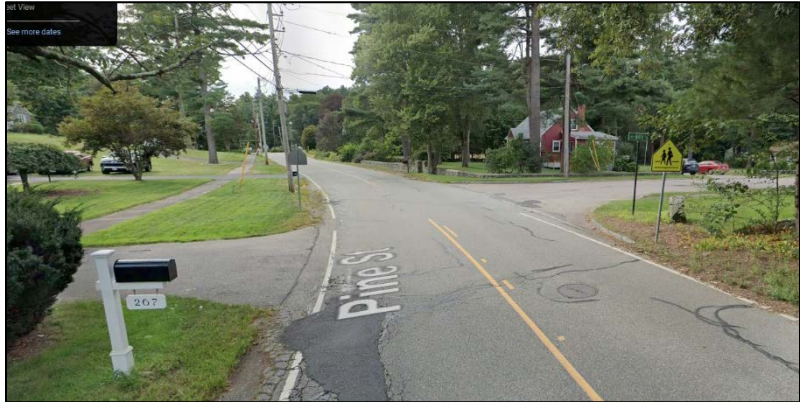
**Safety Issue: There is a lack of a crosswalk across Pine Street at Ruth Road, although a warning sign is posted for pedestrian crossing.**

**Photo above shows the lack of a crosswalk across Pine Street at Ruth Road at the pedestrian crossing sign as well as the faded DYCL.**

**Enhancement:** Consider a crosswalk across Pine Street at Ruth Road with MUTCD compliant warning signs to connect the sidewalk on Ruth Road with the sidewalk on Pine Street.
