Centre Street (Route 123) at Plymouth Street

Municipality of Brockton

November, 2017

Old Colony Planning Council

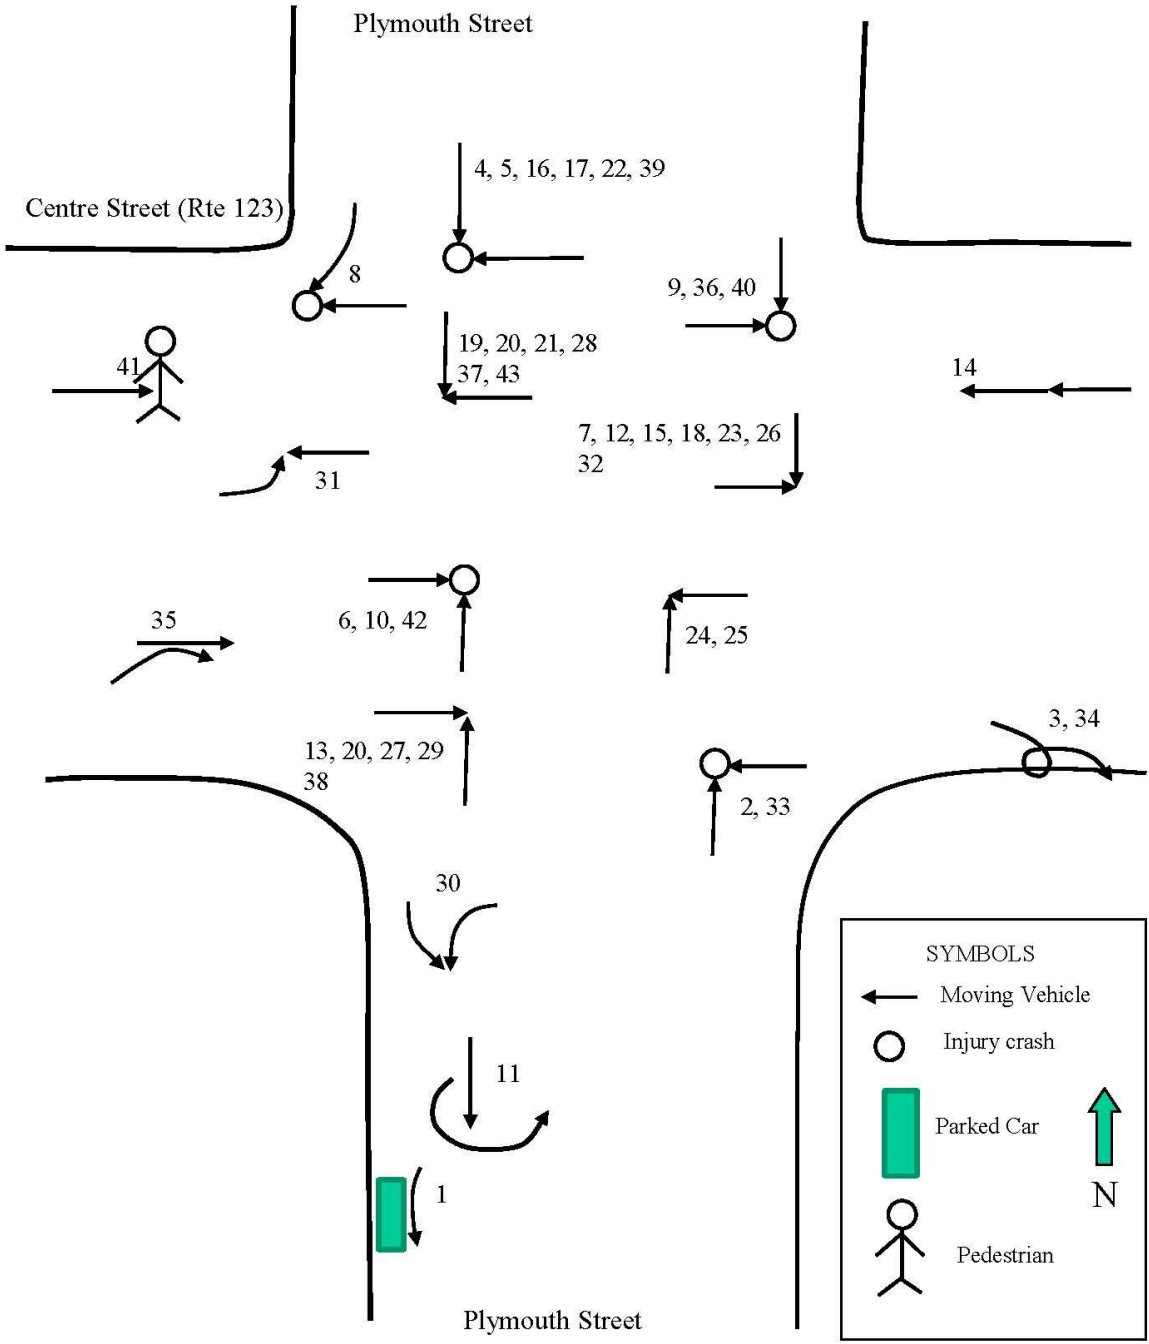
COLLISION DIAGRAM
Centre Street (Route 123) at Plymouth Street
 Collision Diagram for Crashes (2014, 2015, 2016) Prepared by
 OCPC (RG 9/2017) (source: Brockton Police Dept.)

Crash Diag. Ref.	Crash Date	Crash Day	Crash Time	Manner of Coll.	Light Cond	Weather	Road Surf	Severity	Notes	Ages
1	2/14/2014	Friday	2:04 a.m.	Sideswipe	Dark	Rain	Rain wet	PDO	Driver fell asleep hit parked car	23
2	2/14/2014	Friday	1:37 p.m.	Angle	Daylight - Cloudy	Cloudy	Wet	Injury	Plymouth St NB failed to yield ROW at stop sign	41, 48
3	3/23/2014	Sunday	4:48 a.m.	ROR	Dark	Cloudy	Dry	PDO	Single vehicle hit utility pole	20
4	3/24/2014	Monday	2:35 p.m.	Angle	Daylight - Cloudy	Cloudy	Dry	Injury	Plymouth St SB cited for failing to grant ROW at Ssign	20, 55
5	4/1/2014	Tuesday	7:22 a.m.	Angle	Daylight	Clear	Dry	Injury	Plymouth St SB cited for failing to grant ROW at Ssign	54, 35
6	4/13/2014	Sunday	6:04 p.m.	Angle	Daylight	Clear	Dry	Injury	Plymouth St NB cited for failing to yield ROW at Ssign	30, 32
7	5/5/2014	Monday	11:11 a.m.	Angle	Daylight	Clear	Dry	PDO	Plymouth St NB cited for failing to yield ROW at Ssign	70, 26

8	5/6/2014	Tuesday	11:31 a.m.	Angle	Daylight	Clear	Dry	Injury	Plymouth St SB cited for failing to grant ROW at Ssign	30, 47
9	5/21/2014	Wed	4:00 p.m.	Angle	Daylight	Clear	Dry	Injury	Plymouth St SB failed to grant ROW at Ssign	22, 24
10	5/30/2014	Friday	8:16 a.m.	Angle	Daylight	Clear	Dry	Injury	Plymouth St NB cited for failing to yield ROW at Ssign	26, 49
11	6/9/2014	Monday	7:15 a.m.	Sideswipe (same direction)	Daylight	Clear	Dry	PDO	Collision due to attempted u-turn-cited for lane violation	24, 30
12	6/21/2014	Saturday	11:54 a.m.	Angle	Daylight	Clear	Dry	PDO	Plymouth St SB cited for failing to grant ROW at Ssign	47, 26
13	6/22/2014	Sunday	5:17 a.m.	Angle	Daylight	Clear	Dry	PDO	Angle collision with a motorcycle	19
14	7/14/2014	Monday	10:16 a.m.	Rear-end	Daylight	Clear	Dry	PDO		52, 22
15	10/16/2014	Thursday	9:15 a.m.	Angle	Daylight	Rain	Rain wet	PDO	Plymouth St SB failed to yield ROW at Ssign	47, 38, 68

16	10/16/2014	Thursday	4:11 p.m.	Angle	Daylight	Rain	Rain wet	Injury	Plymouth St SB mailed citation warning for failing to grant ROW at Ssign	44, 31
17	10/21/2014	Tuesday	9:46 p.m.	Angle	Dark lighted road	Clear	Dry	Injury	Plymouth St SB cited for failing to grant ROW at Ssign	55, 27
18	10/28/2014	Tuesday	2:27 p.m.	Angle	Daylight	Clear	Dry	PDO	Plymouth St SB cited for failing to grant ROW at Ssign	31, 42
19	12/3/2014	Wed	4:34 p.m.	Angle	Dark lighted road	Rain	Rain wet	PDO	Plymouth St SB failed to stop at Ssign	54, 51
20	12/15/2014	Monday	11:28 a.m.	Angle	Daylight	Clear	Dry	PDO	Plymouth St NB mailed citation for failing to grant ROW at Ssign	49, 64

Num	Date	Time	Type	Light Cond	Surface Cond	Severity	Notes		
21	1/9/2015	Friday	8:16 p.m.	Angle	Dark lighted road	Snow Snow	PDO	Plymouth St. SB could not stop due to snow	23, 50
22	1/20/2015	Tuesday	10:16 a.m.	Angle	Daylight	Clear Dry	Injury	Centre St WB mailed citation for speeding	63, 35
23	2/4/2015	Wed	6:49 a.m.	Angle	Daylight	Snow Snow	PDO	Plymouth St SB failed to stop at Ssign, mailed citation for unlicensed operation	21, 38
24	2/7/2016	Saturday	10:46 p.m.	Angle	Dark lighted road	Snow Snow	PDO	Plymouth St NB mailed citation for failing to grant ROW at Ssign-Snow prevented Centre St WB vehicle from stopping	53, 22
25	6/21/2015	Sunday	11:14 a.m.	Angle	Daylight	Rain Rain wet	PDO	Plymouth St NB operating with permit (did not have it in possession) , criminal complaint filed	30, 20
26	7/21/2015	Tuesday	7:21 a.m.	Angle	Daylight	Clear Dry	PDO	Plymouth St SB issued citation for failing to stop at Ssign	48, 24

27	7/25/2015	Saturday	6:34 p.m.	Angle	Daylight	Clear Dry	Injury	Plymouth St NB failed to stop at Ssign	57, 25
28	11/2/2015	Monday	7:50 a.m.	Angle	Daylight	Clear Dry	PDO		48, 34
29	11/21/2015	Saturday	2:50 p.m.	Angle	Daylight	Clear Dry	Injury	Plymouth St NB failed to stop for Ssign	21, 28
30	12/23/2015	Wed	2:32 p.m.	Sideswipe (same direction)	Daylight	Clear Dry	PDO	Vehicle turning left from Cetnre St WB to Plymouth St SB hit by vehicle pulling out of parking spot (SB Plymouth St)	58, 22
31	12/31/2015	Thursday	5:20 p.m.	Angle	Dark lighted road	Clear Dry	PDO	Centre St EB left turn to Plymouth St cited for failure to yield ROW to Centre St WB	38, 21
32	2/5/2016	Friday	9:30 a.m.	Angle	Daylight	Snow Snow	PDO	Plymouth St SB issued citation for failing to stop at Ssign - snow was a factor as the SB veh slid at the stop sign	58, 52
33	2/13/2016	Saturday	10:55 a.m.	Angle	Daylight	Clear Dry	Injury	Plymouth St NB to be issued citation for failure to yield ROW	66, 40

34	4/9/2016	Saturday	11:35 p.m.	Single Vehicle ROR	Dark lighted road	Clear Dry	Injury	Centre St EB went through the intersection lane departyre ran off road cited for distraction due to cell phone	48
35	5/12/2016	Thursday	3:25 p.m.	Sideswipe (same direction)	Daylight	Clear Dry	PDO	Both vehicles EB, vehicle in right turn only lane changed direction to go through and SS vehicle next to it, citation issues for lane departure	23, 53
36	7/4/2016	Monday	2:17 p.m.	Angle	Daylight	Clear Dry	Injury	Plymouth St SB cited for failure to stop to yield ROW	60, 33
37	7/10/2016	Sunday	12:31 p.m.	Angle	Daylight	Clou dy Dry	PDO	Plymouth St SB issued citation for failing to yield ROW	66, 20
38	7/16/2016	Saturday	2:31 p.m.	Angle	Daylight	Clear Dry	PDO	Plymouth St NB cited for failing to yield ROW	44, 22
39	8/21/2016	Sunday	10:21 a.m.	Angle	Daylight	Clear Dry	Injury	Plymouth St SB cited for failure to yield ROW	57, 58

40	10/5/2016	Tuesday	4:22 p.m.	Angle	Daylight	Clou dy Dry	Injury	Plymouth St SB issued warning for failing to yield ROW	18, 46
41	10/12/2016	Wed	9:47 a.m.	Pedestrian	Daylight	Clear Dry	Injury	Pedestrian struck crossing Centre Street	21, 28
42	11/4/2016	Friday	4:25 p.m.	Angle	Daylight	Clear Dry	Injury	Plymouth St NB collided with Centre St WB	38, 53
43	12/1/2016	Thursday	8:08 a.m.	Angle	Dark lighted road	Clear Dry	PDO	Plymouth St SB collided with Centre St WB	71, 66

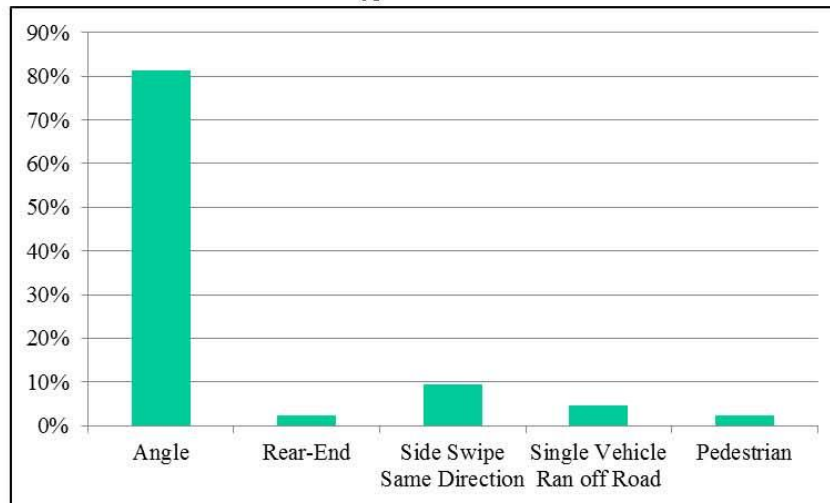
Type of Collision

This intersection experiences a higher number of angle type crashes crash than is expected for a stop controlled four-way intersection. A large portion of these crashes occurred when the southbound vehicle on Plymouth Street failed to yield right of way to an eastbound vehicle or westbound vehicle on Centre Street (Route 123).

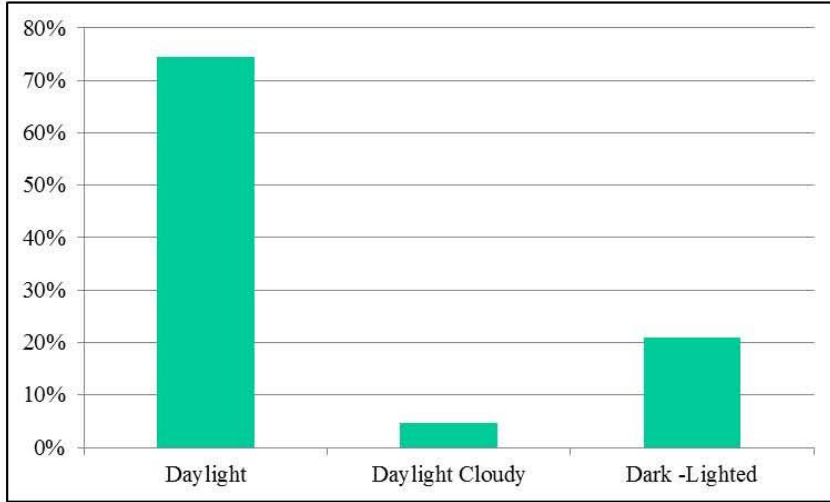
Light Conditions

Street lights are present at the intersection; however, these might not be enough to provide adequate lighting for the intersection after dusk. There were nine crashes that occurred under non-daylight conditions.
