ROAD SAFETY AUDIT

Crescent Street Intersection Improvement Project

City of Brockton

December 30, 2015

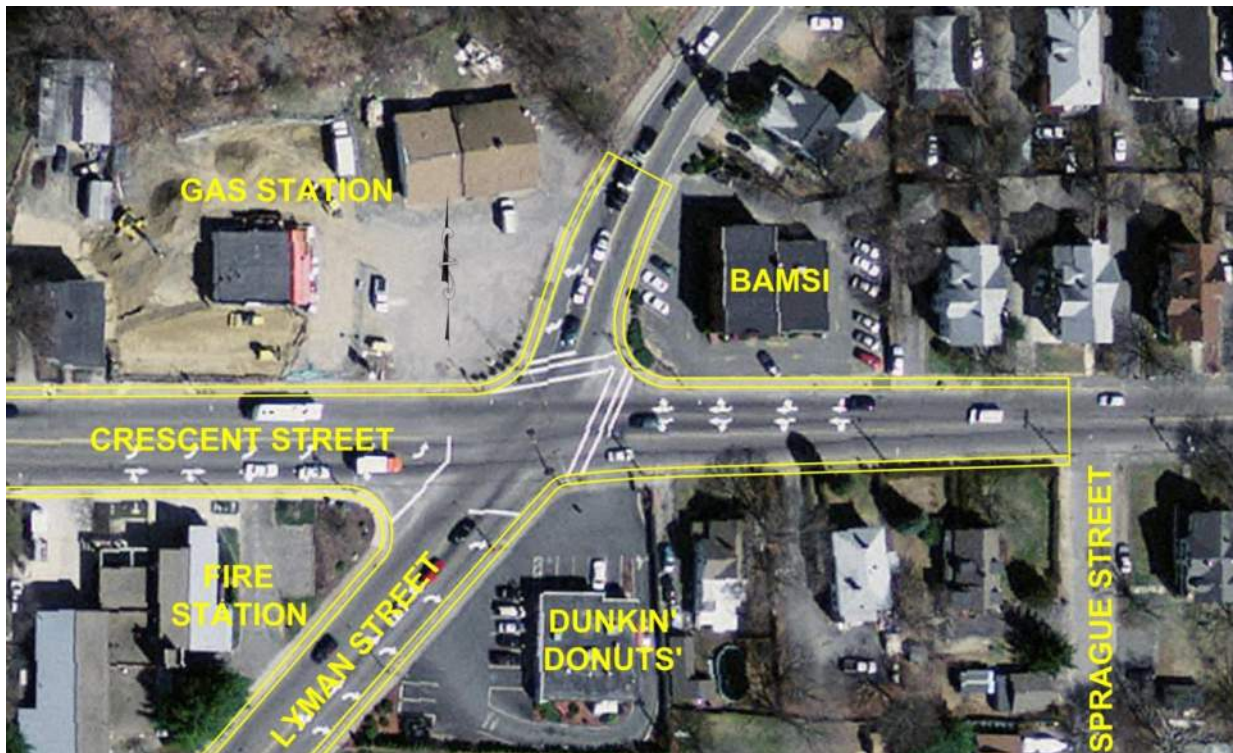
Figure 2: Crescent Street at Lyman Street

The intersection of Crescent Street at Lyman Street had reported 30 crashes during the study period. The majority were angle crashes (57 percent – 17 crashes). The remaining crashes included six single rear-end collisions, four single vehicle crashes and three sideswipe collisions. The most common causes of crashes was angle collisions involving Crescent Street Eastbound vehicles and Lyman Street Northbound vehicles. The majority of crashes occurred during daylight with clear dry conditions. The intersection has a crash rate of 1.26 crashes per million entering vehicles from 2010-2012¹.

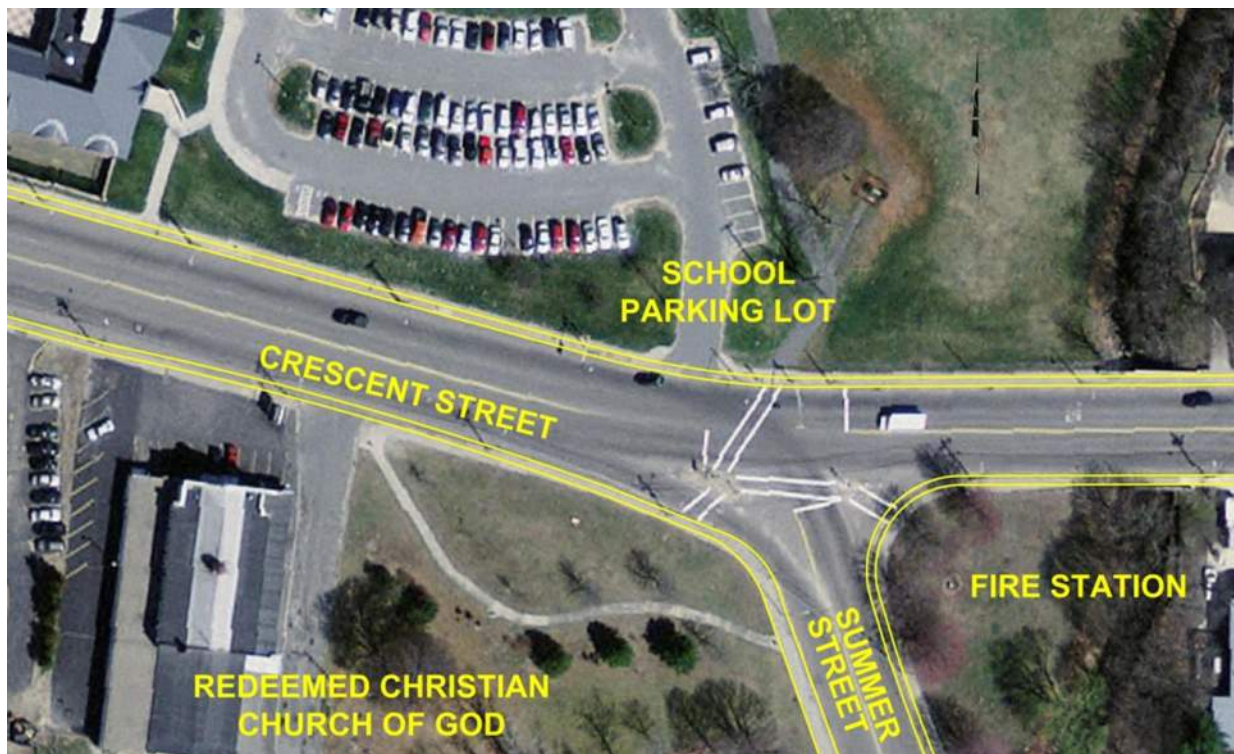
Figure 8: Crescent Street at Summer Street Intersection

The intersection of Crescent Street at Summer Street reported 10 crashes during the study period. The majority were angle crashes (50 percent – 5 crashes). The remaining crashes included four single vehicle crashes and one rear-end collision. The common cause of four (4) of the crashes appears to be vehicles making unsafe turning movements into the Plouffe Academy Middle School parking lot. The majority of crashes occurred during daylight with clear dry conditions. The intersection has a crash rate of 0.52 crashes per million entering vehicles from 2010-2012. The MassDOT District 5 average for crashes at signalized intersections is 0.77 crashes per million entering vehicles. Additional detailed crash data is located in Appendix C.
