# ROAD SAFETY AUDIT

Route 123 (Belmont St.)/West St./West Side Plaza Dr.,  
Route 123/Forest Ave./West Side Plaza Dr.  
Route 123/West St.

City of Brockton

May 5, 2016

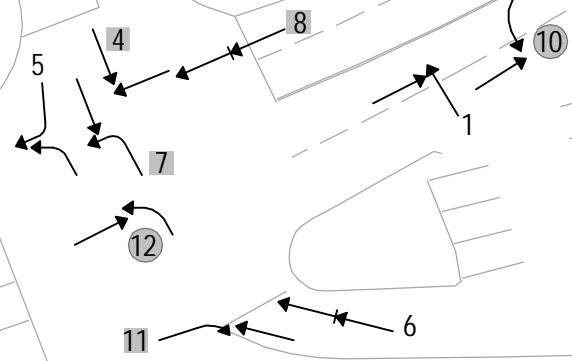
Belmont Street @ West Street (southern end)

- Collision #10 involved a motorcycle.
- Collision #11 involved a police cruiser.

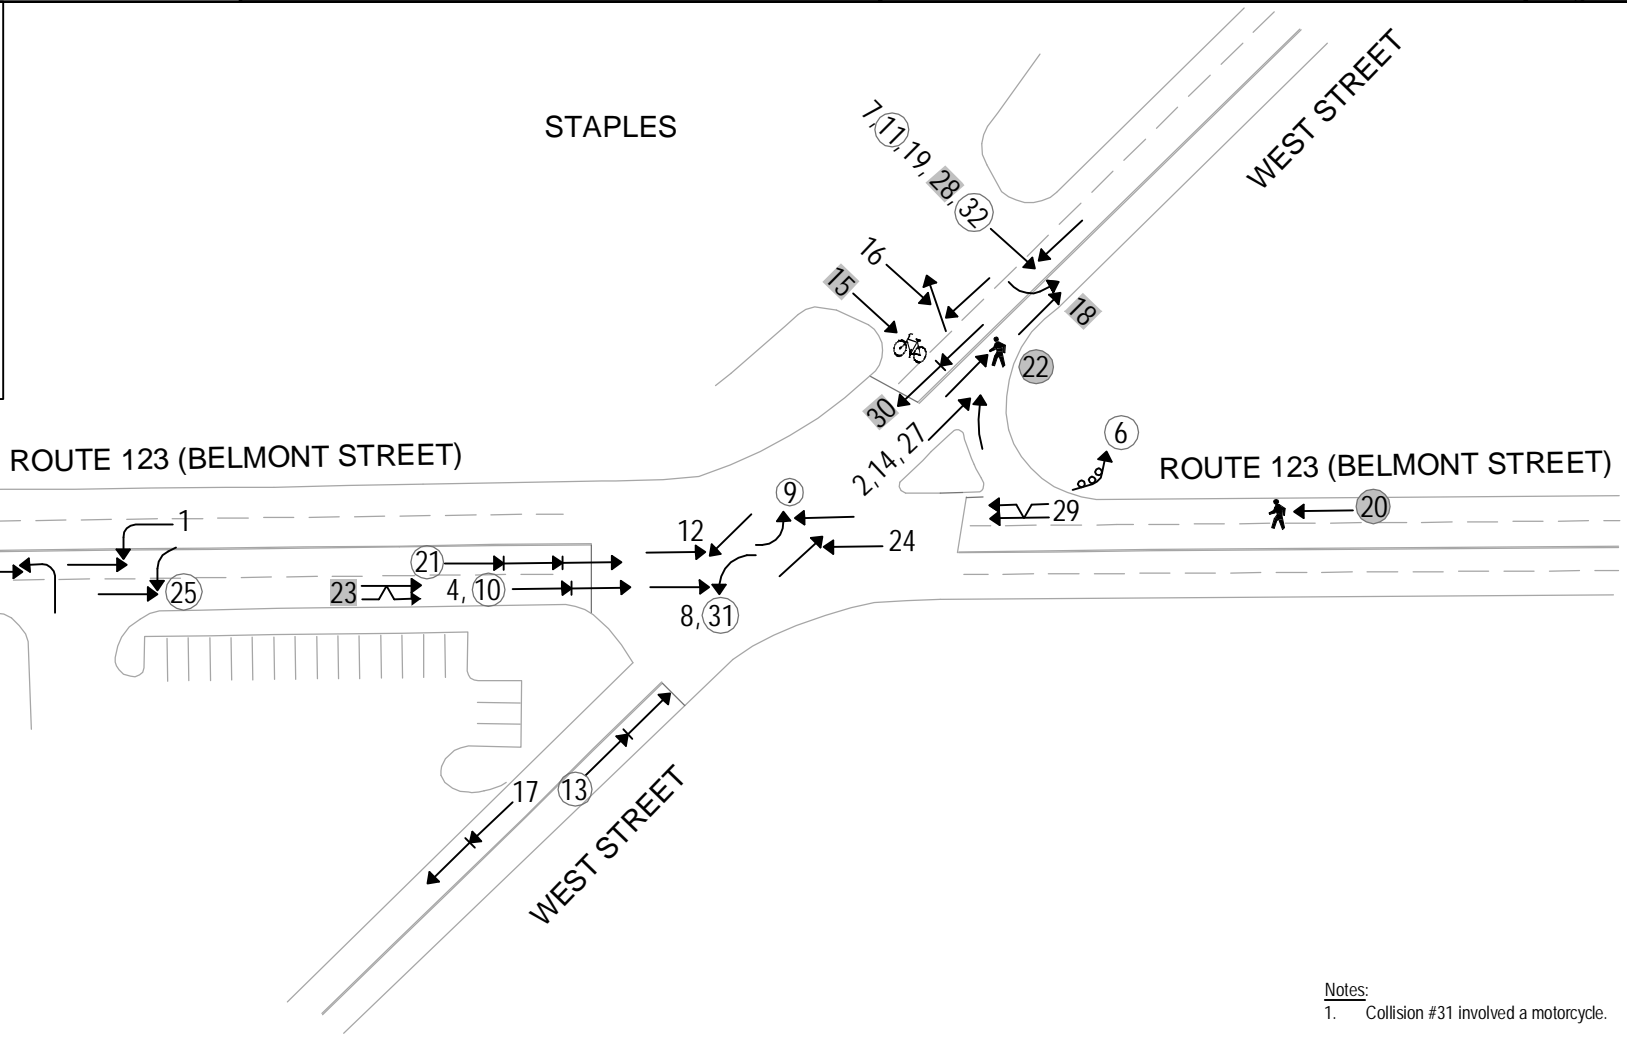
Belmont Street @ West Street (northern end)

Notes:  
1. Collision #31 involved a motorcycle.
