ROAD SAFETY AUDIT

Route 18 (Bedford Street) from
Whitman Street to Central Square

Town of East Bridgewater

May 14, 2014

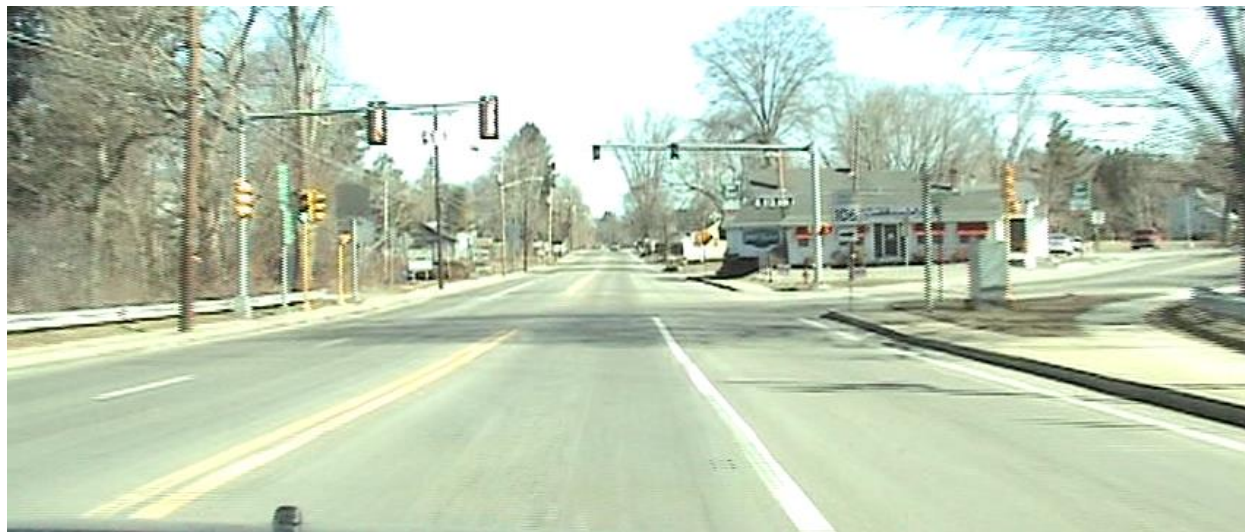
Route 18 at Whitman Street (looking north)

Route 18 provides two lanes in each direction in the vicinity of Whitman Street, with turns accommodated within shared lanes. A solid white edge line is provided to delineate a shoulder, but widths are not sufficient to safely accommodate bicycles. The northbound Route 18 approach provides two through lanes which continue through the intersection, but signage both encourages through vehicles to merge in advance of the intersection and states that the right lane is for right turns. Additional merge signage is provided on Route 18 north of the intersection, and the two lanes merge into one approximately 320 feet north of Whitman Street. The southbound approach widens from one lane to two lanes at the same point approximately 320 feet north of Whitman Street, and left turns to Whitman Street are accommodated from a lane shared with through vehicles.

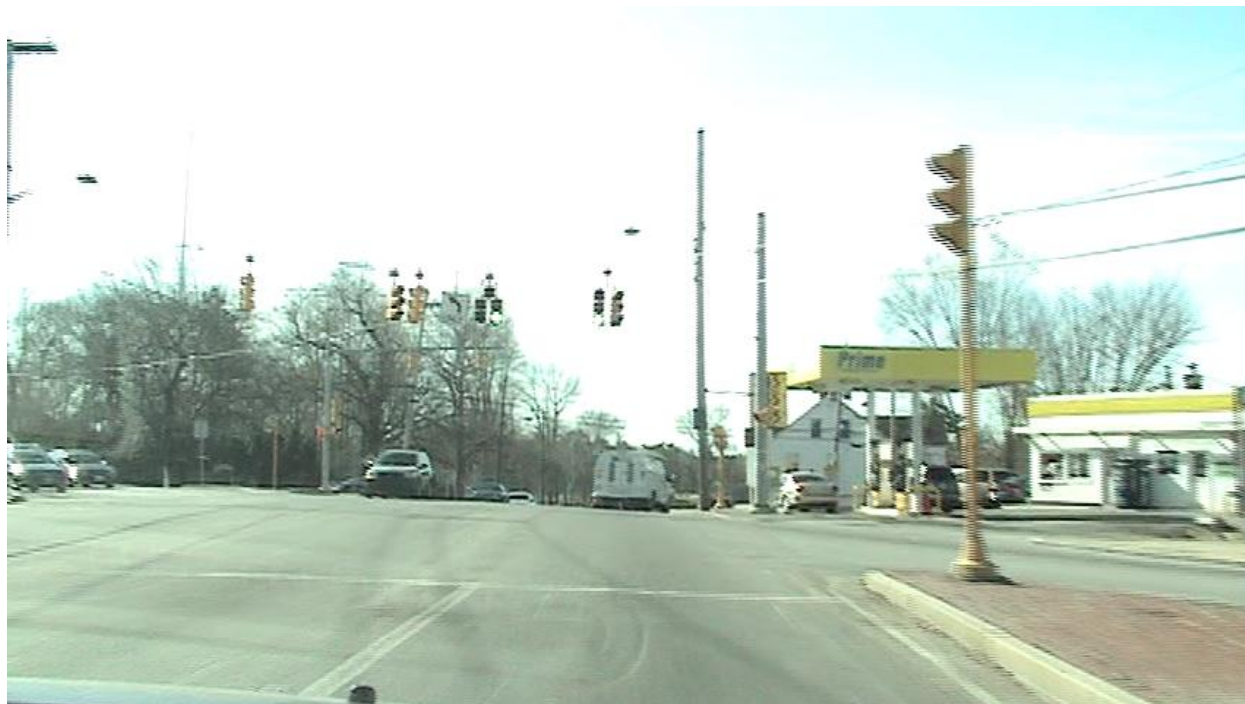
Route 18 at Central Street (Central Square) looking southbound

The traffic signal provides protected/permissive phasing for the southbound left turn, followed by a phase for Route 18 and a phase for Central Street. Separate actuated phases are provided for both Spring Street and Maple Avenue, although it was suggested that the vehicle detection on Spring Street is malfunctioning and the phase is being called every cycle even when no demand exists.

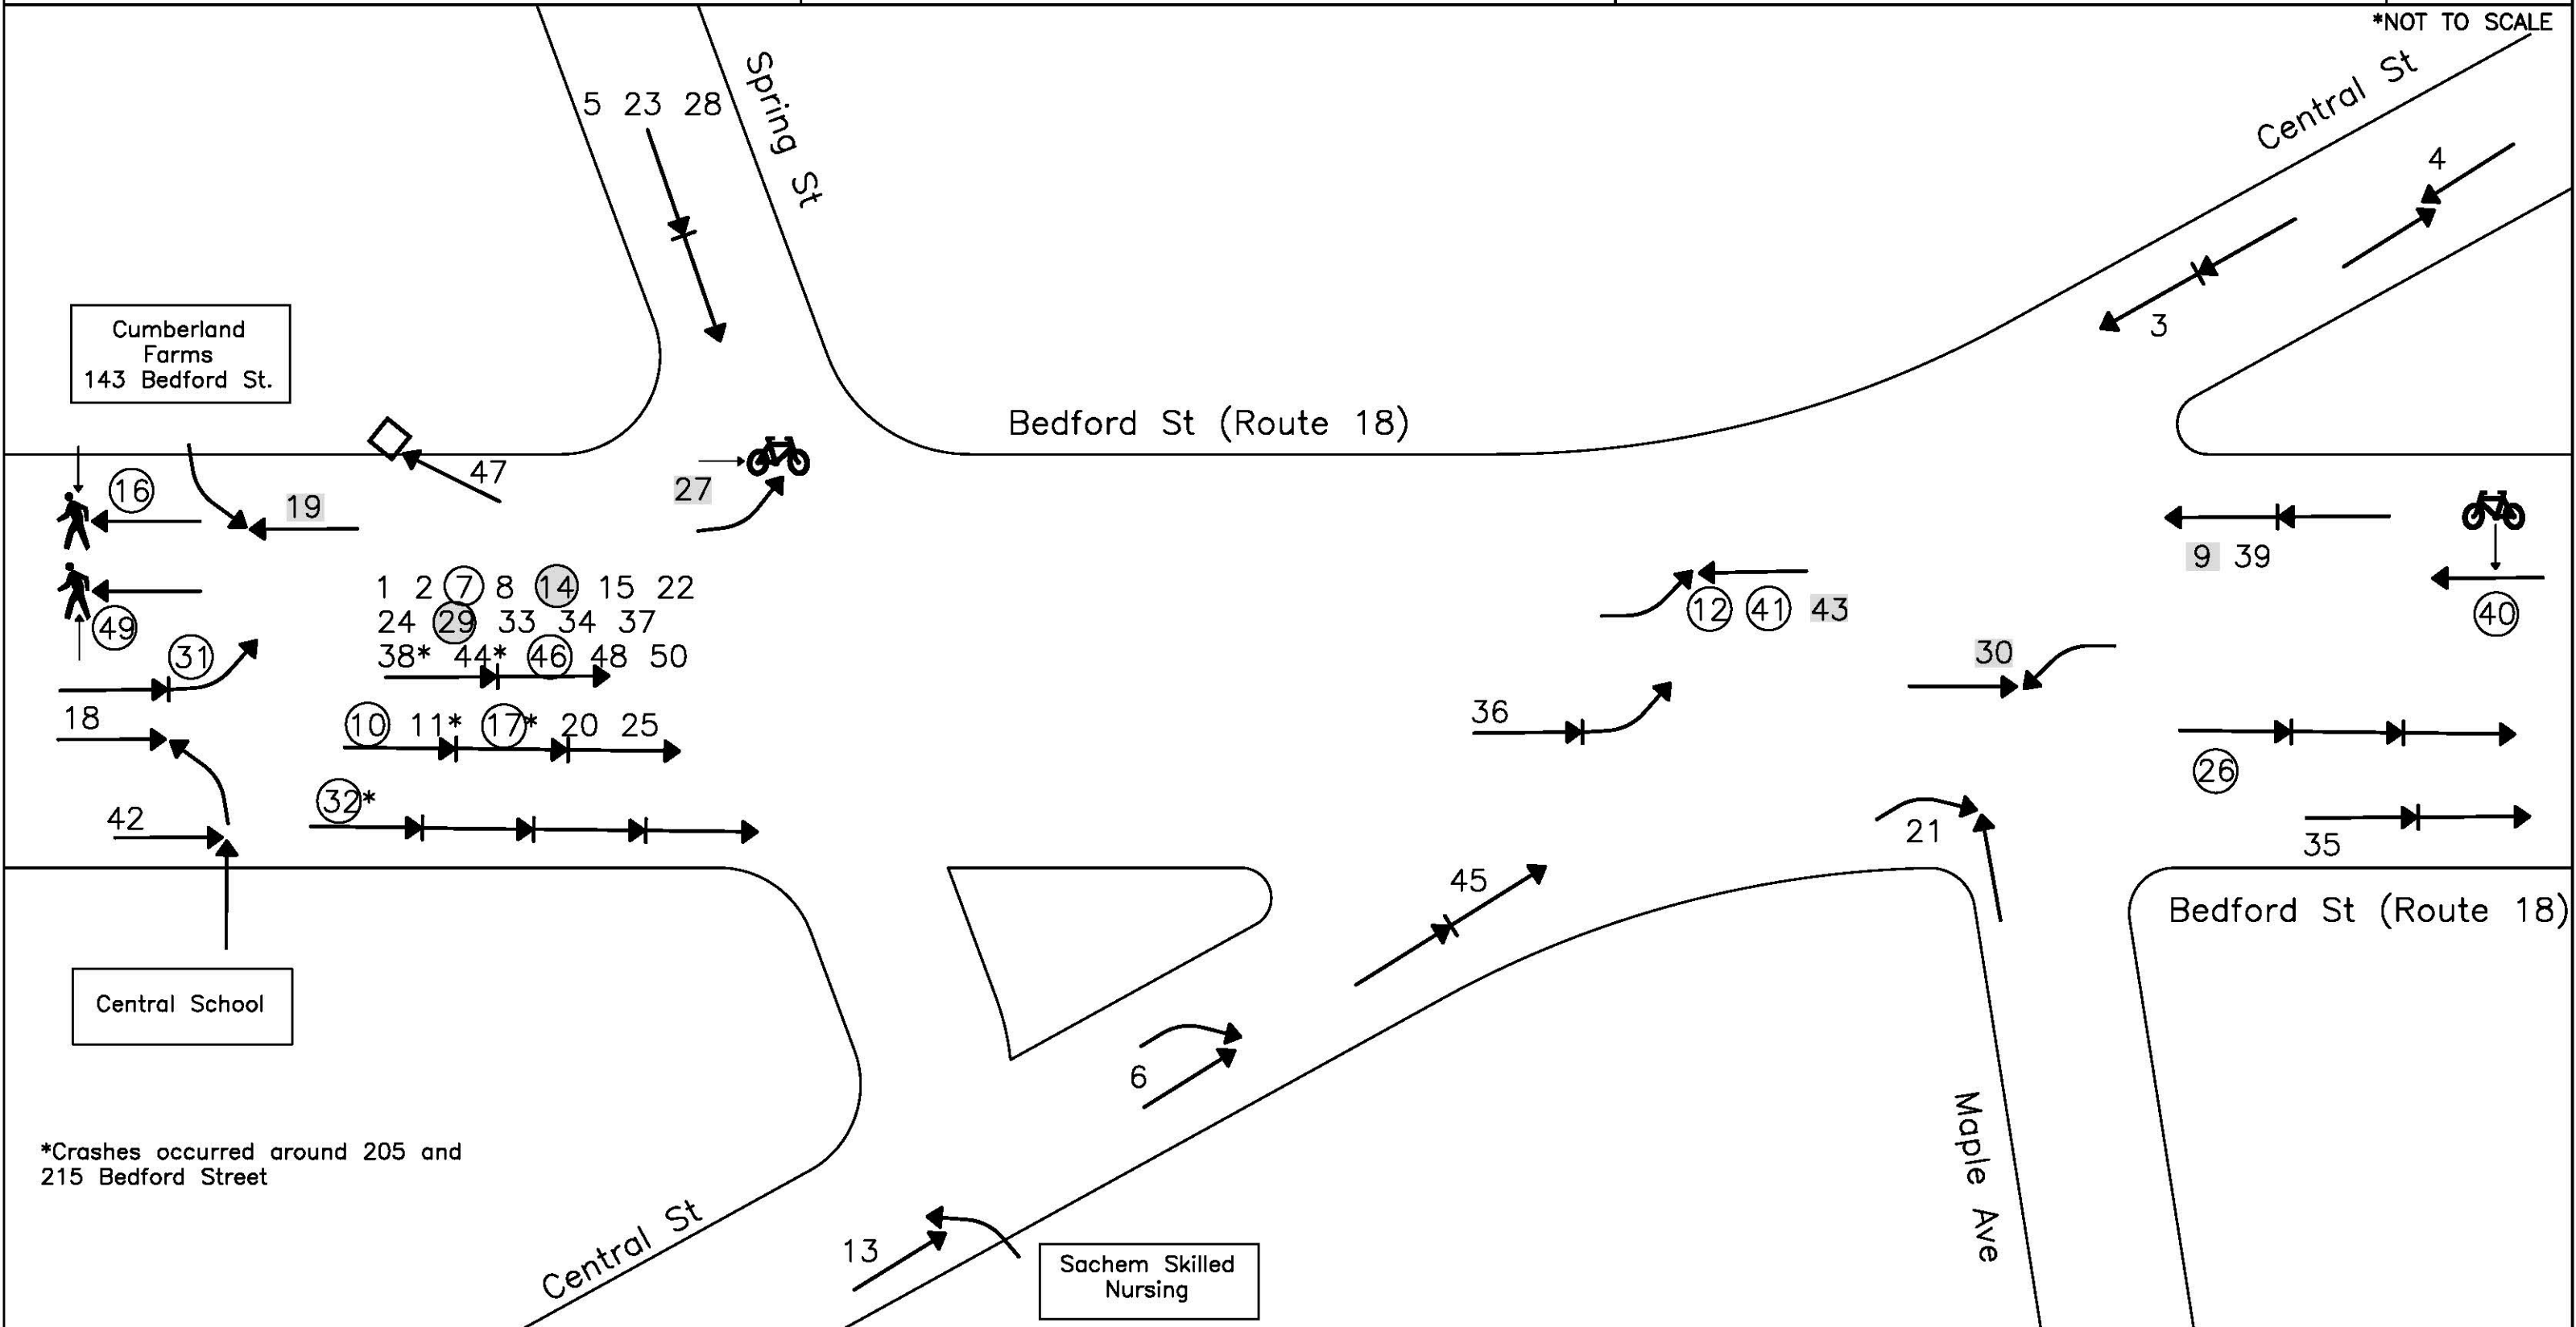
COLLISION DIAGRAM

Crash data provided by the East Bridgewater Police Department and summarized by MassDOT show 50 crashes occurred at the intersection for the three year period from 2011 to 2013. A crash data summary and a collision diagram are included in the Appendix. The most prevalent crash type were rear-end crashes, comprising 64% of all crashes. Of particular note are 23 rear-end crashes on Route 18 northbound. Crashes may be the result of signal visibility deficiencies, or may signify signal clearance violations and variances in driver aggression. Two rear-end crashes occurred northbound departing the intersection, one of which involved a vehicle that stopped for a pedestrian crossing the crosswalk that is located in advance of the southbound stop line on this leg. Three rear-end crashes occurred on the Spring Street approach, two on the Route 18 southbound approach, and one each on the Central Street approaches.

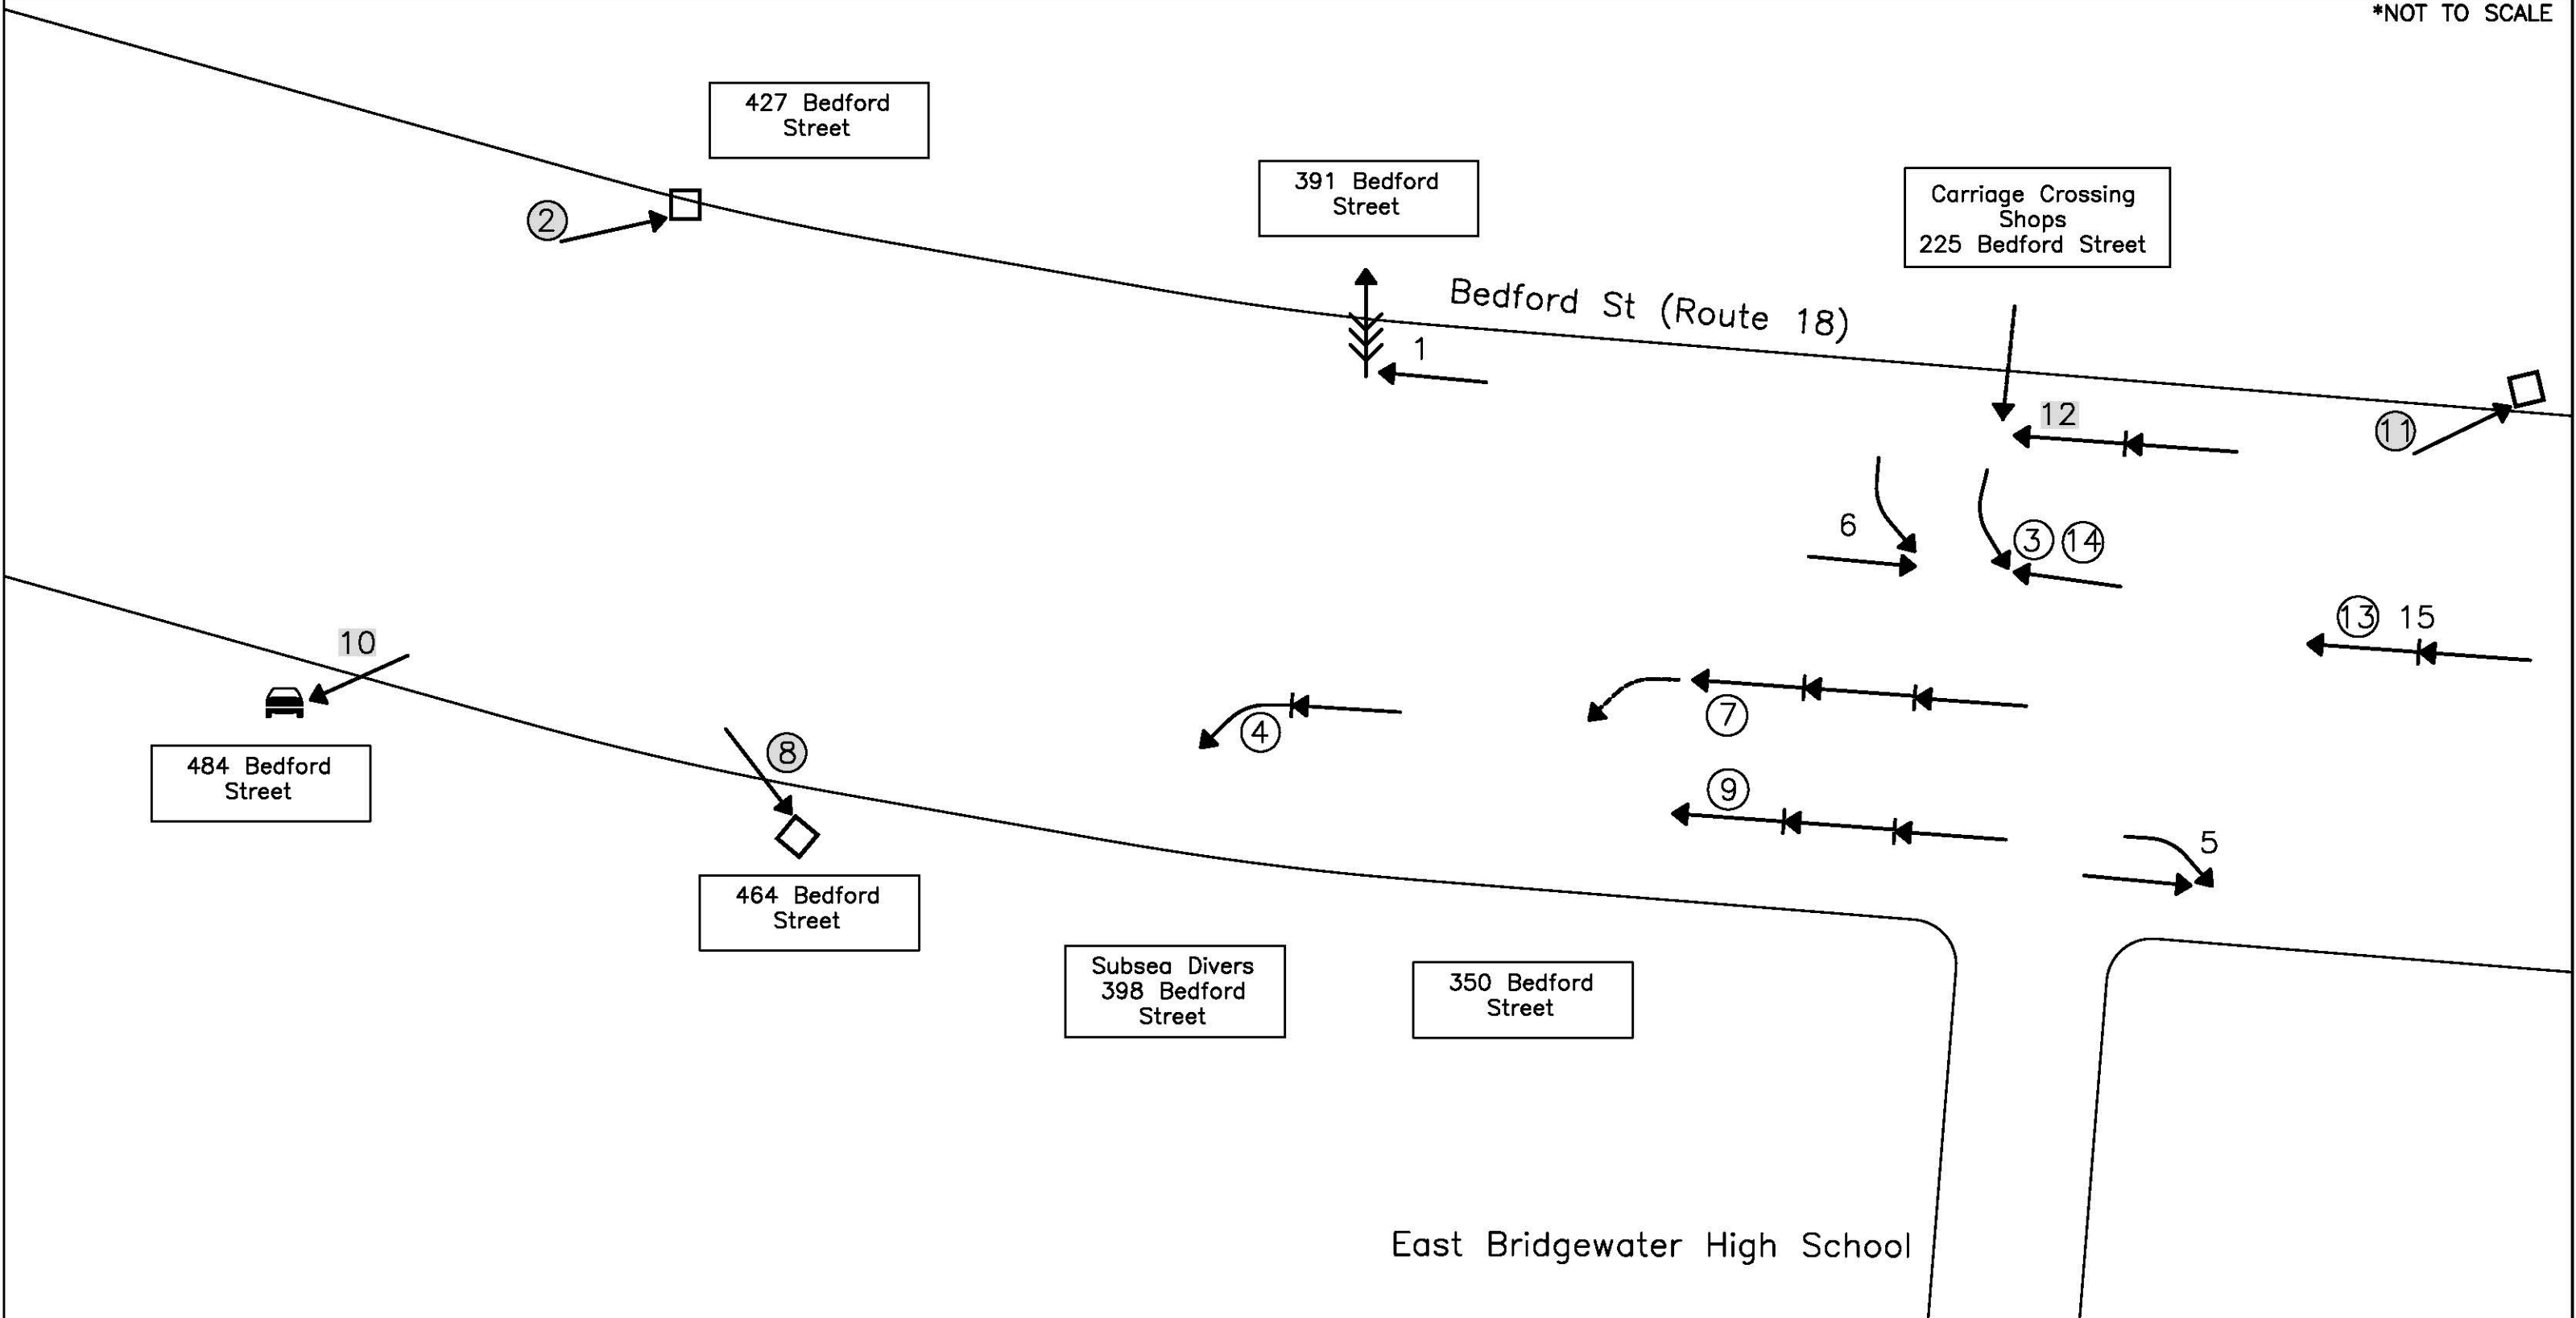
COLLISION DIAGRAM

Crash data provided by the East Bridgewater Police Department and summarized by MassDOT show 15 crashes in the area of the Carriage Crossing Shops for the three year period from 2011 to 2013. A crash data summary and a collision diagram are included in the Appendix. It should be noted that the access road to the high school opened in 2013.

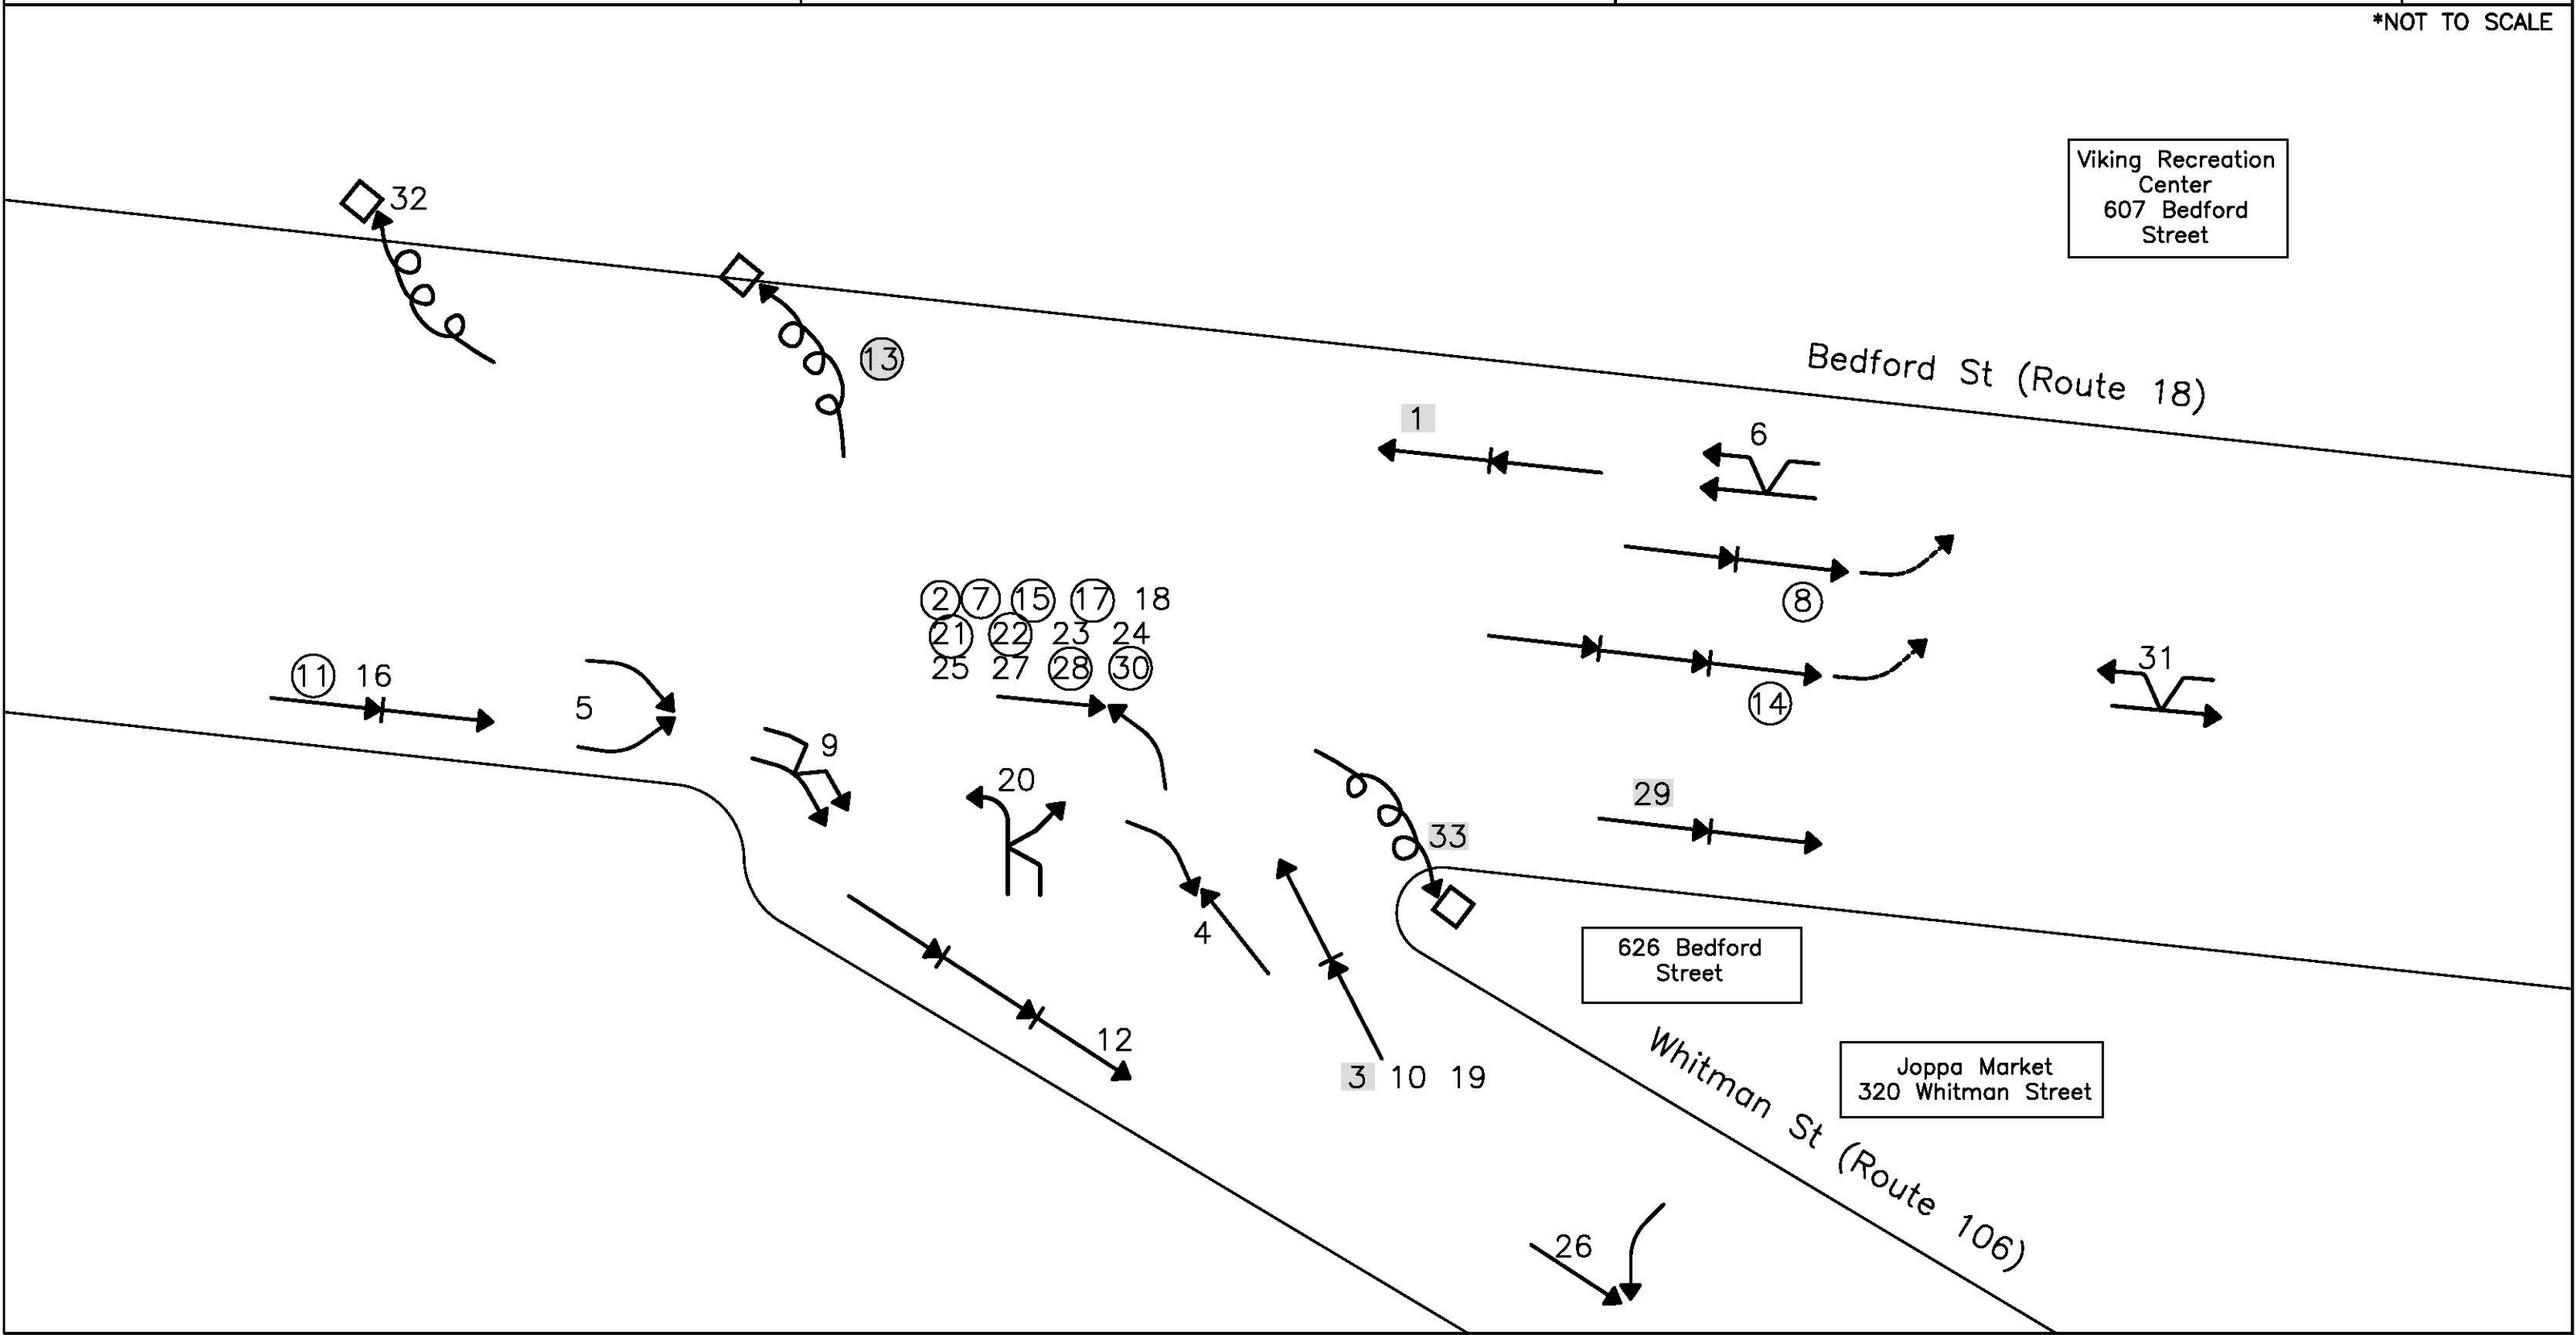
COLLISION DIAGRAM

Crash data provided by the East Bridgewater Police Department and summarized by MassDOT show 33 crashes occurred at the intersection for the three year period from 2011 to 2013. A crash data summary and a collision diagram are included in the Appendix. The most prevalent crash type were angle crashes, including 13 angle crashes between a northbound through vehicle and a vehicle departing Whitman Street. A closer look at these crashes reveals that most involved red light running, and several involved a driver who claimed to not see the red light. It was noted during a review of online imagery that the mast arm for northbound Route 18 traffic was replaced with a temporary post mounted signal. Local officials noted that the traffic signal constructed included a mast arm with overhead signals, and it was surmised that this mast arm was struck, knocked down, and subsequently replaced with a single post-mounted signal head at the mast arm foundation on the right side of the roadway. This signal head was supplemented by an existing post-mounted signal head on the left side of the roadway. Audit participants suggested that signal visibility issues created by the lack of overhead signals contributed to the crash history. MassDOT Highway Division District 5 noted that the mast arm was knocked down in July 2009 and replaced in July 2013. This includes the majority of the crash study period; it should be noted that no angle crashes occurred between a northbound through vehicle and a Whitman Street vehicle following re-erection of the mast arm.

Additional crashes at the intersection include eleven rear-end crashes, occurring both approaching and departing the intersection. Rear-end crashes approaching the intersection include three on Whitman Street, two on Route 18 northbound, and one on Route 18 southbound. Three rear-end crashes occurred departing the intersection northbound; two involved vehicles slowed or stopped to turn left into the Viking Recreation Center, while the third involved a driver reaction to an uninvolved vehicle. One rear-end crash involved a vehicle departing the intersection on Whitman Street. Also of noted are three crashes where vehicles ran off the road. Two of these crashes involved wet roadways.
