# ROAD SAFETY AUDIT

Route 53 (Washington Street) High Crash Locations  
at Route 139 (Schoosett Street)  
and Route 14 (Congress Street)

Town of Pembroke

April 29, 2016

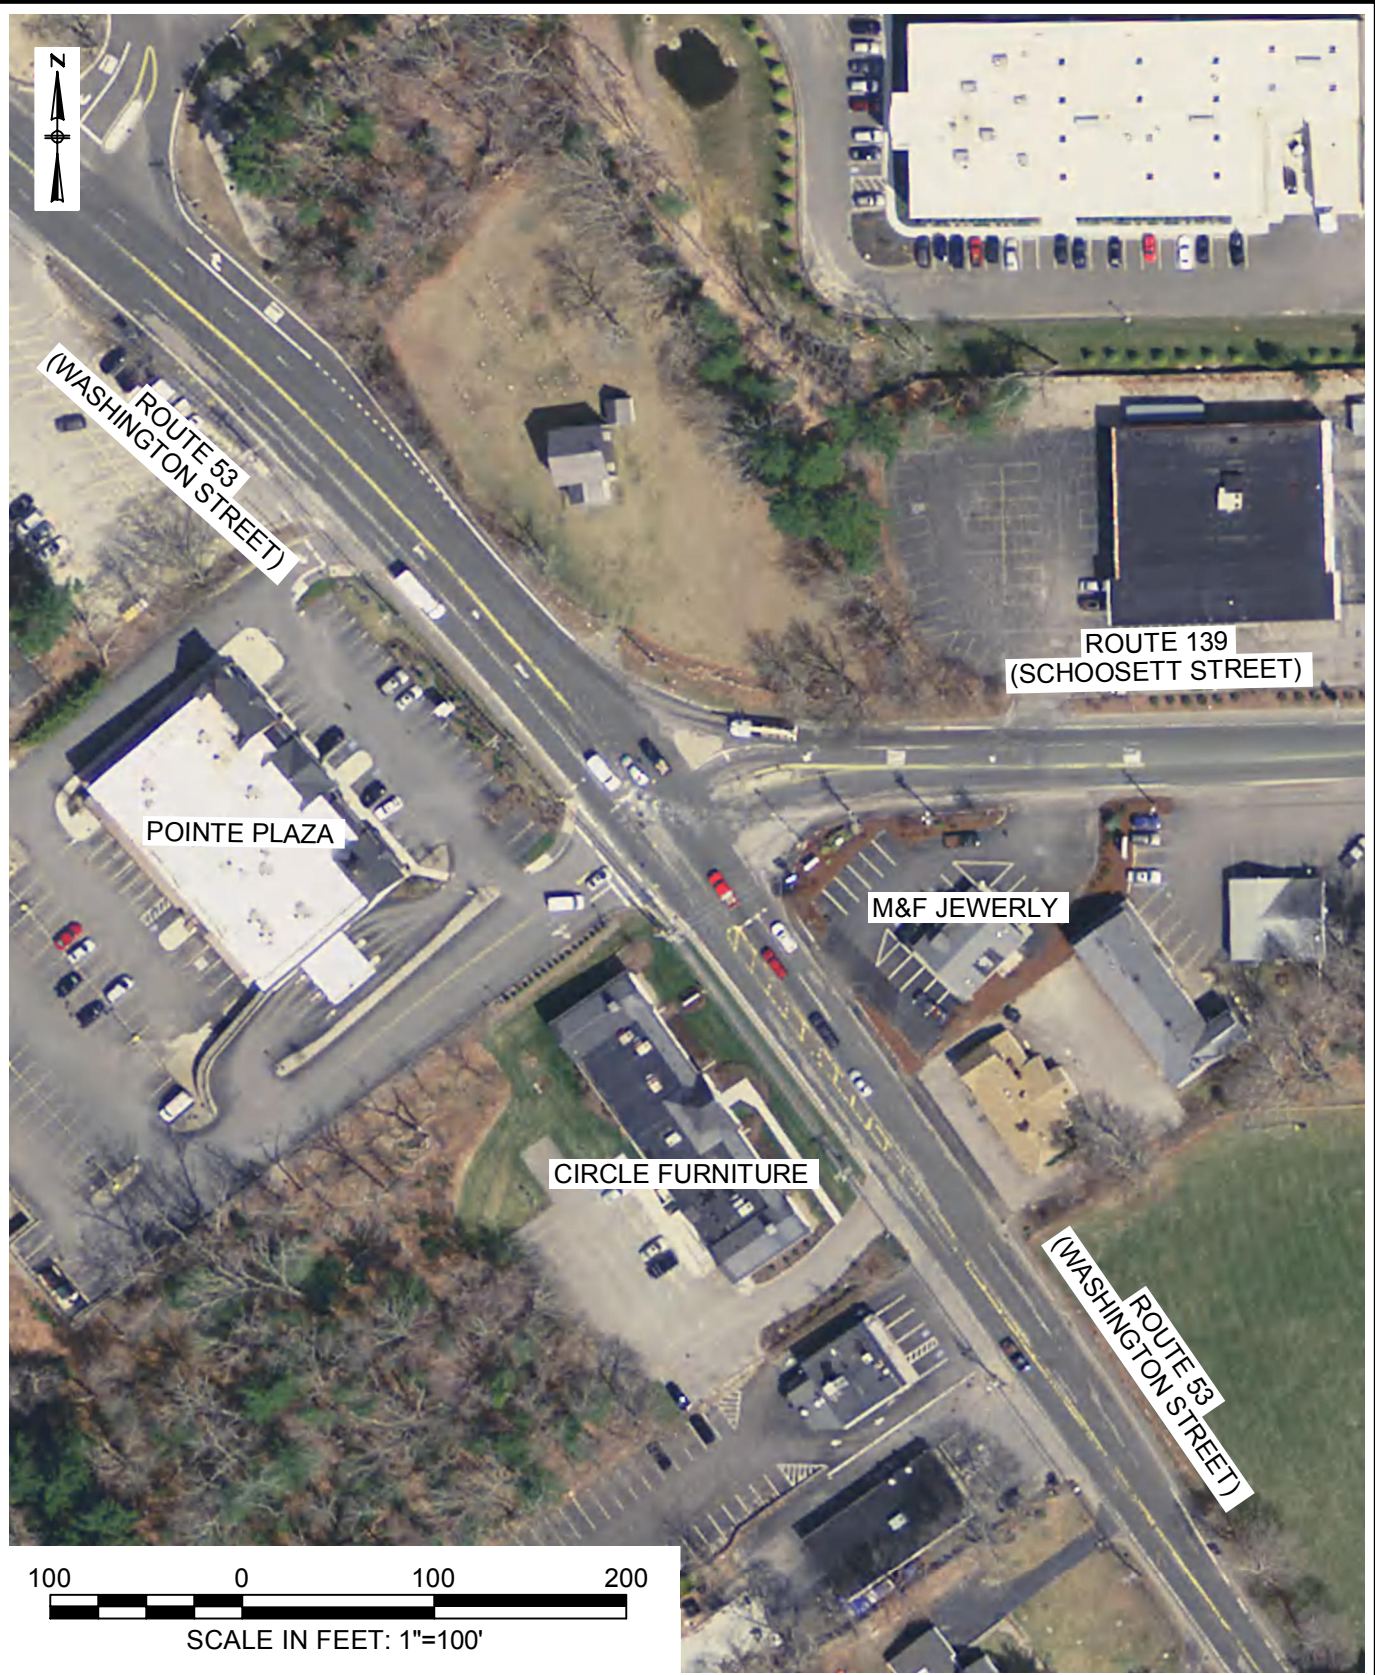
**Figure 2**

No pedestrian signals are provided at the intersection. Sidewalks are provided along the frontage of Circle Furniture and Pointe Plaza on the west side of Route 53, but do not extend for any significant length along Route 53 beyond the intersection. A crosswalk is provided across the Pointe Plaza approach. Sidewalk was recently constructed along the east side of Route 53 south of the intersection, and around the southeast corner of the intersection. It was noted by audit participants that no crosswalk is provided across Route 53, despite the presence of sidewalk on both sides of the roadway on the southern leg of the intersection.

Pavement markings are faded at the intersection. As previously noted, arrow and only markings in the left lane of the Schoosett Street approach appear to prohibit through movements to Pointe Plaza, although they are accommodated from within this lane. A solid white edge line is provided to delineate a shoulder, but widths are not sufficient to safely accommodate bicycles.

crashes were most prevalent between a southbound left-turning vehicle and a northbound through vehicle. It is assumed that the majority of these crashes occurred during the permissive phase and are the result of drivers taking chances on unacceptable gaps. Town personnel estimated that the flashing yellow arrow for the southbound left turn movement was installed within the last few months, and it should be noted that all crashes occurred prior to that installation. Of note are two angle crashes north of the intersection involving northbound left turning vehicles; one was turning into a paint store north of the Pointe Plaza, while the other was erroneously turning into a one-way exit from the plaza.

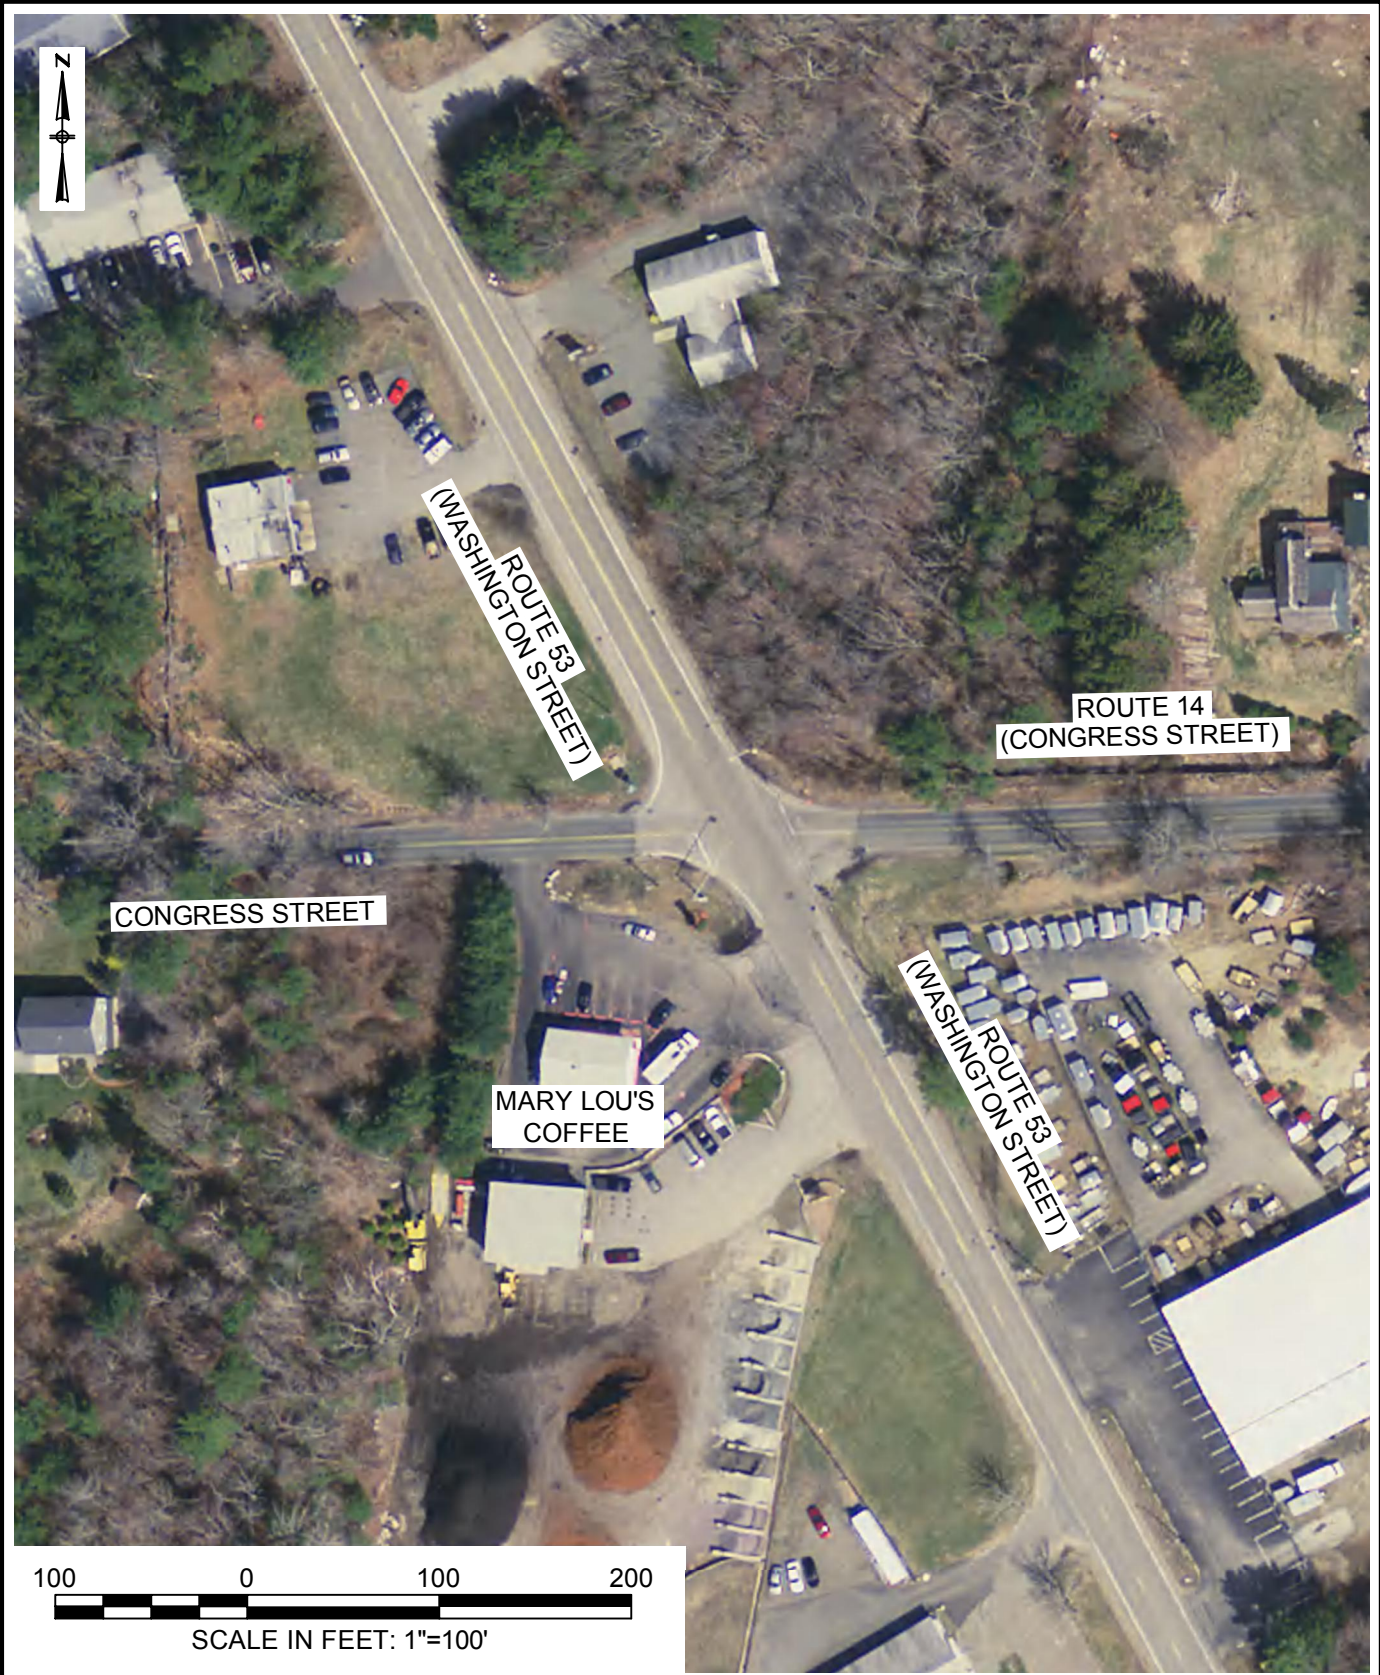
The most prevalent crash type were angle crashes, comprising 83% of all crashes. Six angle crashes involved vehicles departing Congress Street westbound; three collided with a northbound vehicle, while three collided with a southbound vehicle. Three additional angle crashes involved an eastbound vehicle and a northbound vehicle. One angle crash involved a northbound turning vehicle and a southbound vehicle. The two non-angle crashes in the study period were a rear-end crash where both vehicles were turning left to Congress Street westbound, and a head-on crash where solar glare was cited as a contributing factor. Seven of the twelve total crashes occurred between 2 PM and 6 PM.

Speed regulations included in the Appendix establish a 50 mph regulatory speed limit for Route 53 in the vicinity of Congress Street. No signs are provided enforcing this regulatory speed limit in the vicinity of the intersection.
