# ROAD SAFETY AUDIT

Route 18 (Bedford Street) at  
Auburn Street (Route 14) and Temple Street (Route 27)  
Town of Whitman

March 3, 2015

Prepared By:  
BETA Group, Inc.

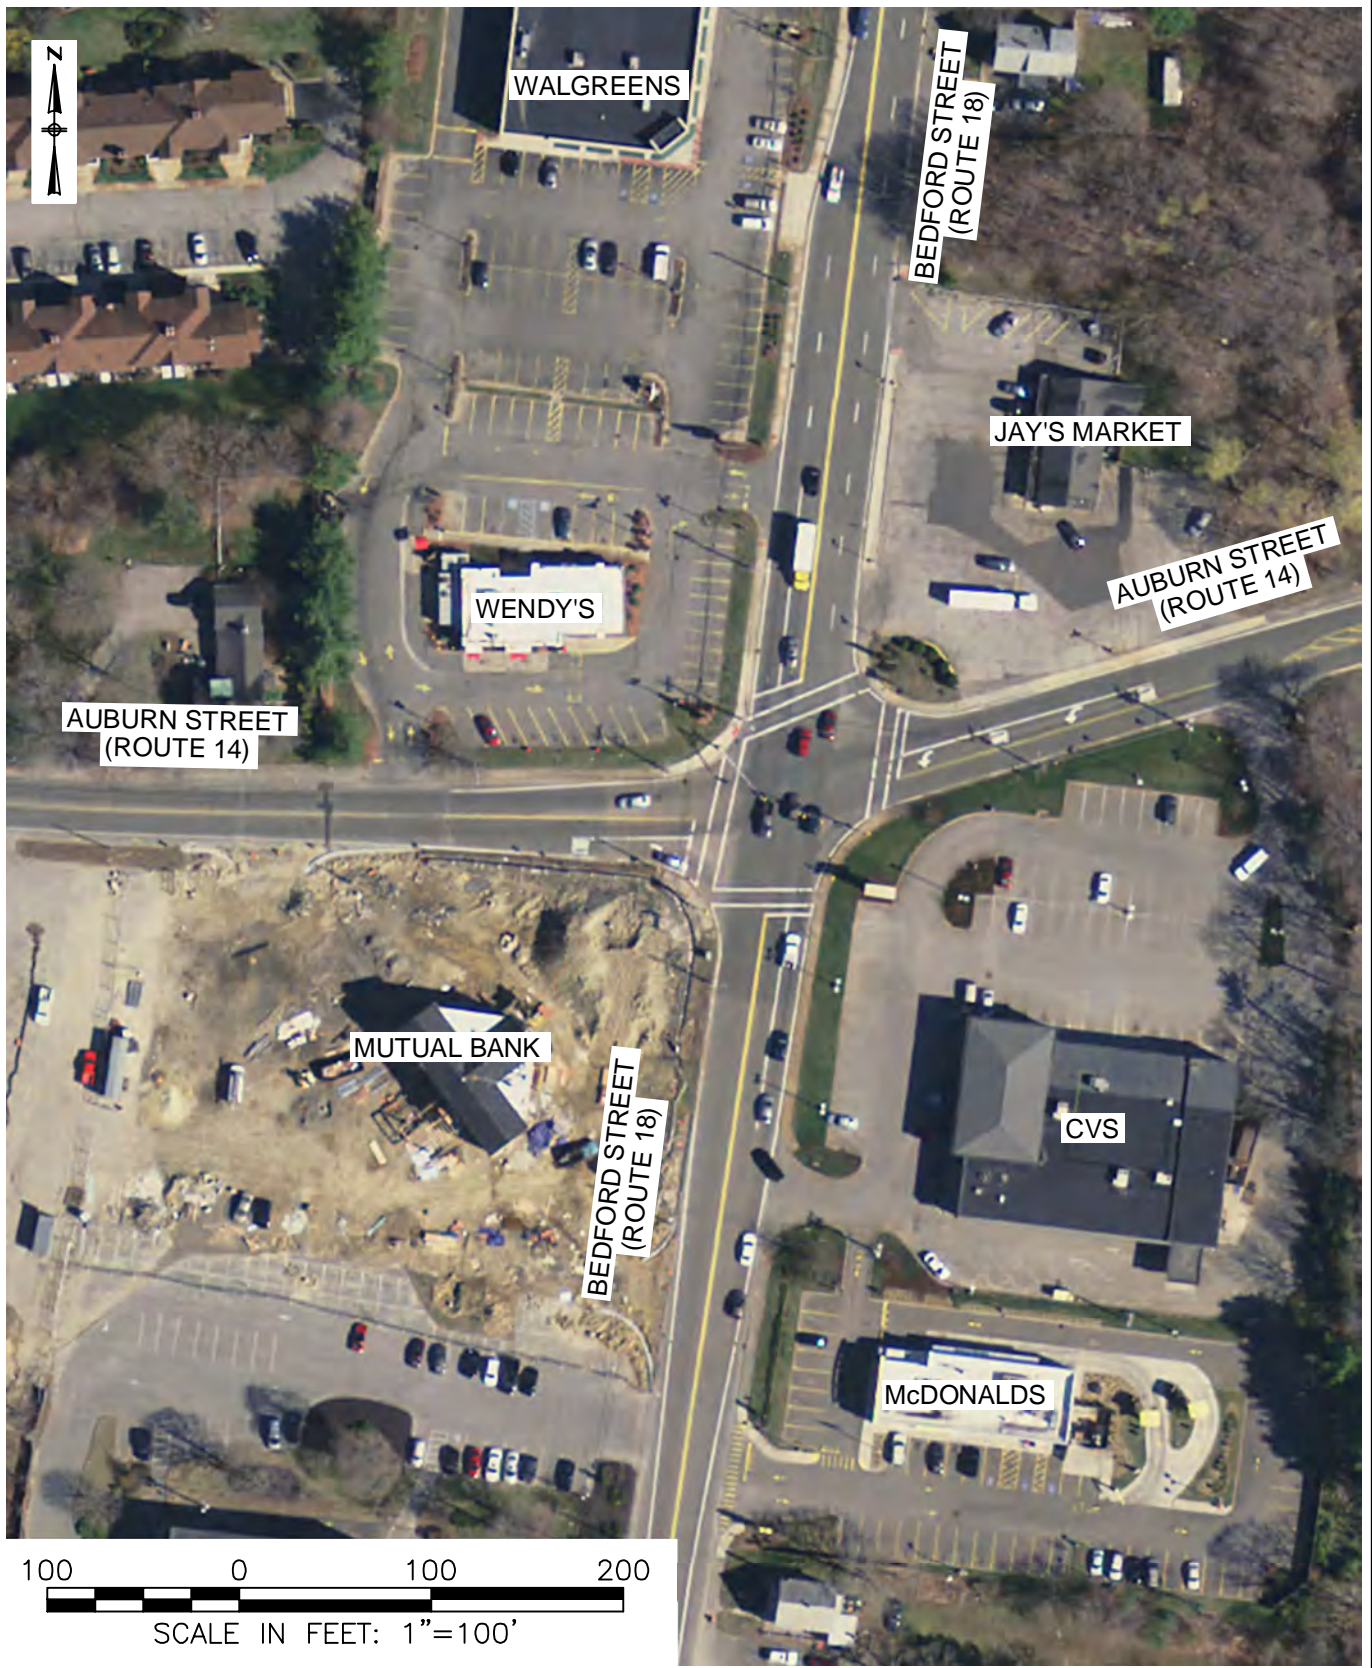
Location Detail  
(Bedford Street at Auburn Street)

Bedford Street provides two lanes in each direction at Auburn Street, with turns accommodated within shared lanes. A solid white edge line is provided to delineate a shoulder, but widths are not sufficient to safely accommodate bicycles. The northbound and southbound approaches widen to two lanes at the intersection and merge back to a single lane departing the intersection. The northbound approach widens to two defined lanes just north of the shared CVS/McDonald's driveway, approximately 110 feet in advance of the northbound stop line. The roadway provides two lanes northbound departing the intersection

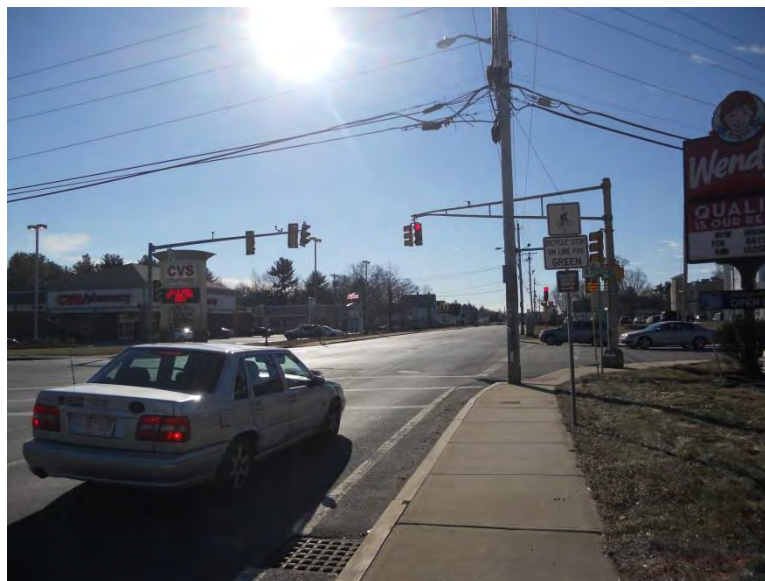
**Bedford Street at Auburn Street (looking south)**

for approximately 380 feet before merging back to a single lane. It was noted that drivers show aggressive tendencies when traveling through the intersection because they are aware of the impending merge and want to “beat” the driver in the adjacent lane. The southbound approach provides two defined lanes for approximately 225 feet in advance of the stop line. The roadway provides two defined lanes in the vicinity of the shared Wendy's/Walgreens driveway, which is approximately 100 feet in advance of the stop line. The roadway provides enough width for two lanes for approximately 100 feet departing the intersection southbound, but is not marked as such.

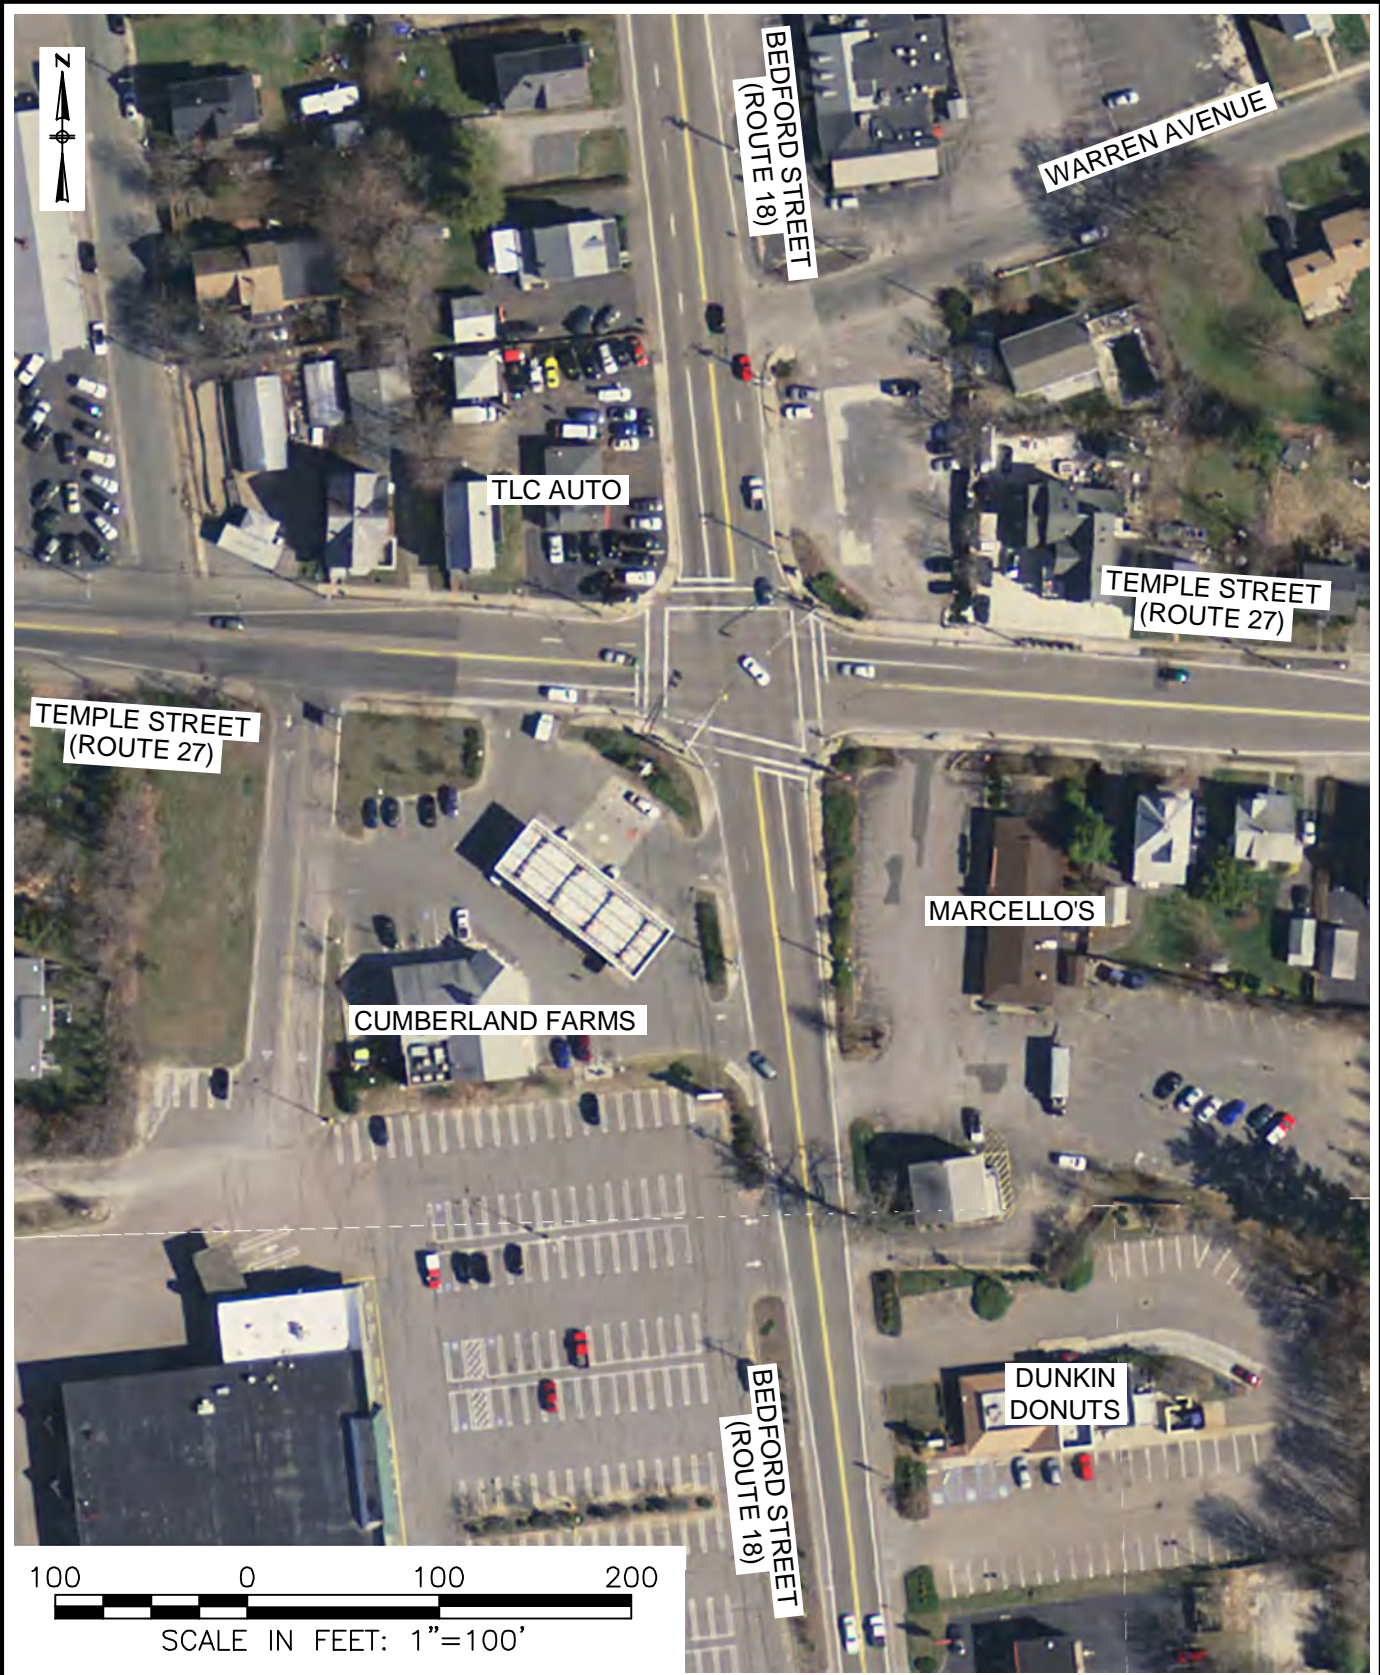
Location Detail  
(Bedford Street at Temple Street)

northbound departing the intersection for approximately 110 feet before merging back to a single lane in the vicinity of Warren Avenue, which intersects Bedford Street from the east. The southbound approach provides two defined lanes for approximately 320 feet in advance of the stop line. The roadway provides enough width for two cars to travel side by side immediately departing the intersection, but is not marked as such.

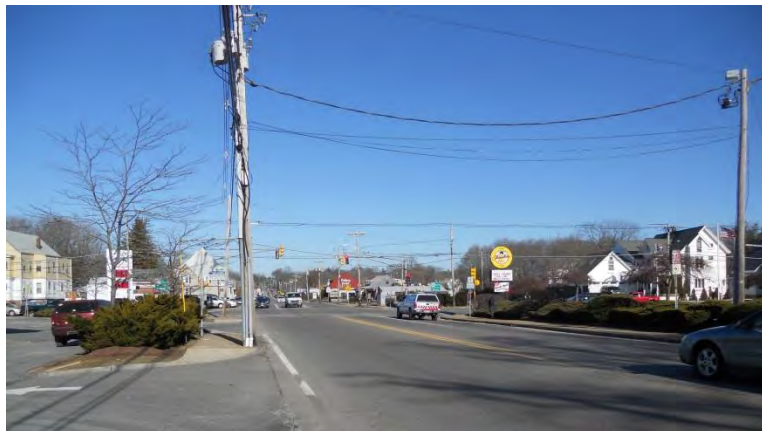
**Bedford Street at Temple Street (looking north)**

Temple Street (Route 27) generally provides a single lane in each direction, but widens to provide two shared lanes in each direction at Bedford Street. The two lane section extends approximately 100 feet eastbound and approximately 60 feet westbound departing the intersection before merging back into a single lane. A solid white edge line is provided to delineate a shoulder, but widths are not sufficient to safely accommodate bicycles.
