ROAD SAFETY AUDIT

Intersection of Bay Road, Chestnut Street, Depot Street,
Standish Street, and Washington Street
(Hall's Corner)

Duxbury, Massachusetts

October 16, 2023

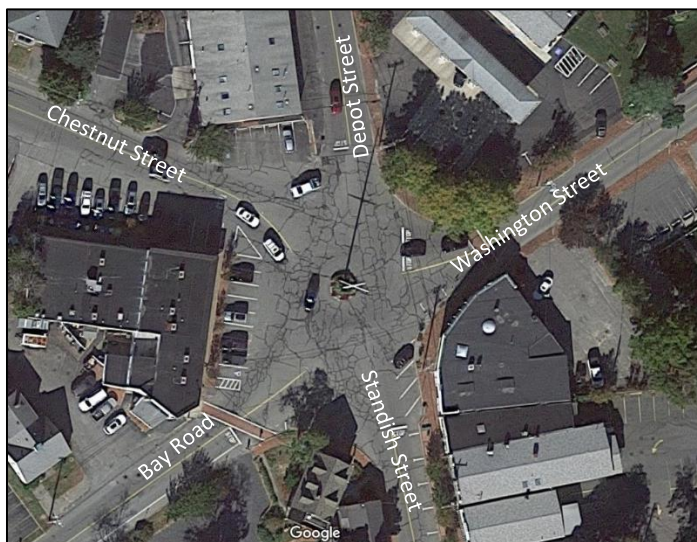
Aerial view of Hall's Corner in Duxbury showing traffic circle in the center and five intersecting streets.

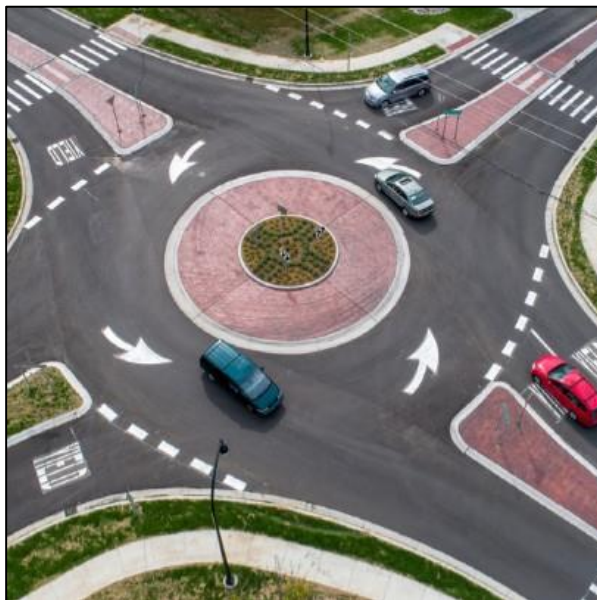
Safety Issue: There is a wide pavement area on the Bay Road and Washington Street approaches and an extensive wide area of pavement for vehicles to travel through the intersection from all approaches (approximately 160 by 90 feet of width). This wide area in combination with lack of pavement markings creates driver and road user confusion.

Enhancement: Evaluate pavement markings, signs on all approaches, advanced warning, and traffic control, to create a traffic control plan and sign plan for channeling traffic around the circle. Consider street design with geometric changes to accommodate and provide safe movement for all road users.

An illustration of a mini roundabout with mountable apron and mountable splitter islands on approaches. In addition, crosswalks and pedestrian refuge islands are included for safe pedestrian crossings.
