ROAD SAFETY AUDIT AND TRAFFIC STUDY

Palmer Road (Route 58) at Center Street

Municipality of Plympton, MA

June 18, 2024

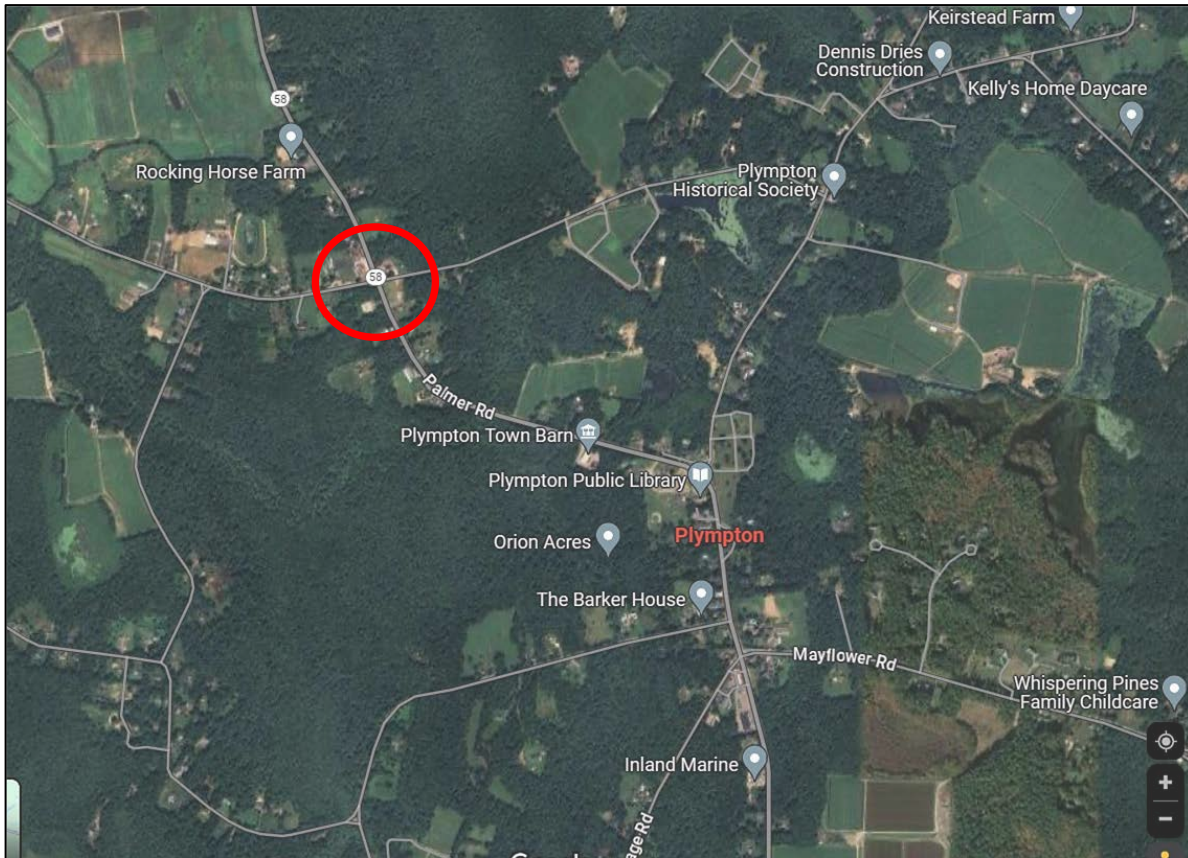
Figure 1: Locus Map

This Road Safety Audit (RSA) and Traffic Study was completed by the Old Colony Planning Council (OCPC) at the request of the Town of Plympton. The study request was initiated due to speeding, safety concerns, and historic crashes at the intersection of Route 58 at Center Street in Plympton. The location of the intersection is shown in Figure 1.
