ROAD SAFETY AUDIT

Avon Center

Main St. (Route 28) at East High St and West High Street to
Main Street (Route 28) at East Main Street and West Main Street

October 9, 2024

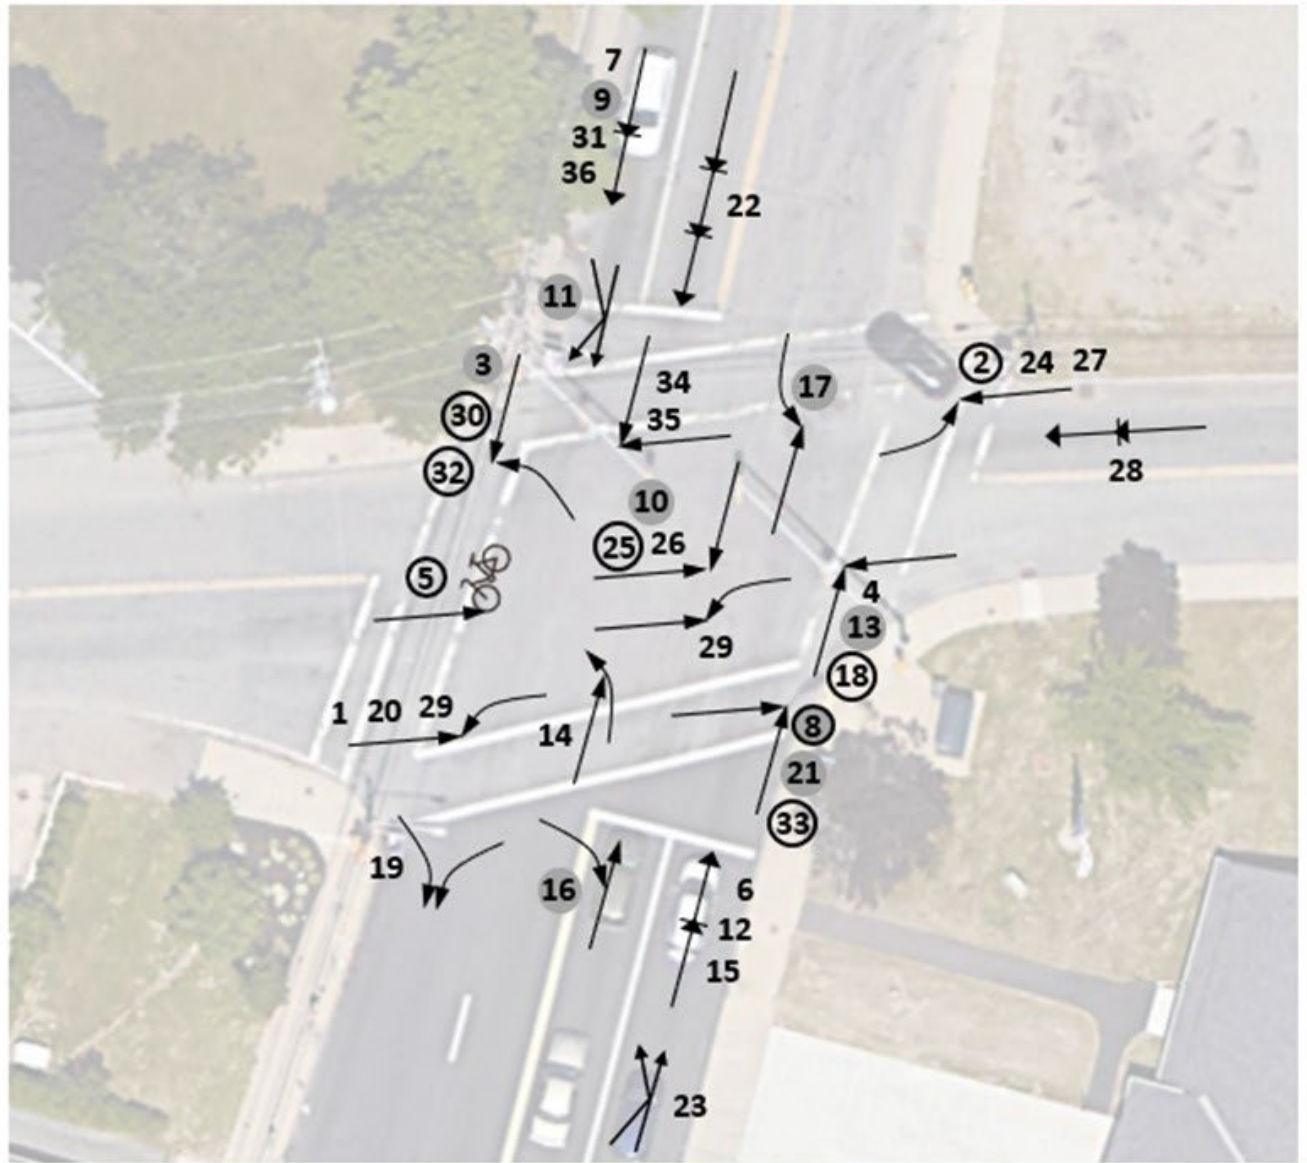
Old Colony Planning Council	Avon, MA Main/North Main Streets at East/West High Streets
COLLISION DIAGRAM	TIME PERIOD ANALYZED: 2019, 2020, 2021, 2022 and 2023 SOURCE OF CRASH REPORTS: AVON POLICE DEPARTMENT; SUPPLEMENTED BY MASSDOT DATA PREPARED TIME: September 19, 2024 PREPARED BY: Shawn Bailey

There were 36 crashes at this intersection within the 5-year study period, of which 36 percent were angle type crashes. The crash time of day trended between noon and 6 PM, and the light conditions were daylight for 67 percent of the crashes. The surface conditions were dry for 72 percent of the crashes and the age of the drivers trended toward the younger ages with 64 percent of the drivers under the age of 40 (41 percent being between 20 and 29). Eight of the 36 crashes resulted in personal injury, with the remainder being property damage only. The intersection of East High Street/West High Street/Main Street (Route 28) was identified as a Top 5% Highway Safety Improvement Program (HSIP) crash cluster for the years 2017-2019 within OCPC region.
