ROUTE 18 CORRIDOR STUDY

INCLUDING THE TOWNS
OF
ABINGTON, WHITMAN,
EAST BRIDGEWATER, & BRIDGEWATER, MASSACHUSETTS

PREPARED BY
OLD COLONY PLANNING COUNCIL
70 SCHOOL STREET
BROCKTON, MA 02301
UNDER MASSDOT CONTRACT # 0052455

NOVEMBER, 2009

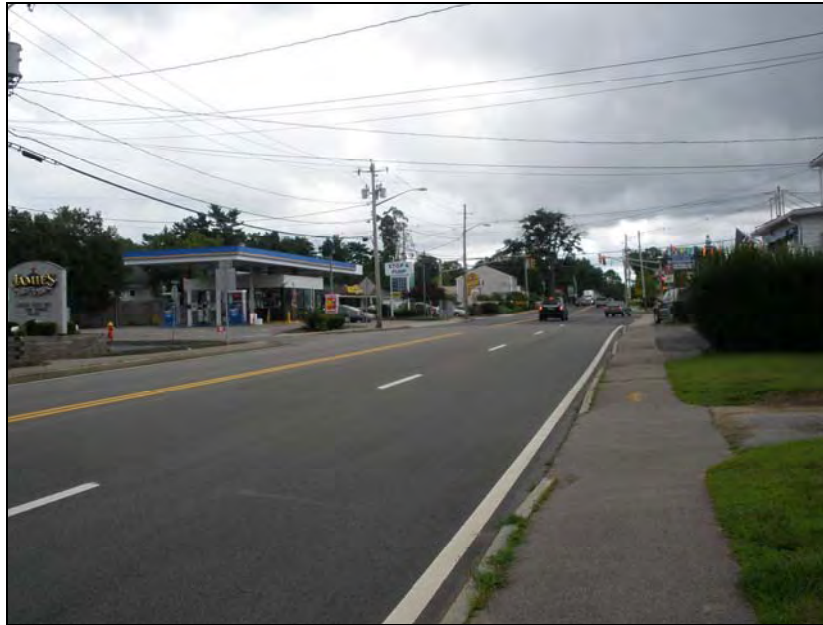
Resurfacing Route 18 in Whitman at the Route 27 intersection

Table 4 shows one Route 18 improvement project in Whitman; the resurfacing of Route 18 from Joyce Avenue to the East Bridgewater Town Line, which is currently under construction.

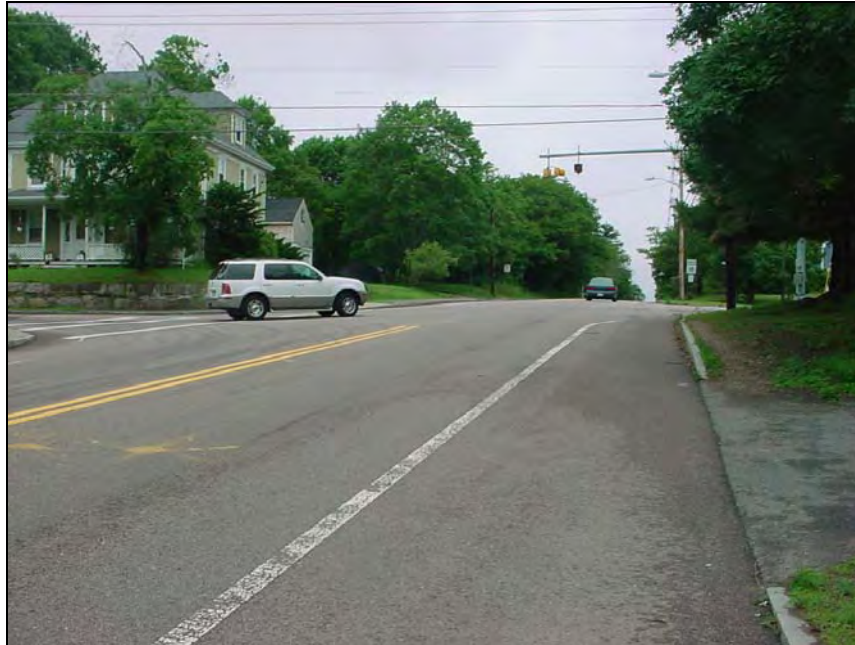
Route 18 Broad Street at High Street in Bridgewater

There are two proposed improvement projects for Bridgewater listed in Table 4, including resurfacing of Route 18/28 Bedford Street and the installation of traffic signals at Route 18 Broad Street at High Street. The Bridgewater portion of the resurfacing project is complete, and the signal project is currently under design by MassDOT.

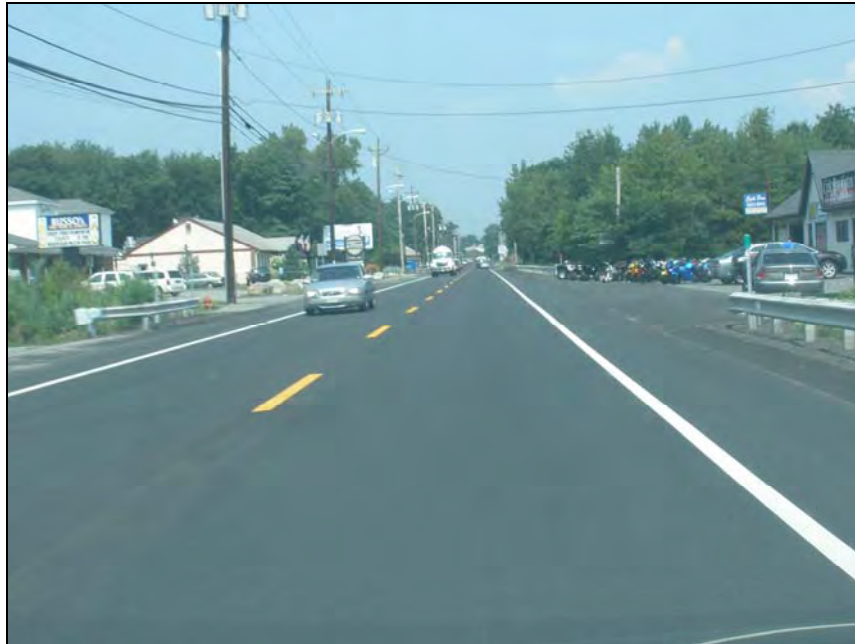
Route 18/28 Bedford Street in Bridgewater

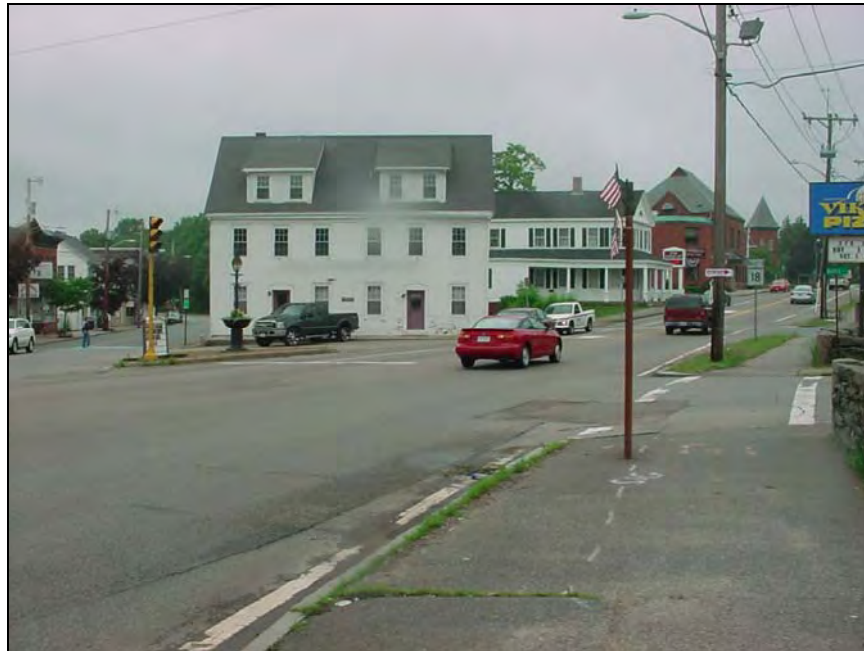
East Bridgewater Center looking north toward mid-block crossing on Route 18

Other improvements discussed for East Bridgewater Center include the enhancement of signage and crosswalks for pedestrian safety within the center. Although there is a pedestrian actuated signal currently at the signalized Route 18/Central Street/Spring Street/Maple Street intersection, there is a mid-block crosswalk across Route 18 in the center located just north of Maple Street and Central Street.

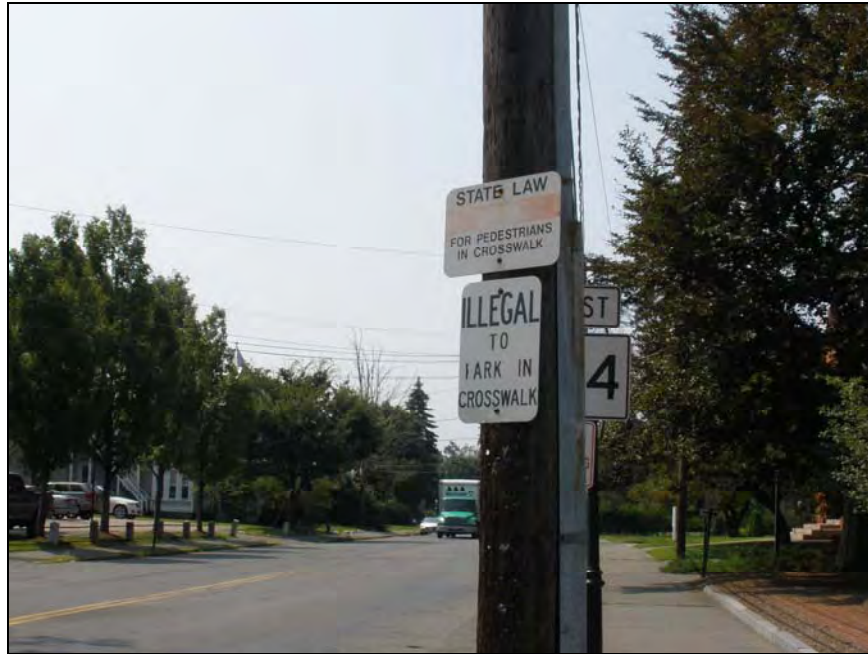
Faded pedestrian sign on Route 104 at Central Square intersection

Other improvements for Central Square include upgrading signage and adding more signs in the square to alert motorists of pedestrian crossings. In addition, pedestrian visibility features such as lighted crosswalks should be considered. An example of such features is present in Plymouth along Route 4A across from Memorial Hall.

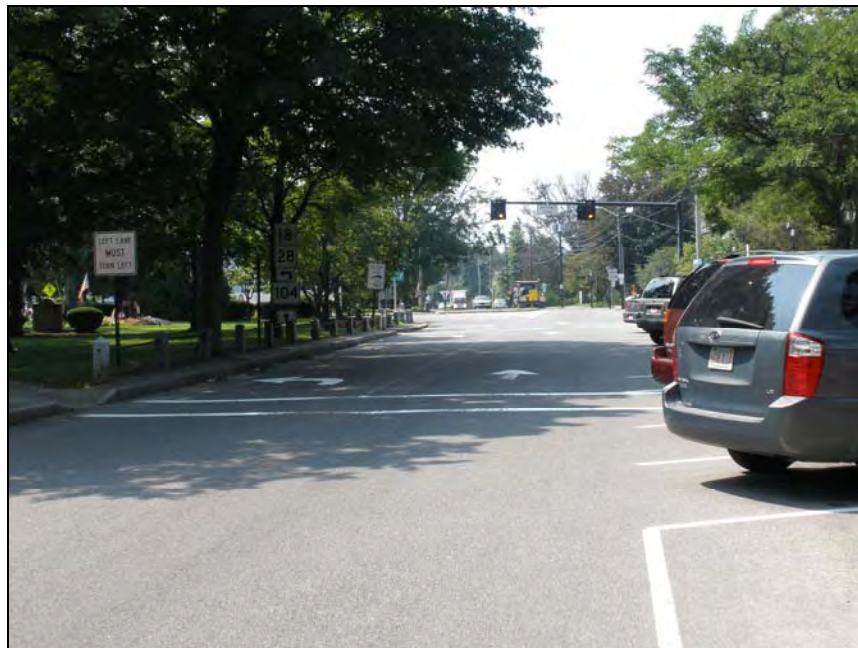
Lack of pedestrian warning signs looking southbound in Central Square

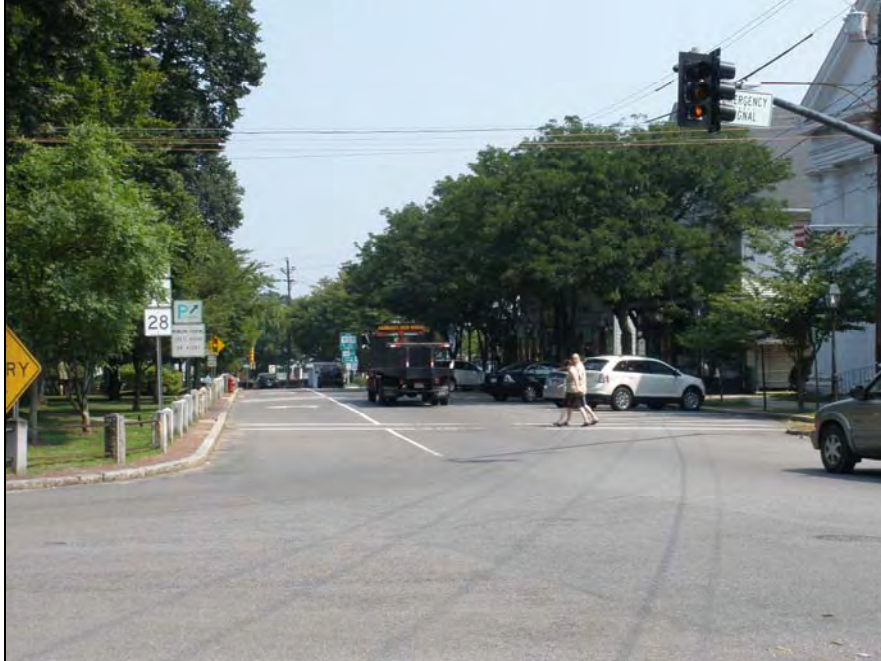
Lack of pedestrian warning signs in Central Square looking northbound
